# WMSC Commissioner Brief: W-0133 – Improper Roadway Worker Protection – near Forest Glen Station – August 6, 2021

Prepared for Washington Metrorail Safety Commission meeting on December 7, 2021

## FINAL REPORT OF INVESTIGATION A&I E21345

## Forest Glen – Improper Roadway Worker Protection

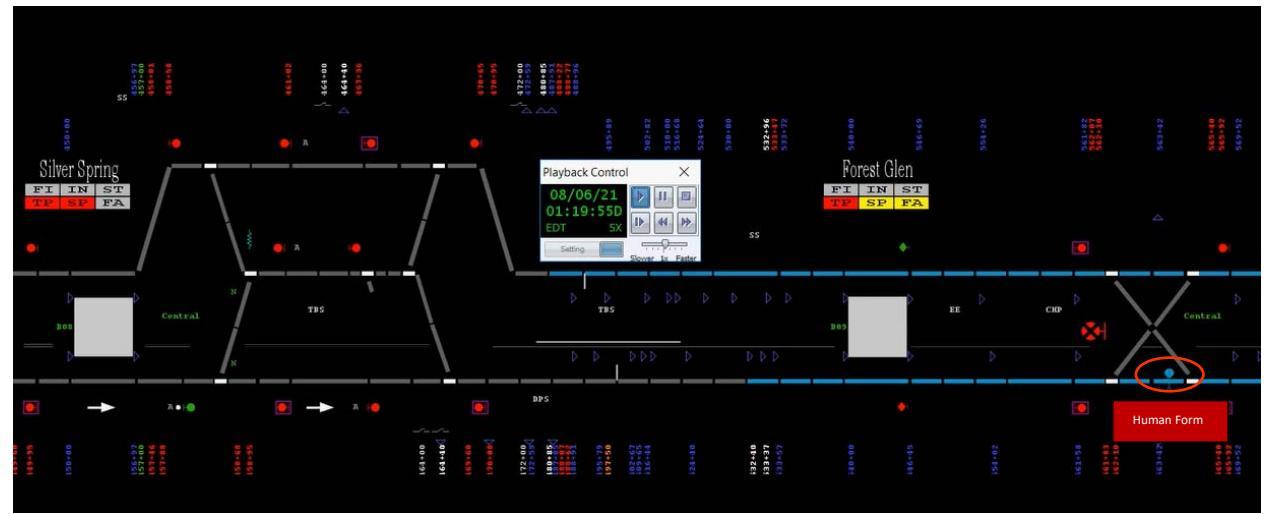
At approximately 01:19 hours, a Power Maintenance Crew requested permission to enter the roadway under foul time between CM B1 547+00 and B1 564+00. The AIMS display verified that signals B08-44, B08-36 were red, and B08-38 signal was prohibited, and human form was in place at Forest Glen Interlocking. The Radio RTC granted the Power Maintenance Crew personnel foul time to enter track one at Forest Glen Station to perform switching and hot sticking.

Image 1 – Human Form in place at Forest Glen Station Interlocking.

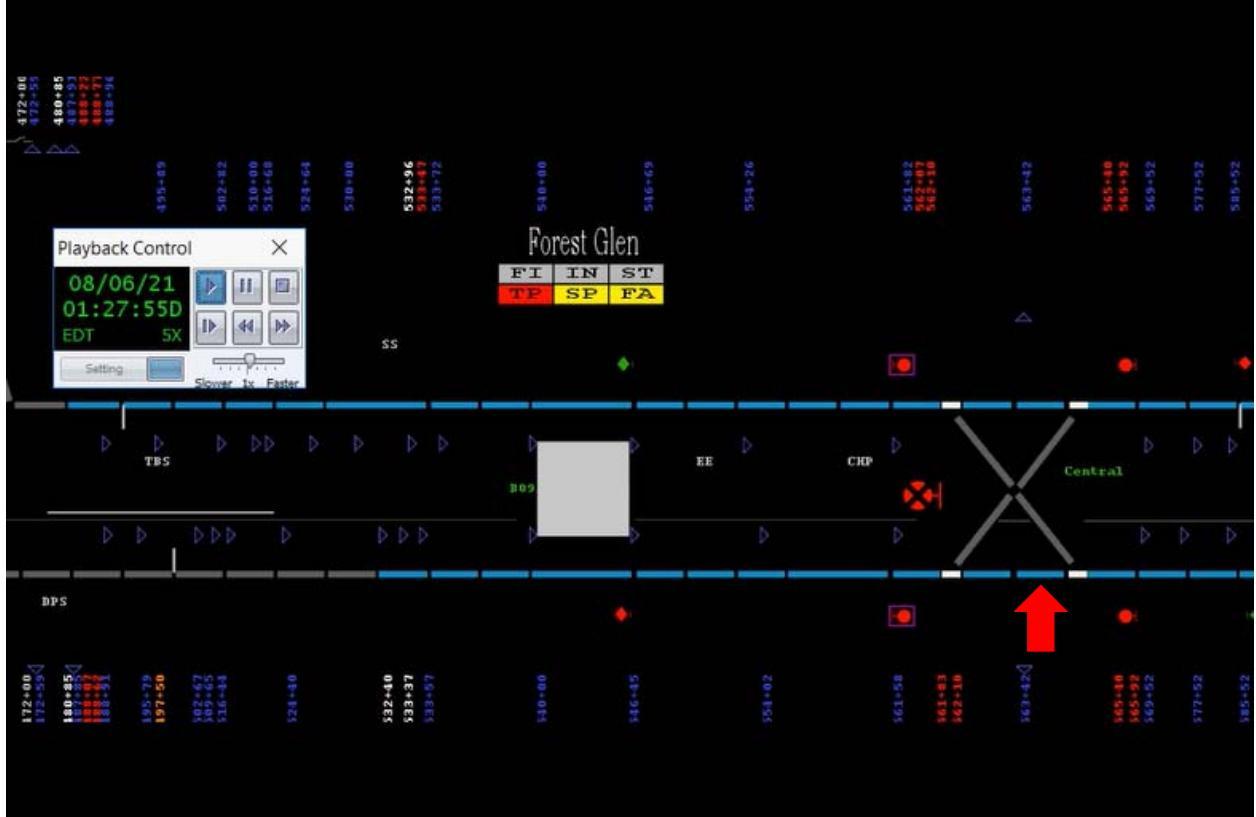
At approximately 01:26 hours, a different Power Maintenance Crew located at Wheaton Station, also operating under foul time protection, relinquished their protection with the Radio RTC between CM B1 637+00 and B1 632+00. At approximately 01:27 the foul time protection in human from was removed from the AIMS Display at Forest Glen Interlocking.

Image 2 – Human Form removed while Power Maintenance Crew are still under foul time protection.

It was at this time that the Radio RTC confused the two Power Maintenance Crews that were working at Forest Glen Station and Wheaton Station. The Power Unit located at Forest Glen Station had not relinquished their foul time. The Radio RTC confirmed during the interview that they advised the Buttons RTC that the Power Maintenance Crew that was located at Forest Glen Station had relinquished their foul time causing the Buttons RTC to remove the human form protection from the AIMS Display at Forest Glen as well. This action was a violation of MSRPH Section 5 - RWP, 5.13.5 Foul Time Protection.

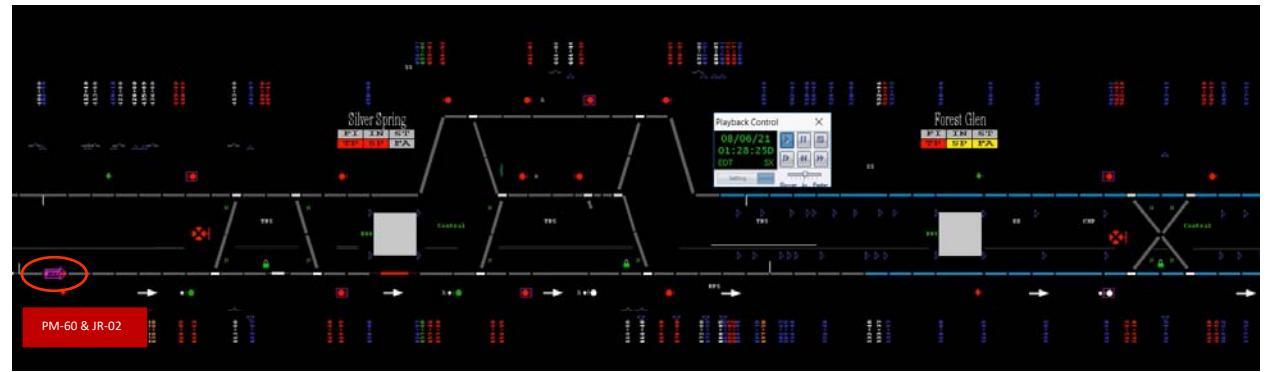
Image 3 – Signal B08-36 set to normal as Track Unit PM-60 approaches Silver Spring Station.

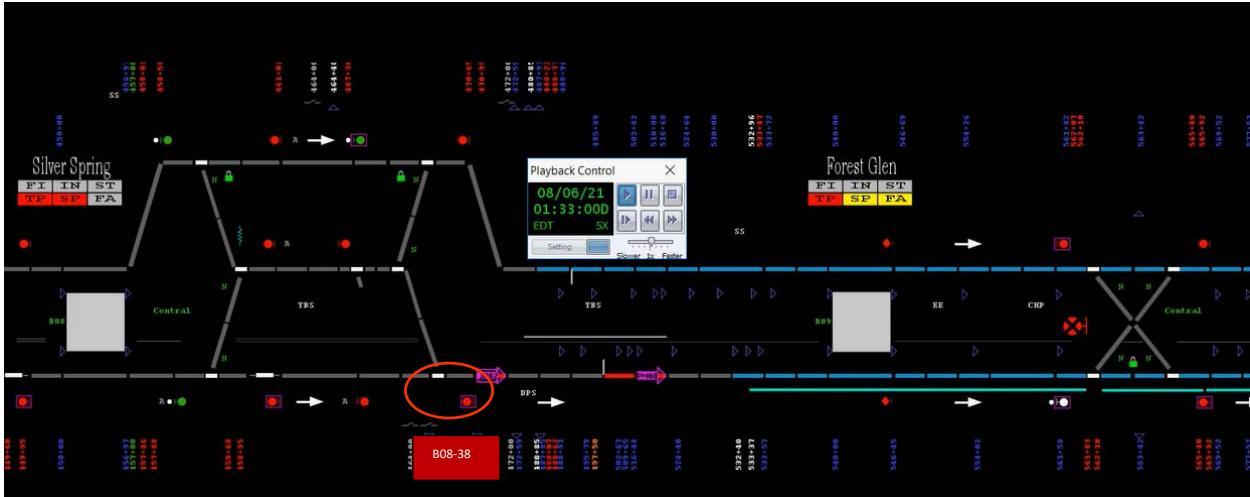
At approximately 01:32 hours, RMM PM-60 and JR-02 cleared signal B08-38 at Silver Spring Station.

Image 4 – Track Units PM-60 & JR-02 clear signal B08-38.

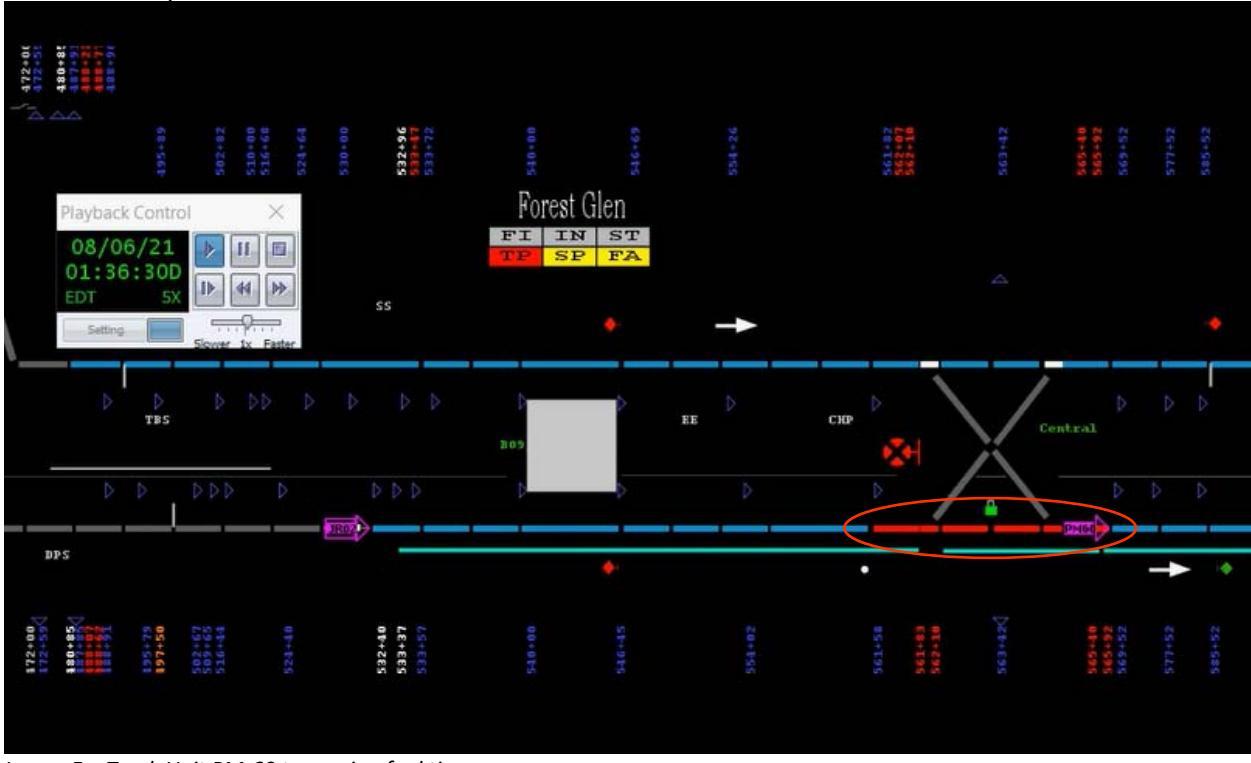
After arriving at the end of their Absolute Block at Forest Glen Station, track 1, the Radio RTC extended RMM PM-60's absolute block to Wheaton Station, track one causing the rail vehicle to traverse the protected area.

Image 5 – Track Unit PM-60 traversing foul time area.

The Power Maintenance Crew contacted the Button RTC via landline and reported that the work crew was still under foul time protection when Track Unit PM-60 traversed through the area. The Radio RTC contacted all Track Units in the area to confirm that they were not moving and instructed the Track Units to secure in their locations. The Radio RTC again granted the Power Maintenance Crew foul time at Forest Glen Station track one tie breaker. The Power Maintenance Crew personnel relinquished their foul time on track one at Forest Glen Station platform.

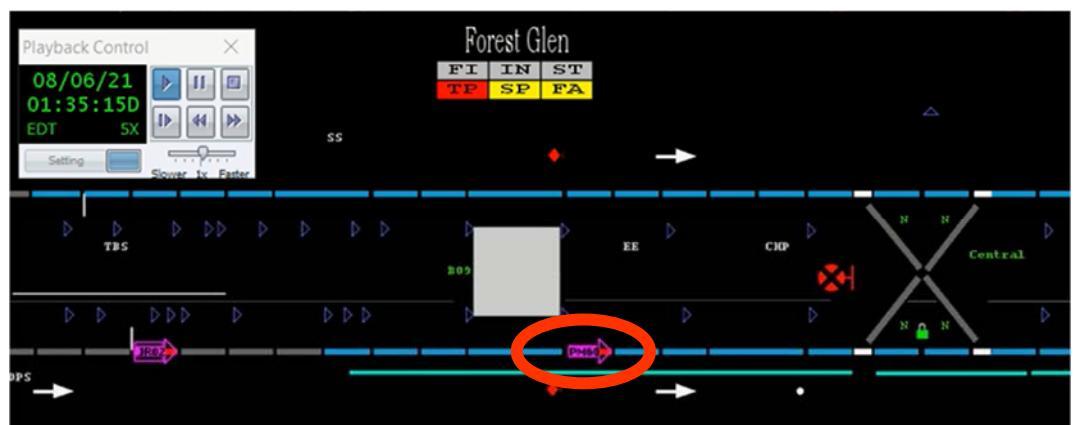
Figure 1 - Based on the AIMS, at 01:35:15 hours, Track Unit PM-60 was on approach to CM B1 547+00, Forest Glen Station, Track 1. \*Note lack of human form icon

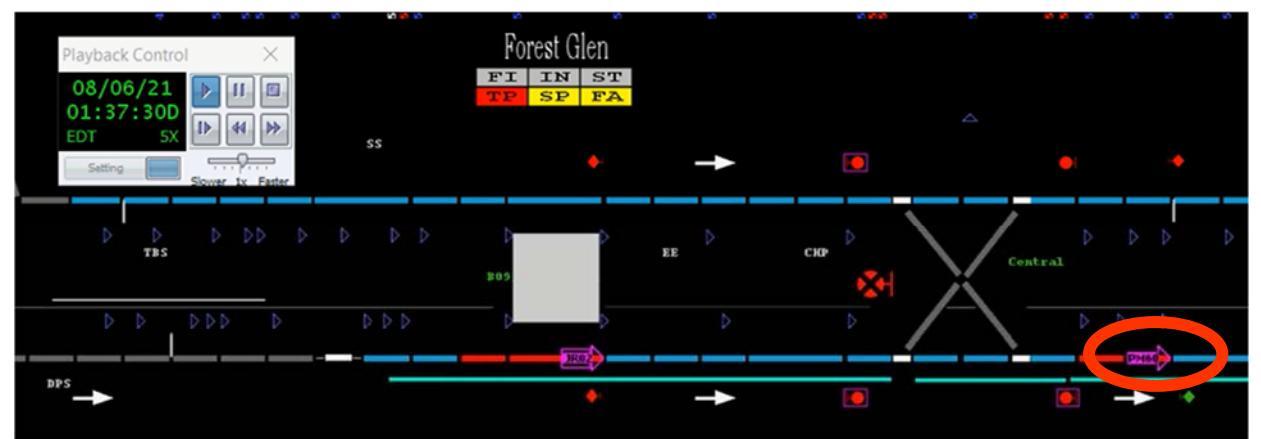
Figure 2 - Based on the AIMS, at 01:37:30 hours, Track Unit PM-60 was traveling through the area protected under foul time on approach to CM B1 564+00, Forest Glen Station, Track 1. \*Note lack of human form icon

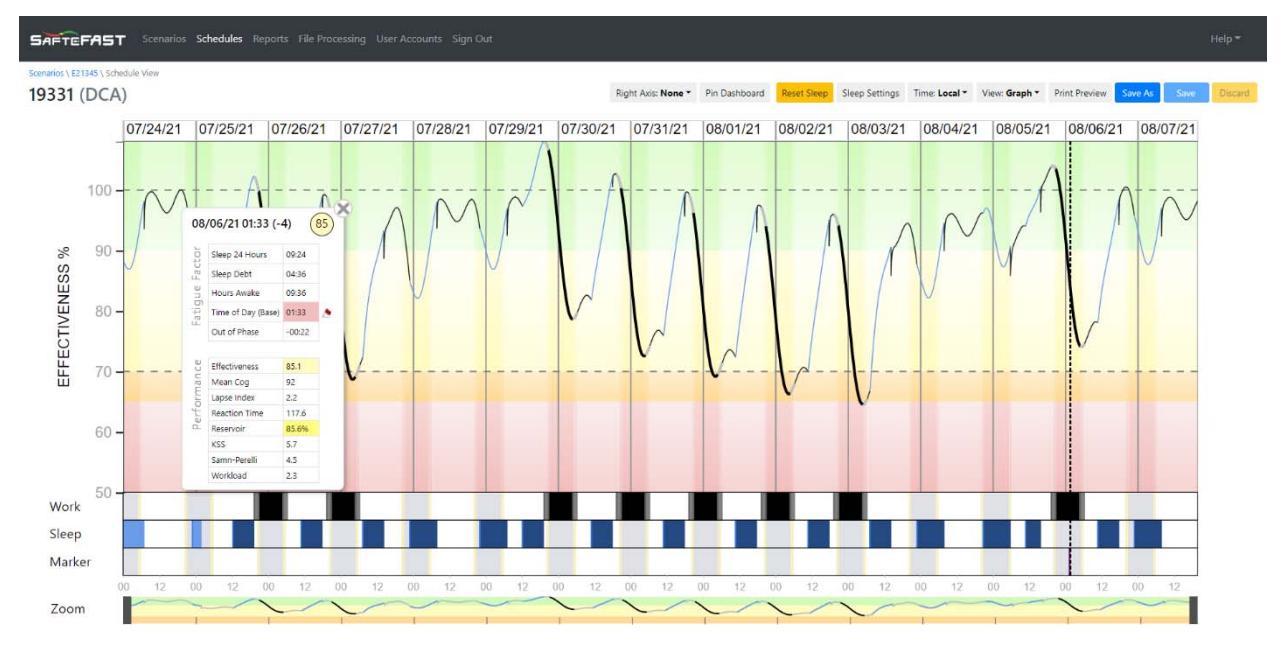
A biomathematical fatigue modelling application (SAFTE-FAST WebSFC) was used to further evaluate fatigue risk factors that may have been present in the RTC's schedule. The analysis was based on the RTC's work schedule, bed, and wake times from the day before the incident and reported habitual sleep durations. Estimated performance effectiveness at the time of the incident was 85.1%. Specifically, the analysis identified the circadian effects of night work as a factor contributing to an increased risk of fatigue at the time of the incident.

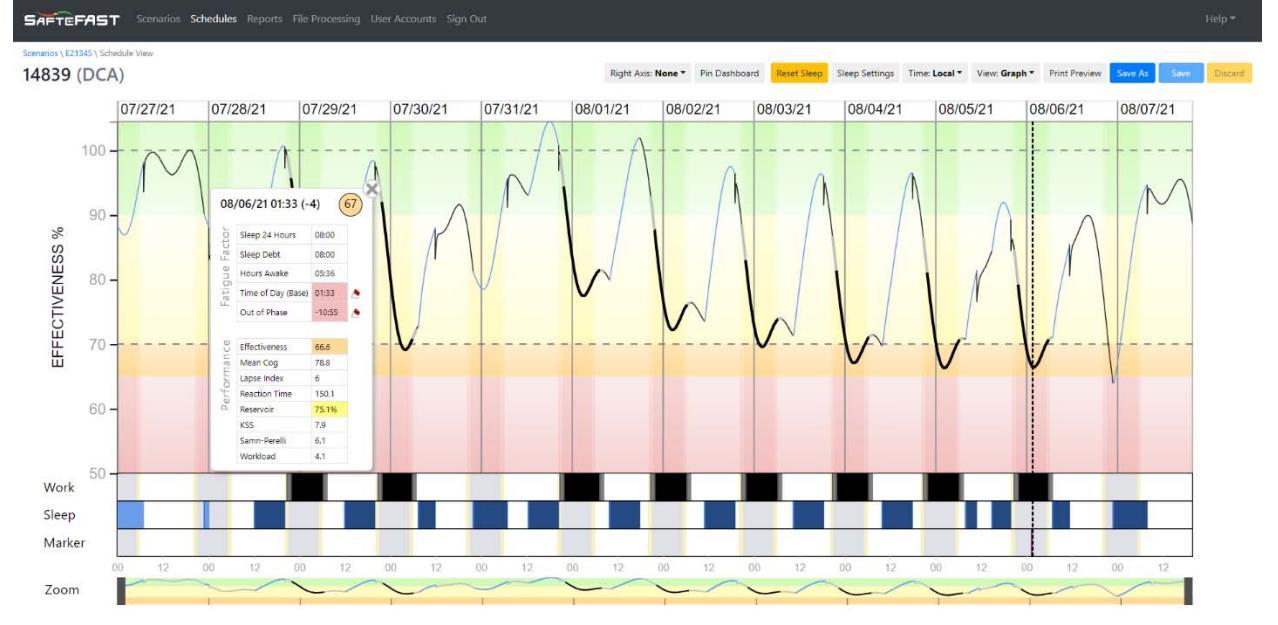
SAFTE-FAST WebSFC was used to further evaluate fatigue risk factors that may have been present in the Mechanical Helper's schedule. The analysis was based on the PWR Technician's work schedule, bed, and wake times from the day before the incident and reported habitual sleep durations. Estimated performance effectiveness at the time of the incident was 66.6%. Specifically, the analysis identified the circadian effects of night work as a factor contributing to an increased risk of fatigue at the time of the incident.

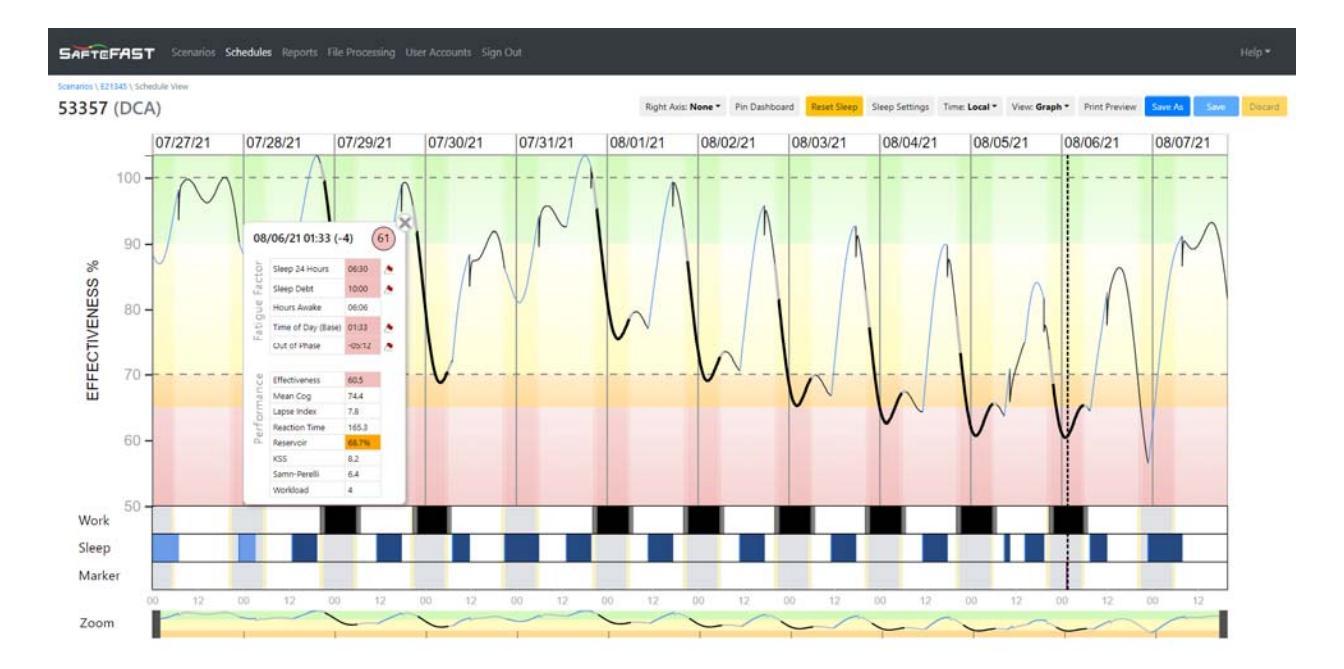
SAFTE-FAST WebSFC was used to further evaluate fatigue risk factors that may have been present in the Mechanical Helper's schedule. The analysis was based on the Mechanical Helper's work schedule, bed, and wake times from the day before the incident and reported habitual sleep durations. Estimated performance effectiveness at the time of the incident was 60.5%. Specifically, the analysis identified short sleep duration in the last 24 hours, the circadian effects of night work, and sleep debt (inferring accumulated sleep loss of more than 8 hours) as factors contributing to an increased risk of fatigue at the time of the incident.

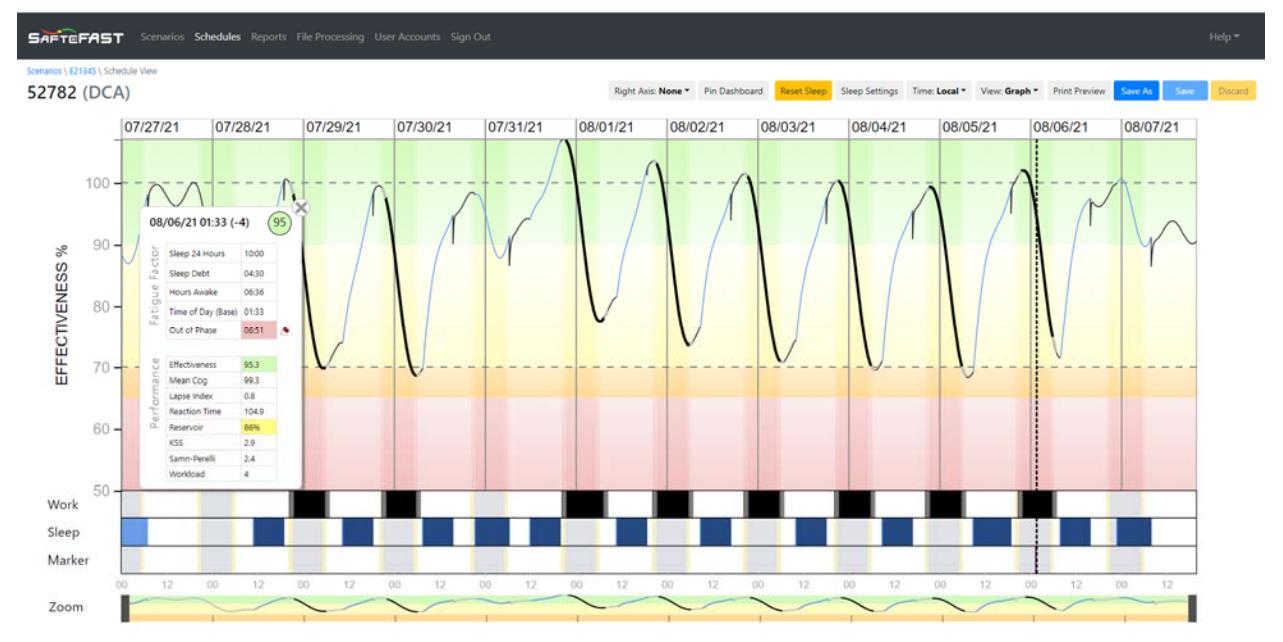
SAFTE-FAST WebSFC was used to further evaluate fatigue risk factors that may have been present in the Mechanical Helper's schedule. The analysis was based on the PWR Technician's work schedule, bed, and wake times from the day before the incident and reported habitual sleep durations. Estimated performance effectiveness at the time of the incident was 95.3%. Specifically, the analysis identified the circadian effects of night work as a factor contributing to an increased risk of fatigue at the time of the incident.
