WMSC Commissioner Brief: W-0140 – Red Signal Overrun – Twinbrook Station – September 28, 2021

Washington Metro Area Transit Authority Department of Safety and Environmental Management (SAFE) FINAL REPORT OF INVESTIGATION A&I E21471

Twinbrook Station Interlocking at A13-02 Signal Red Signal Overrun September 28, 2021 **Table of Contents**

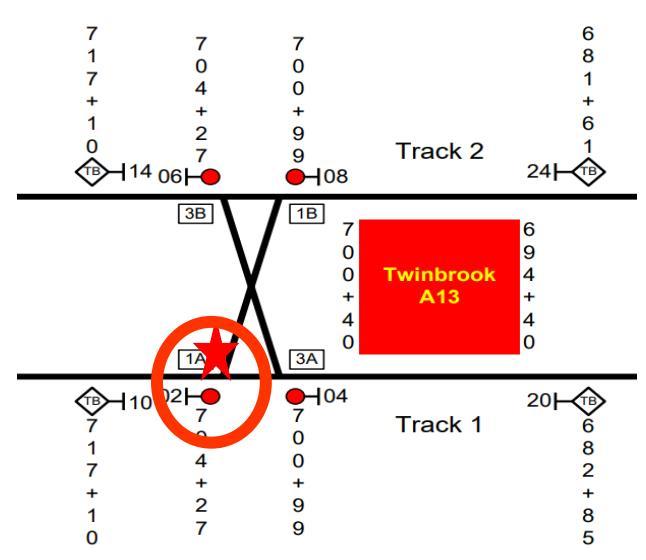
Diagram 1 – Train ID 124 crossed over from Track 1 to Track 2 and overran A13-02 signal displaying a red aspect.

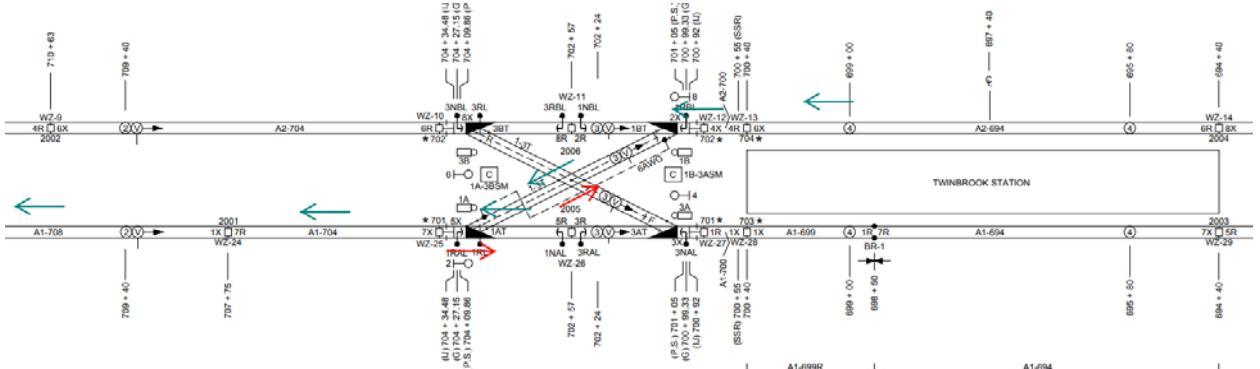
Diagram 2 – The green arrows illustrate Train ID 124 departed Twinbrook Station, Track 2 traveling outbound. Train ID 124 passed the A13-08 signal and proceeded through interlocking crossing over to Track 1. The red arrows illustrate that after Train ID 124 cleared the interlocking, Train ID 124 traveled inbound on Track 1, proceeded past the A13-02 signal displaying red signal aspects, and crossed over from Track 1 to Track 2.

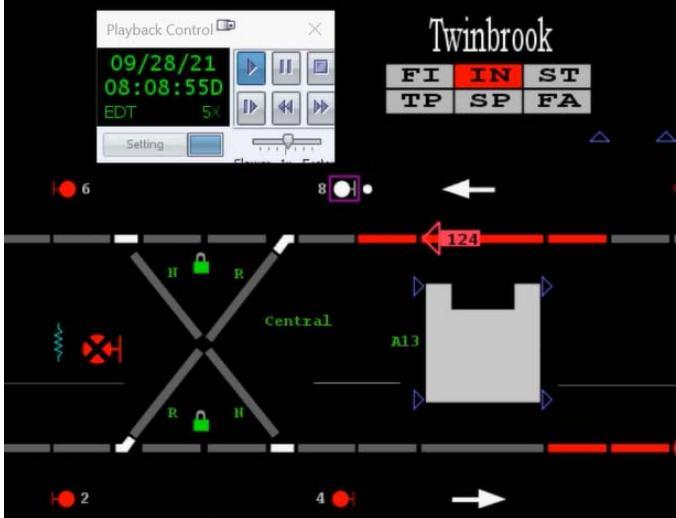
Diagram 3 - At 08:08:55 hours, Train ID 124 berthed at Twinbrook Station platform, Track 2 to discharge passengers.

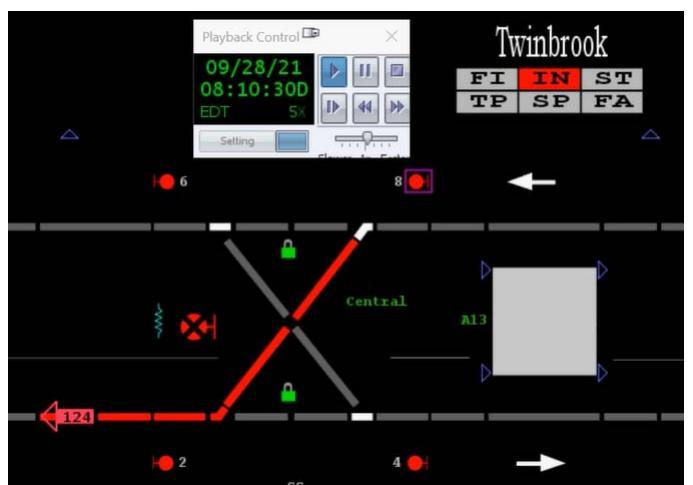
Diagram 4 - At 08:10:30 hours, Train ID 124 cleared the A13-08 signal displaying a lunar aspect and crossed over from Track 2 to Track 1.

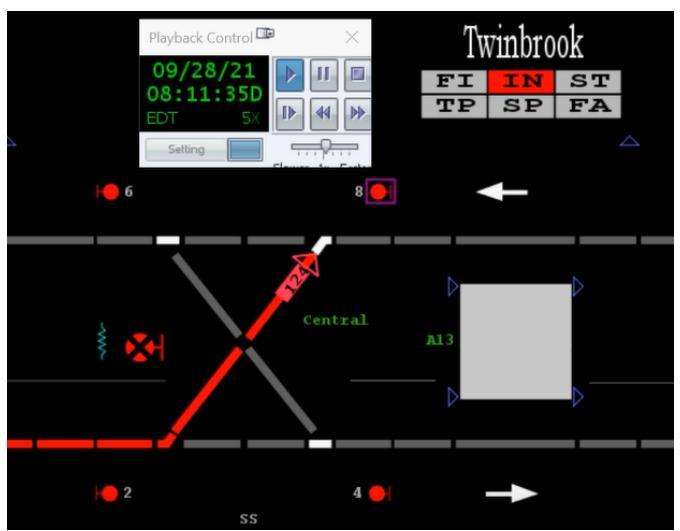
Diagram 5 - At 08:11:35 hours, Train ID 124 overran A13-02 signal displaying a red aspect and began to cross over from Track 1 to Track 2.

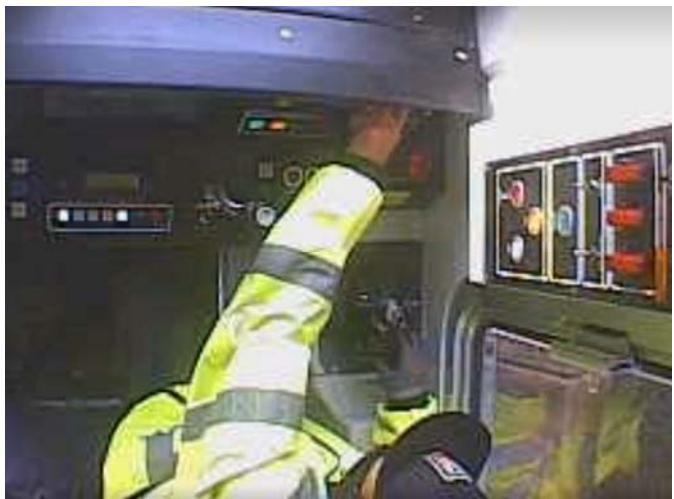
Figure 1 – At approximately 08:11 hours, Train ID 124 Operators Cab camera video footage revealed the Train Operator on Car 7658 initiated the "Stop and Proceed" mode.

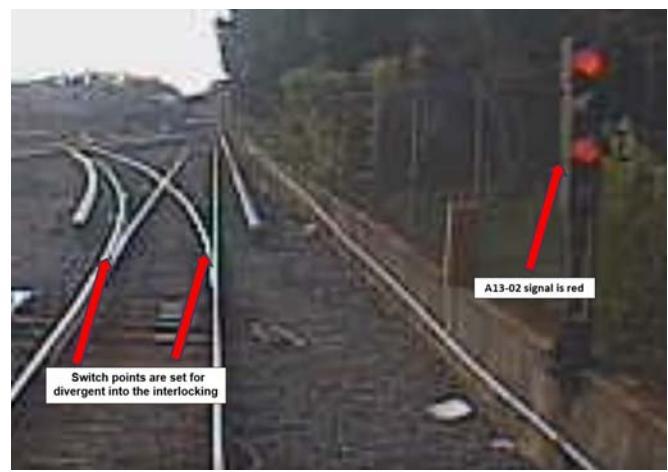
Figure 2 – At approximately 08:11 hours, Train ID 124 forward-facing camera video footage revealed the train overran A13-02 signal displaying a red aspect. The train responded as expected, and its performance was within design specifications. Additionally, no operational anomalies were noted on the VMDS fault log during the reported incident time.
