WMSC Commissioner Brief: W-0142 – Improper Roadway Worker Protection – Near Court House, Rosslyn Stations – September 21, 2021

FINAL REPORT OF INVESTIGATION A&I E21460

Date of Event:	09/21/2021
Type of Event:	Improper Roadway Worker Protection
Incident l'ime:	01:31 hours
Location:	Rosslyn Station, Track 1 & 2
Time and How received by SAFE:	02:29 hours, SAFE IMO
WMSC Notification Time:	02:29 hours
Responding Safety Officers:	WMATA SAFE: No
	WMSC: No
	Other: N/A
Rail Vehicle:	N/A
Injuries:	None
Damage:	None
Emergency Responders:	None
SMS I/A Incident Number:	20210921#95696

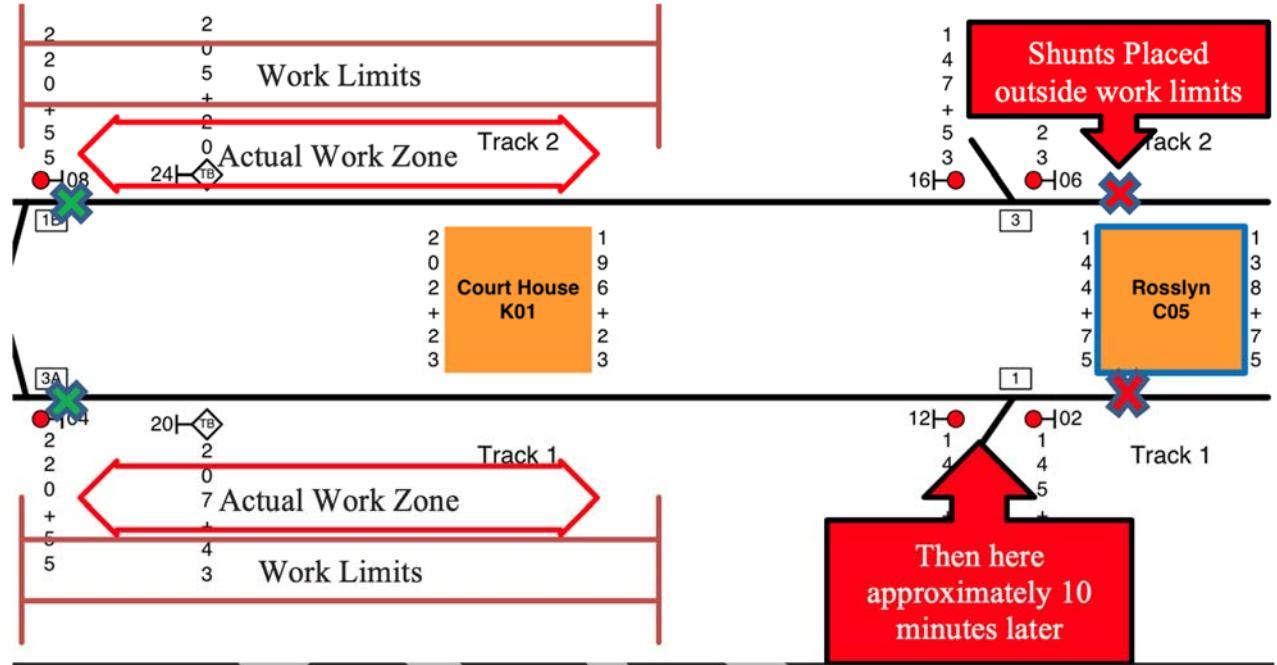
A review of the facts determined, the work crew failed to install shunts a minimum of 500 feet from their work limit CMs. The Work crew installed shunts at Rosslyn Station, which was outside their work limits, and without FT protection.

Improper RWP setup -- *Not to scale

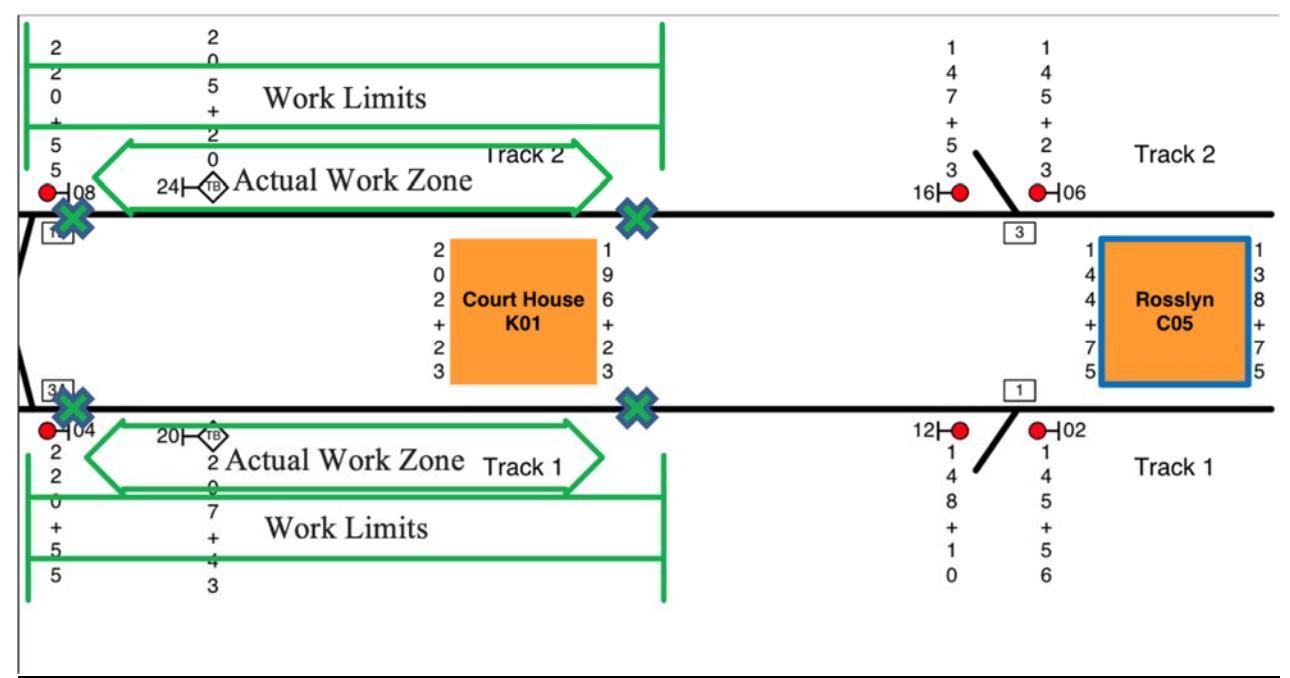
Proper RWP setup -- *Not to scale

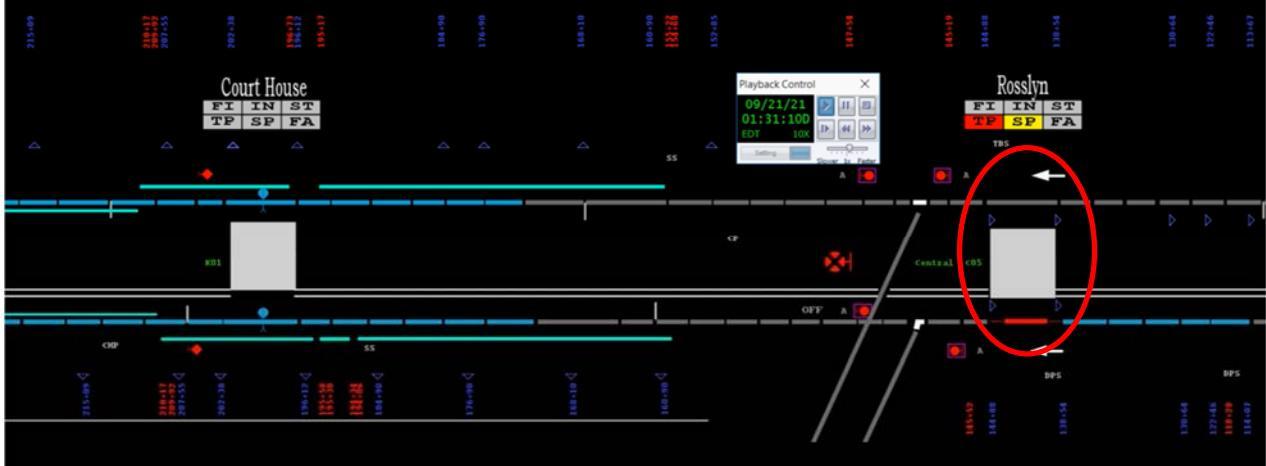
At approximately 01:31 hours, AIMS playback shows a shunt was placed in position on Track 1 on an energized section within Rosslyn Station platform limits, outside of the work crew's work limits and FT area.

Figure 1 - AIMS Playback shows the first shunt placed outside work limits at Rosslyn Station on track 1.

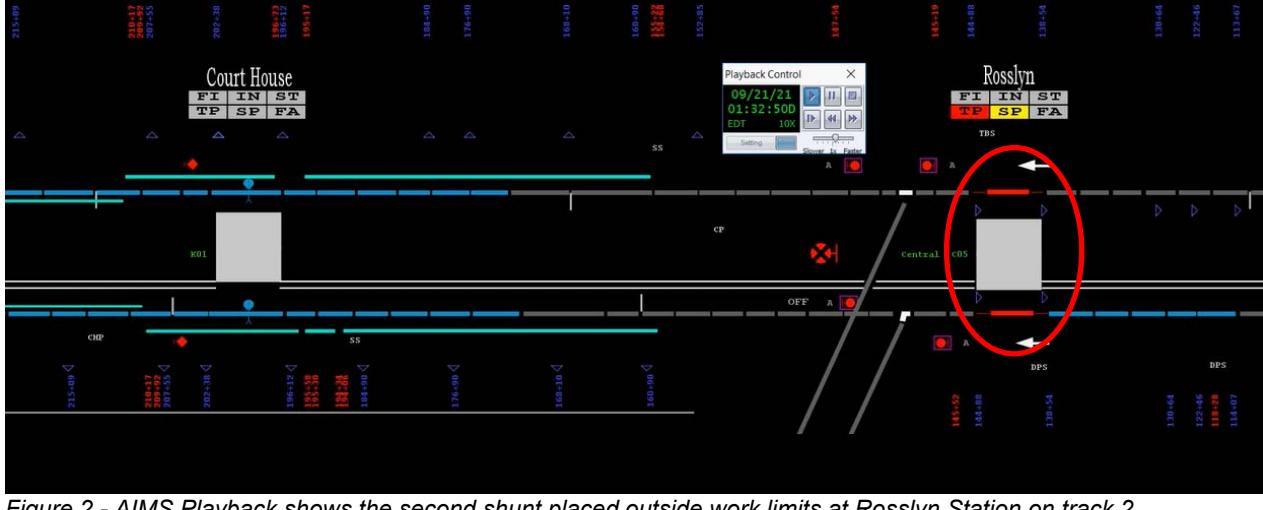
At 01:32 hours, AIMS Playback showed the second shunt placed at Rosslyn Station.

Figure 2 - AIMS Playback shows the second shunt placed outside work limits at Rosslyn Station on track 2.

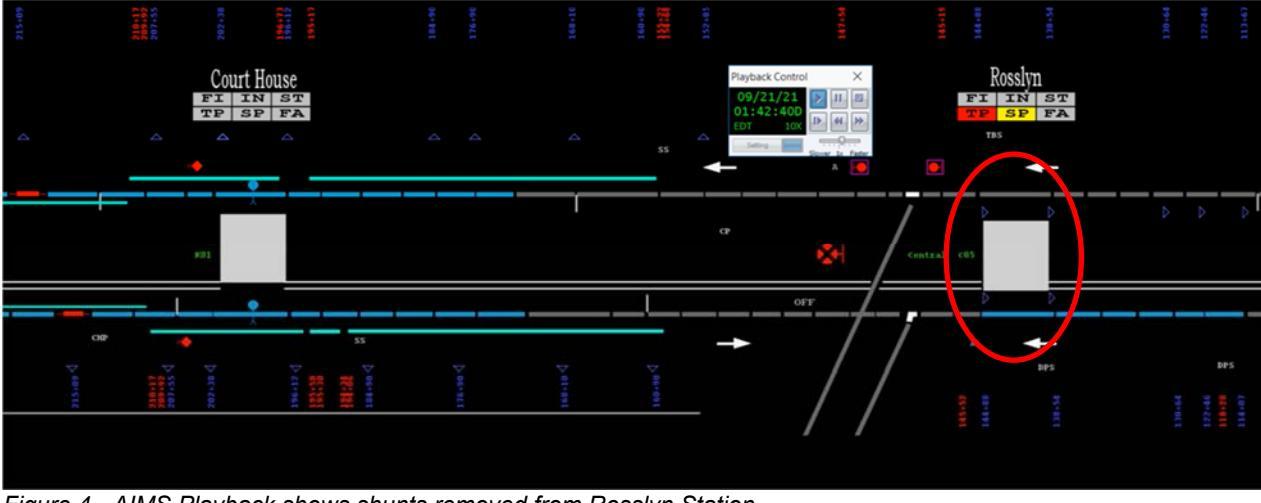
At approximately 01:42 hours, AIMS playback showed shunts were removed from Rosslyn Station platform limits on Track 1 and 2.

Figure 4 - AIMS Playback shows shunts removed from Rosslyn Station.

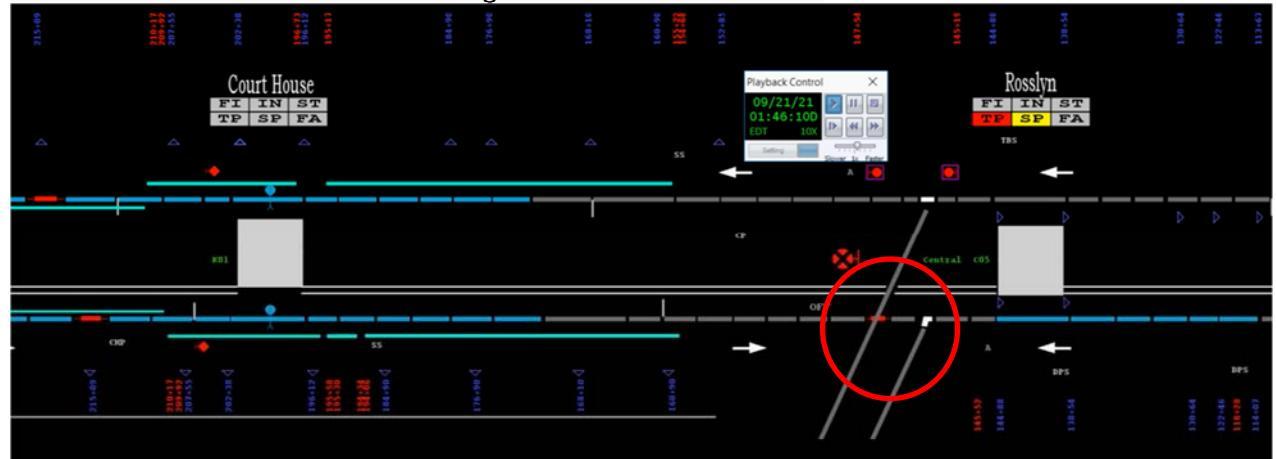
Between 01:45 hours and 01:51 hours, AIMS Playback shows shunt placed outside Rosslyn Station near CM K1 147+50, which is not in compliance with MSRPH ETO authority Step 6, which states, "*Install shunts with two (2) red lanterns or e-flares a minimum of 500 feet outside of each end of the work zone and confirm shunt locations with ROCC.*" The location of this shunt was also outside of the Protected Working Limits of the Work Zone.

Figure 5 - AIMS Playback shows the first shunt placed near Chain Marker K1 147+54.

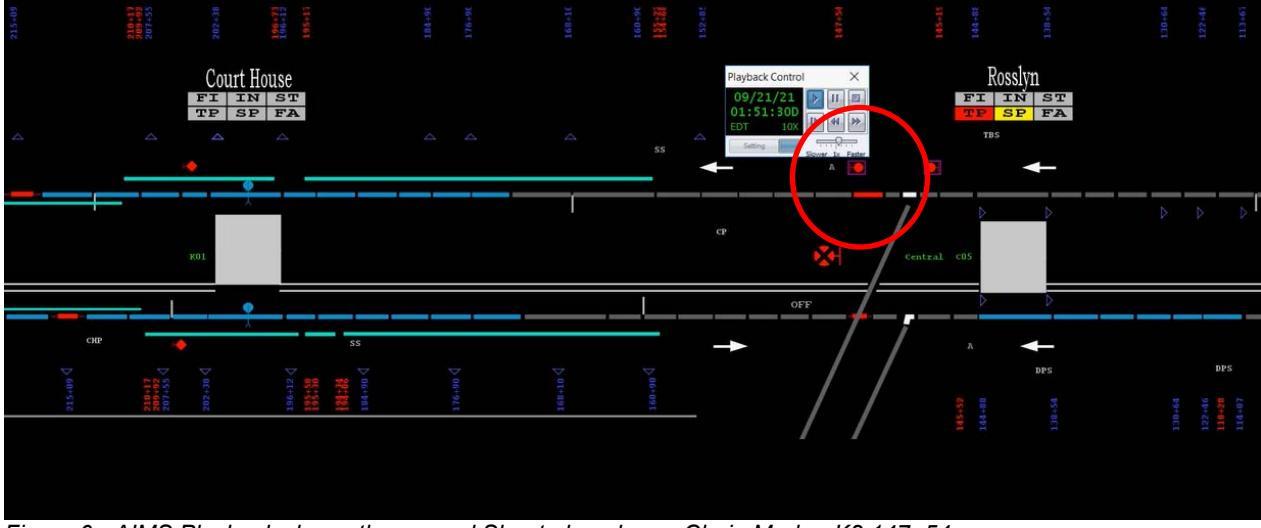
Figure 6 - AIMS Playback shows the second Shunt placed near Chain Marker K2 147+54.

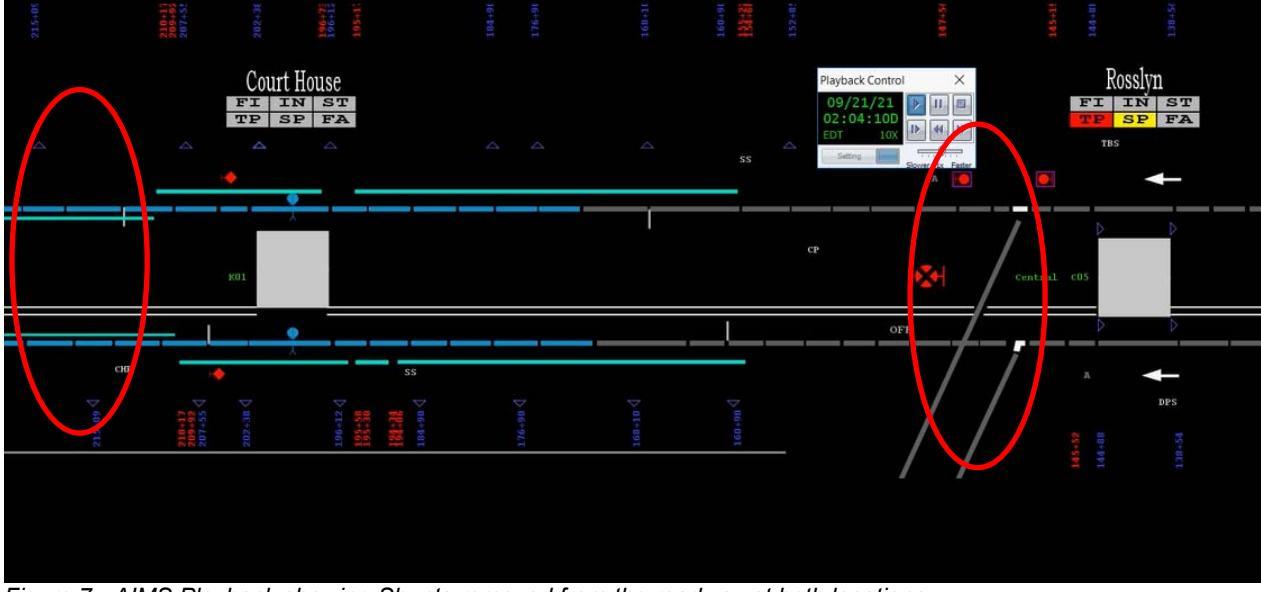
Figure 7 - AIMS Playback showing Shunts removed from the roadway at both locations

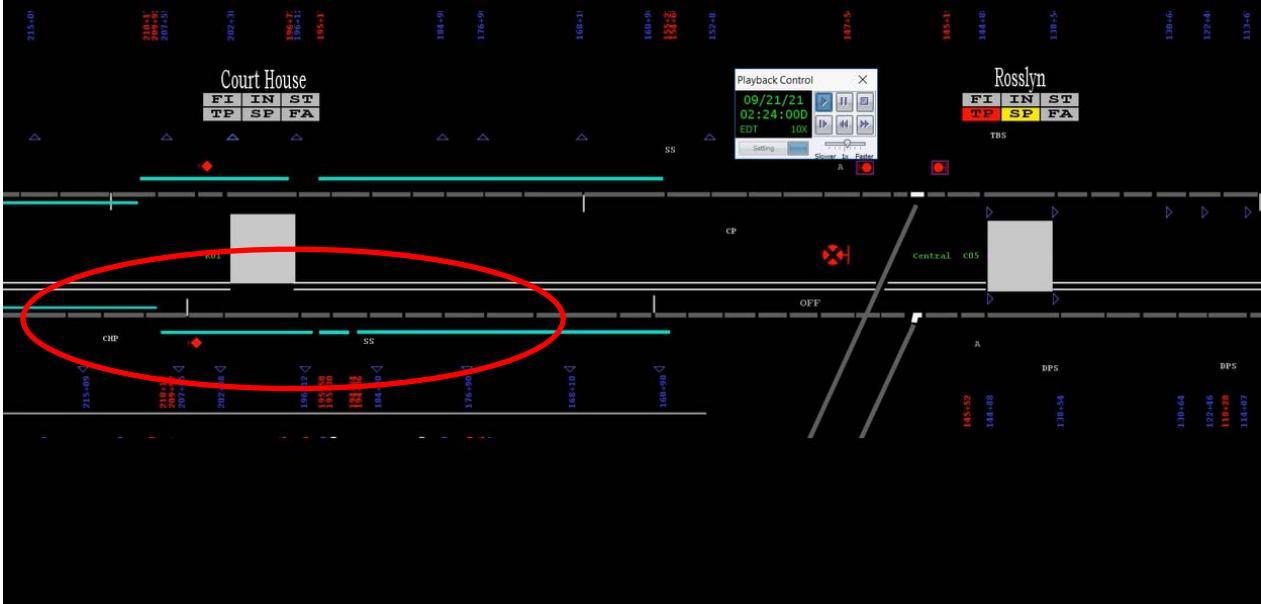
At approximately 02:14 hours, the LVEM RWIC reported personnel and equipment clear, and thirdrail power could be restored at ROCC's discretion. The Work Zone setup was not completed and no work was performed. LVEM removed the work crew from service for post-incident toxicology testing. OCC removed blue blocks and human forms from the AIMS display at approximately 02:24 hours.

Figure 8 - AIMS Playback showing Blue Blook Human Form removed at Court House Station

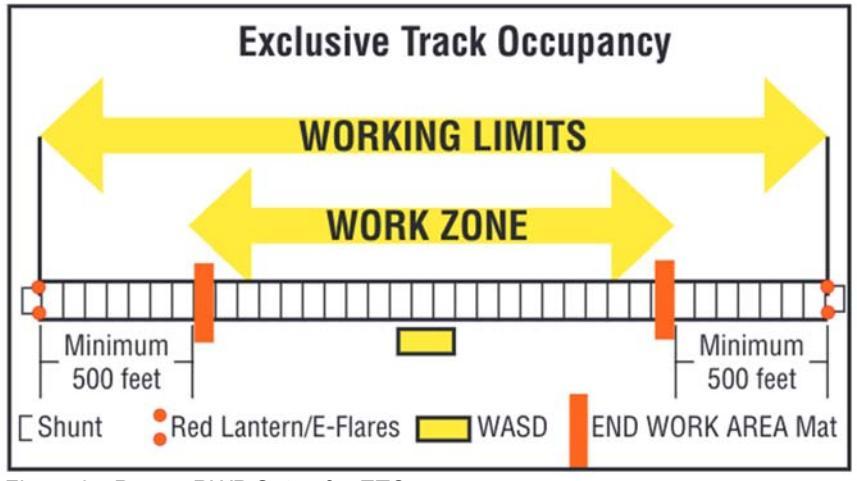
The LVEM RWIC was not in compliance with the MSRPH quick Access guide step six of ETO Authority,

Step 6: "the work zone should be set up as follows: "Install shunts with two (2) red lanterns or eflares a minimum of 500 feet outside of each end of the work zone and confirm shunt locations with ROCC."

Figure 9 - Proper RWP Setup for ETO.

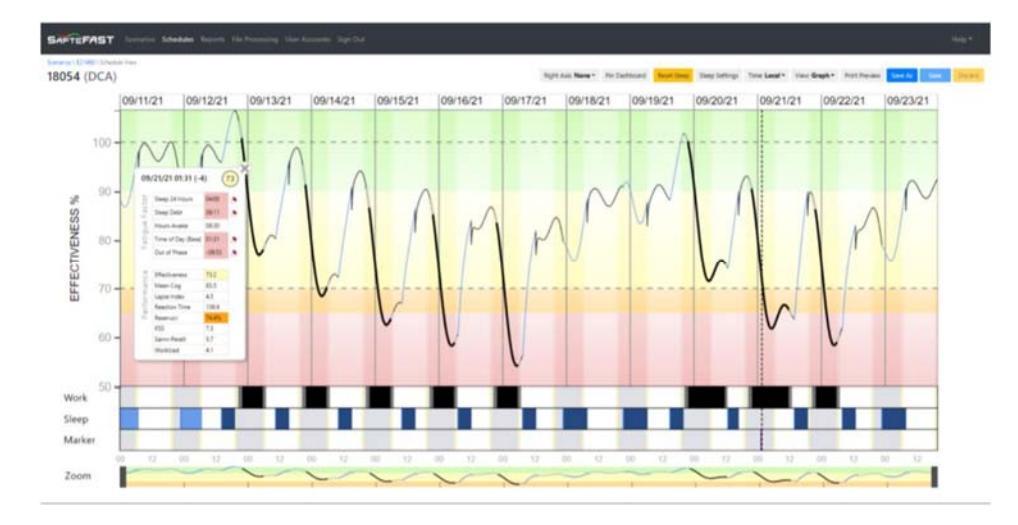
A biomathematical fatigue modelling application (SAFTE-FAST WebSFC) was used to further evaluate fatigue risk factors that may have been present in the RWIC's schedule. The analysis was based on the RWIC's work schedule, bed, and wake times from the day before the incident and reported habitual sleep durations. Estimated performance effectiveness at the time of the incident was 73.2%. Specifically, the analysis identified short sleep duration in the last 24 hours, the circadian effects of night work, and sleep debt (inferring accumulated sleep loss of more than 8 hours) as factors contributing to an increased risk of fatigue at the time of the incident.

Modeling analysis output shows estimated performance effectiveness during the incident work shift (top), and for the week leading up to the work shift (bottom) based on the employee work and reported sleep schedule. Estimates were based on the RWIC's work schedule, bed, and wake times from the day before the incident, and reported habitual sleep durations (5 hours a day). Bold portions of the modeled curve show work (in black) and sleep times (in blue). Effectiveness is shown on the vertical axis, with colored fields in the chart background signifying ranges of effectiveness scores including high effectiveness (>90%) in green and low effectiveness (<65%) in red. Time is shown on the horizontal axis. Markers for work and sleep times are shown in the lanes above the time of day on the horizontal axis.
