WMSC Commissioner Brief: W-0154 – Evacuation for Life-Safety Reasons – Dunn Loring Station – November 25, 2021

Washington Metro Area Transit Authority Department of Safety and Environmental Management (SAFE) FINAL REPORT OF INVESTIGATION A&I E21602

Date of Event:	11/25/2021
Type of Event:	Evacuation for Life Safety Reasons
Incident Time:	18:55 hours
Location:	Dunn Loring, Track 2
Time and How received by SAFE:	19:00 hours. SAFE/IMO On-call Phone
WMSC Notification Time:	20:17 hours
Responding Safety Officers:	WMATA SAFE: No
	WMSC: No
	Other: N/A
Rail Vehicle:	Train ID 901, [L3164-3165.3035-3034.3246-3247T]
Injuries:	None
Damage:	Left side Operator Cab Heater/floor heater element
	burnt on Lead Car 3164.
SMS I/A Incident Number:	20211125#97041MX

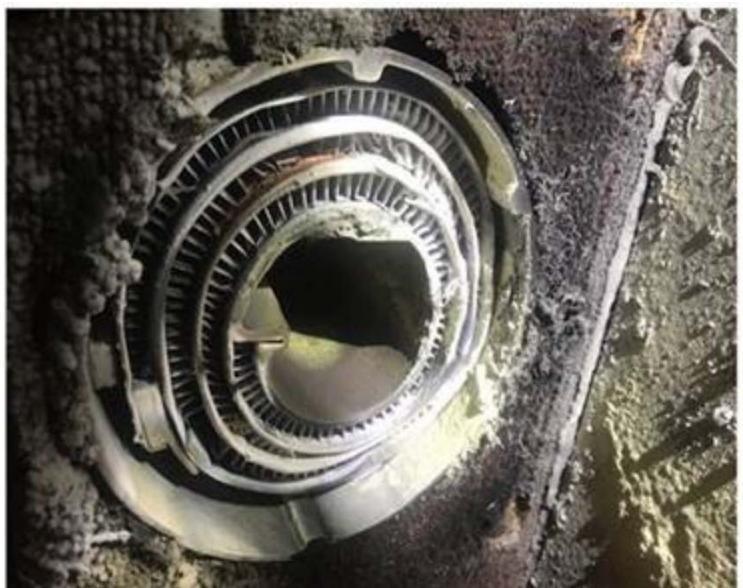
Figure 1 – Non Operating Cab side floor heater element burnt on Car 3164.

A CMNT Road Mechanic arrived at the incident site and inspected the consist. During the onsite inspection process, the CMNT Road Mechanic discovered a shortage of the operator's cab heater on Lead Car 3164 that caused the smoke conditions. In addition, the cab heater circuit breaker had tripped. After the CMNT Road Mechanic completed their assessment of the incident train, the CMNT Road Mechanic deemed the consist safe for transport. Based on ARS playback, the Radio RTC instructed the RTRA Supervisor to transport the non-revenue train down the line to West Falls Yard for post-incident inspection. At West Falls Church Yard, CMNT conducted troubleshooting efforts on November 26, 2021, and found a failed CHC3 contactor. A CHC3 contactor is an electrical contactor and it is activated when heat is called for. When this occurs, the contactor turns on and closes a set of contacts that provides electrical energy to the heating element. It is located in various places throughout the cars, dependent on what series vehicle it is, and whether it is an "A" car or "B" car. It can be located under the operator console and/or in the HVAC control box. CMNT replaced all the components associated with the overheated damage. CMNT reported they monitored the cab heater while operating for an hour with no issues identified. See Appendix A.

Corrective Action Code	Description	Estimated Completion Date
97041_SAFECAPS_ CMNT_001	CMNT issued memorandum reinstructing all personnel on the requirement to replace cab heater contactors. Rebuilding or repairing the component is not permitted.	Completed (Appendix D)
97041_SAFECAPS_ CENV_001	CENV to evaluate appropriate inspection interval (e.g., annual) for cab heater and contactors.	3/31/2022

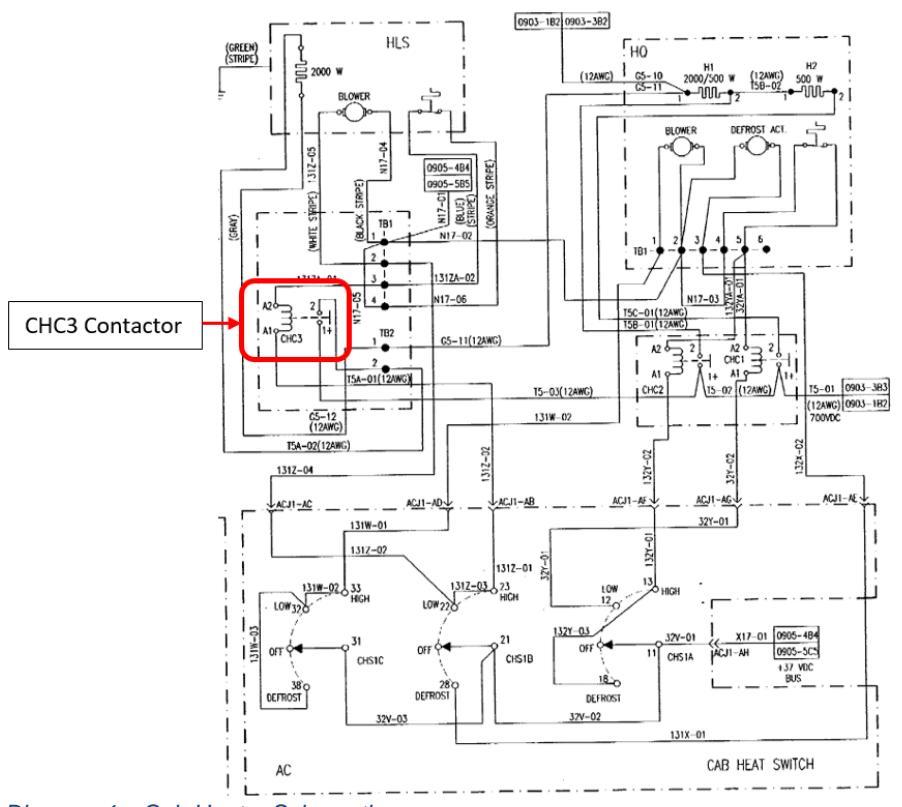
Diagram 4 – Cab Heater Schematic

operator's cab heater overheating. Specifically, contacts 1-2 were stuck in the closed position, keeping the heater element constantly energized, likely to the point of failure. They are part of the cab heater assembly. These parts are located internally. Additionally, CMOR IIT identified the that cab heater blower was damaged. The cab heater blower provides heat to the cab area to keep passengers and train operator warm. A full failure analysis of the assembly was not conducted as the CHC3 contactor was identified as the probable cause of the event.

CMOR IIT post-incident analysis revealed no faults in the logs that would have contributed to this incident. However, after CMOR IIT analyzed the operator's cab circuit, they identified two items that may have contributed to the operator's cab heater overheating, including a failed CHC3 Contactor. Specifically, contacts 1-2 were stuck closed, keeping the heater element energized. Additionally, CMOR IIT identified a damaged cab heater blower. A cab heater blower is similar in design to a computer fan but in a larger scale. It forces the ambient air across the heating element and out to the cab area. CMOR did not perform an analysis of the cab heater blower to determine the root cause of that defect. It is part of an assembly consisting of the fan, the control wiring points/connections, and the heating element and housing. While not related to the heater failure, details from the data analysis revealed that Cars 3164 and 3165 ATC was not communicating with the VMS at the time of the incident. Additionally, the 3/4 friction brake system did not communicate with Cars 3164, 3165, and 3246. CMOR IIT reported that VMS signals did not monitor the operator's cab heater circuit.

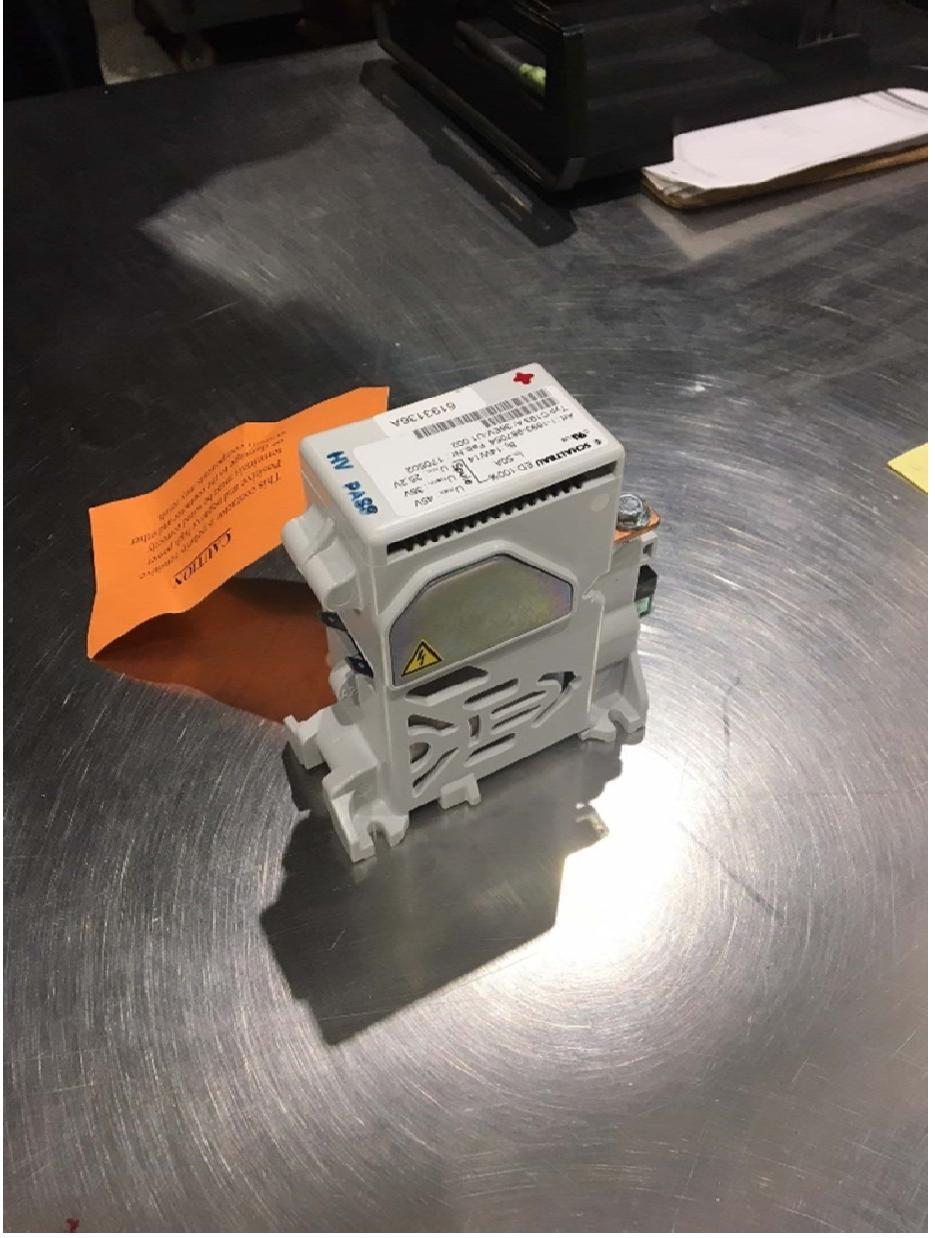
Appendix C – Cab Heater Contactor

*This image shows a new cab heater contactor.

Metrorail issued a memorandum instructing all personnel on the requirement to replace cab heater contactors with new contactors. Rebuilding or repairing the component is not permitted.
