WMSC Commissioner Brief: W-0179 - Collision - Forest Glen Station - May 7, 2022

Prepared for Washington Metrorail Safety Commission meeting on September 20, 2022

Washington Metro Area Transit Authority Department of Safety and Environmental Management (SAFE) FINAL REPORT OF INVESTIGATION A&I E22283

Forest Glen Station – Collision

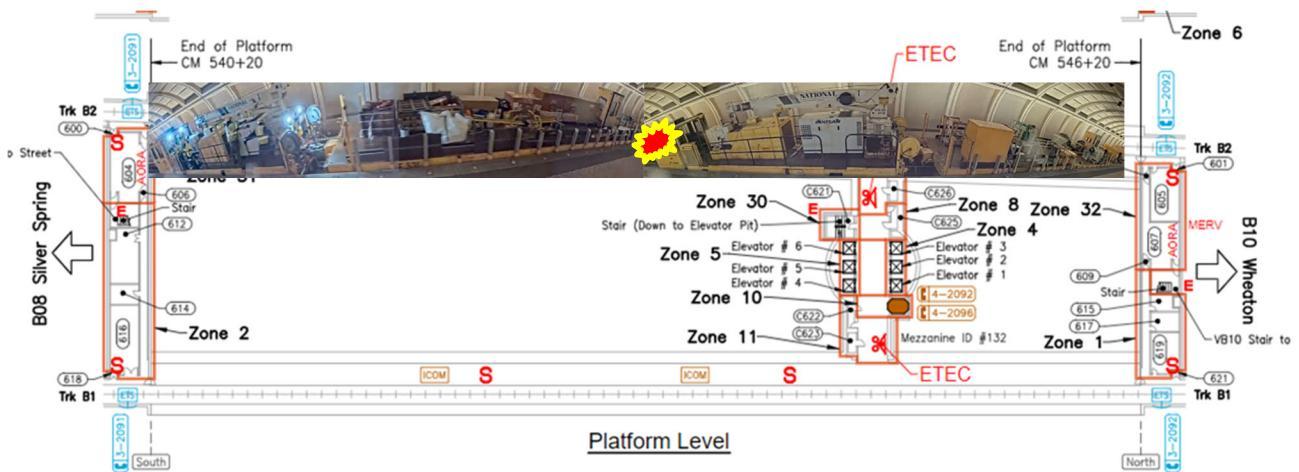
Figure 1: Shows where Flat 531 made contact to PM26 on track 2 at Forest Glen Station platform.

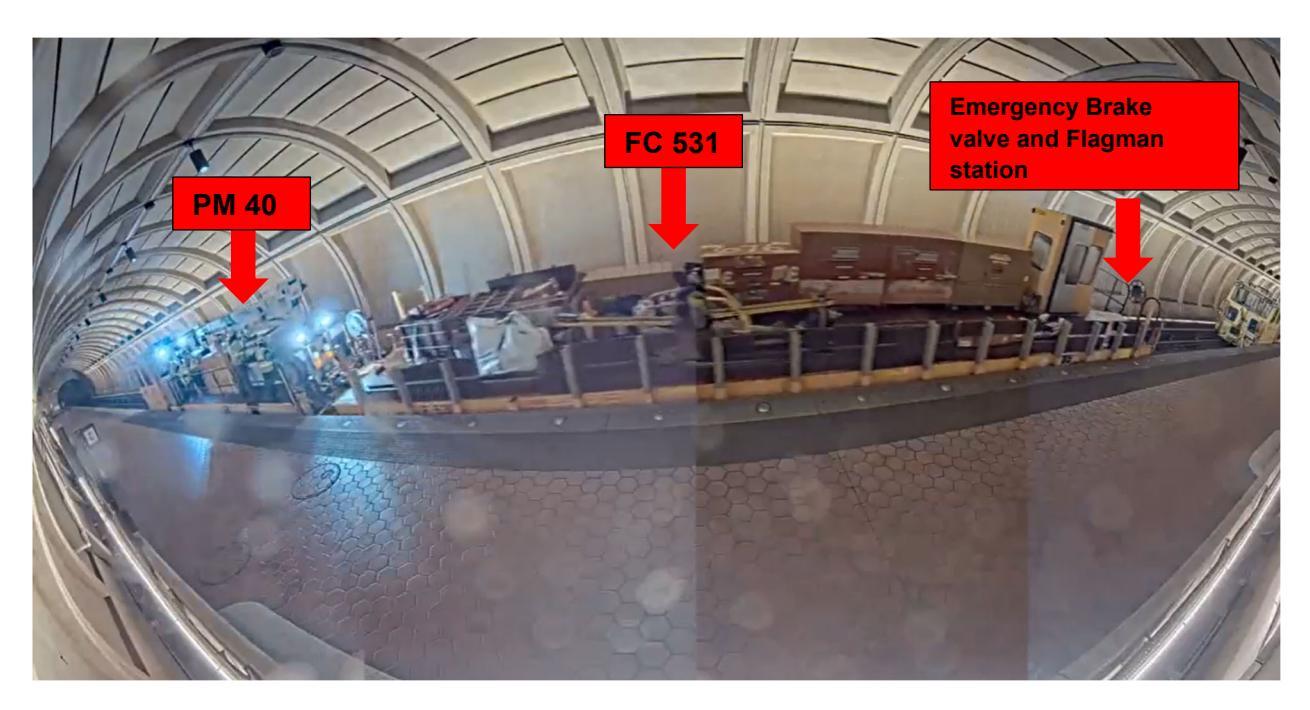
Figure 2: At approximately 05:07:45 hours, CCTV shows PM40 pushing FC 531 into Forest Glen Station prior to contact.

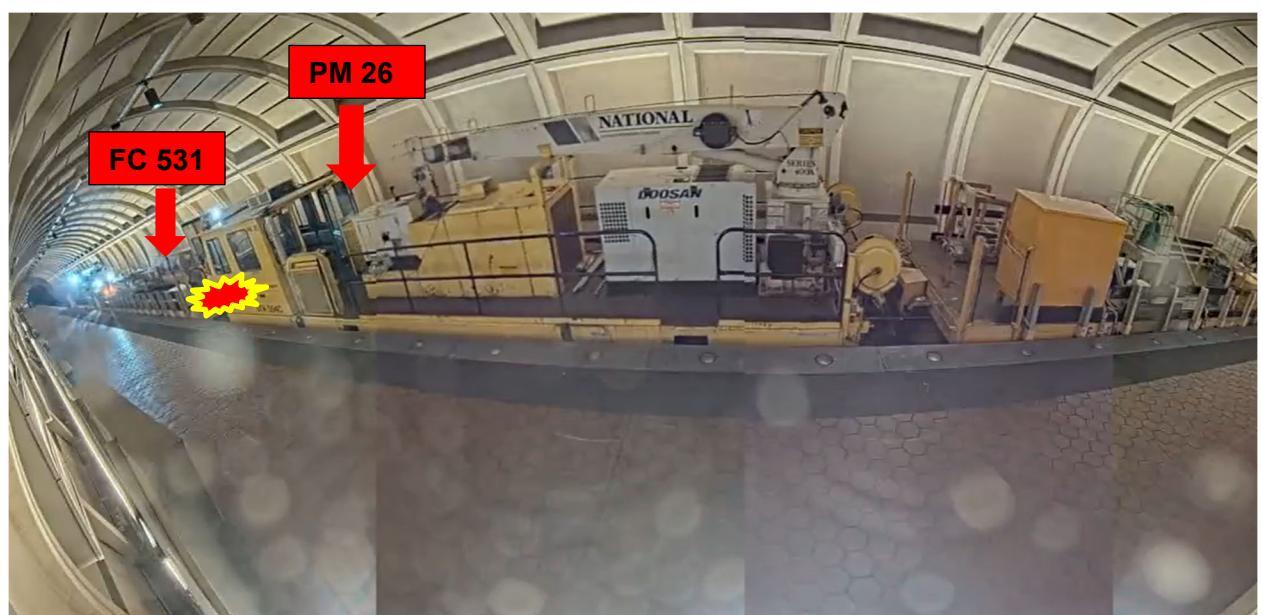
Figure 3: At approximately 05:07:51, CCTV shows when FC 531 and PM 26 made contact.

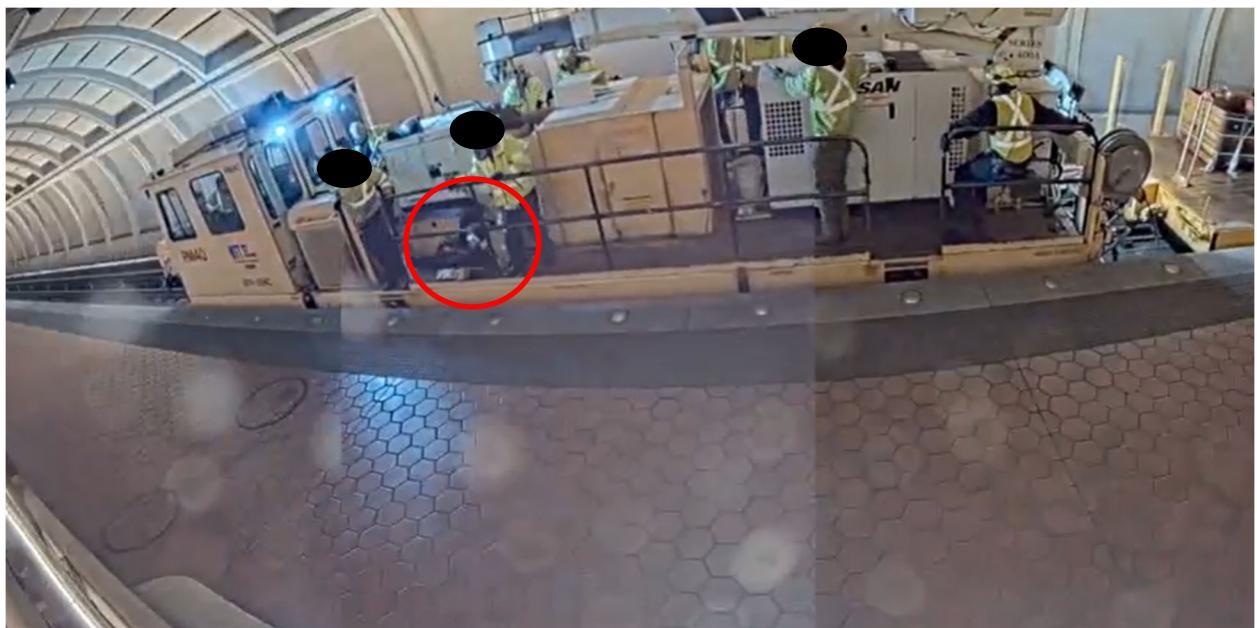
Figure 4: At approximately 05:07:51, CCTV shows when one of the crew members on-board PM 40 fell from the force of the collision.

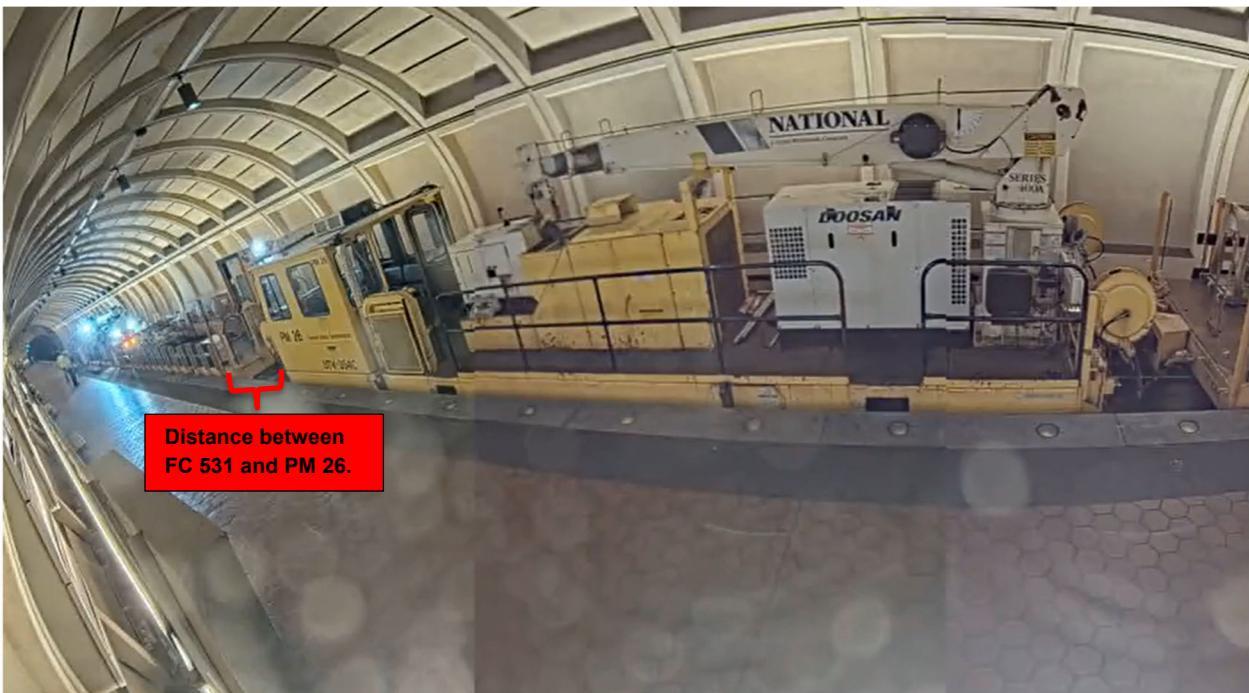
Figure 5: At approximately 05:08:27 hours, CCTV shows the first time PM 40 was moved a few feet after contact was made.

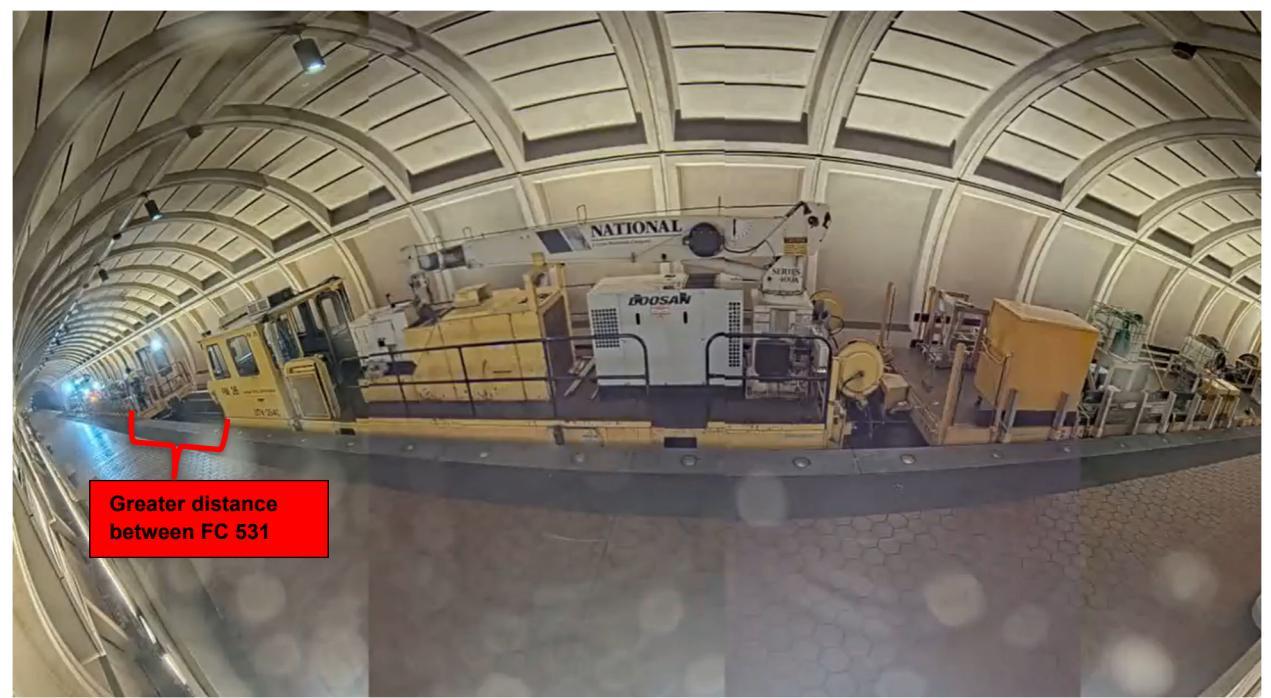
Figure 6: At approximately 05:16 hours, CCTV shows the second time PM 40 was moved several feet after contact was made without authorization.

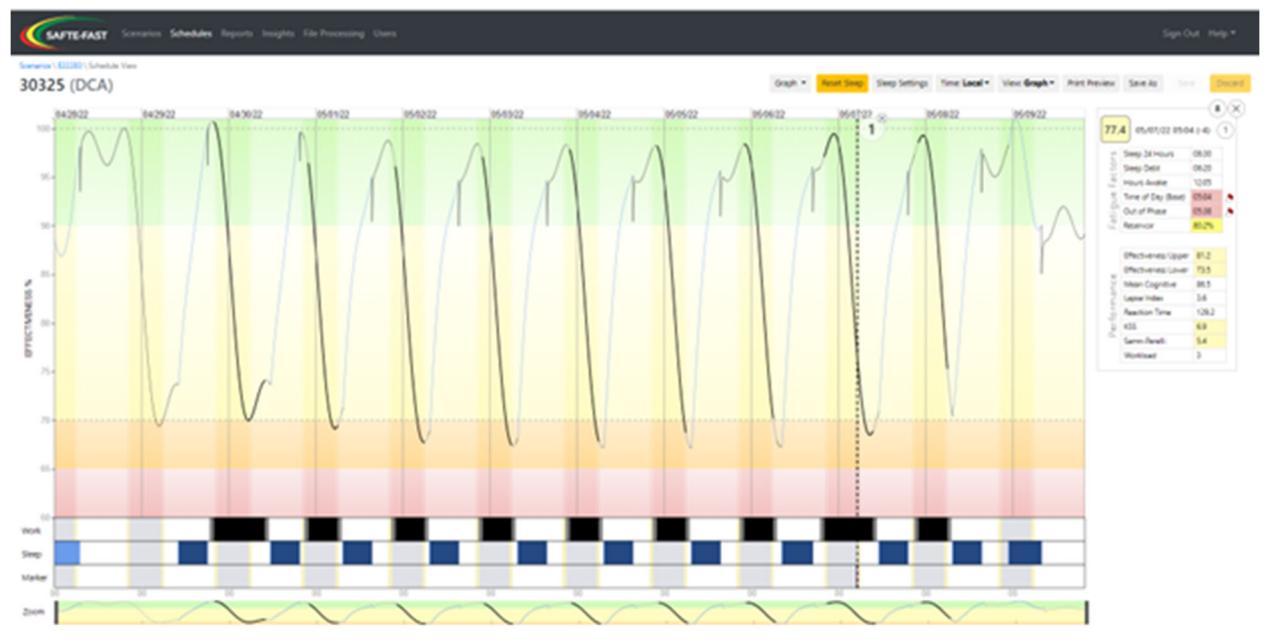
A biomathematical fatigue modelling application (SAFTE-FAST WebSFC) was used to further evaluate fatigue risk factors that may have been present in the Equipment Operator's schedule. The analysis was based on the Equipment Operator's work schedule, reported sleep from the day before the incident, and reported habitual sleep durations. Estimated performance effectiveness at the time of the incident was 77.4%. Specifically, the analysis identified the incident time of day and the circadian effects of night work as factors contributing to an increased risk of fatigue at the time of the incident.

Figure 7: Modeling analysis output shows estimated performance effectiveness during the incident work shift and for the week leading up to the work shift, based on the employee work and reported sleep schedule. Estimates were based on the Equipment Operator's work schedule, reported sleep from the day preceding the incident, and reported habitual sleep durations (8 hours a day). Bold portions of the modeled curve show work (in black) and sleep times (in blue). Effectiveness is shown on the vertical axis, with colored fields in the chart background signifying ranges of effectiveness scores including high effectiveness (>90%) in green, and low effectiveness (<65%) in red. Time is shown on the horizontal axis.

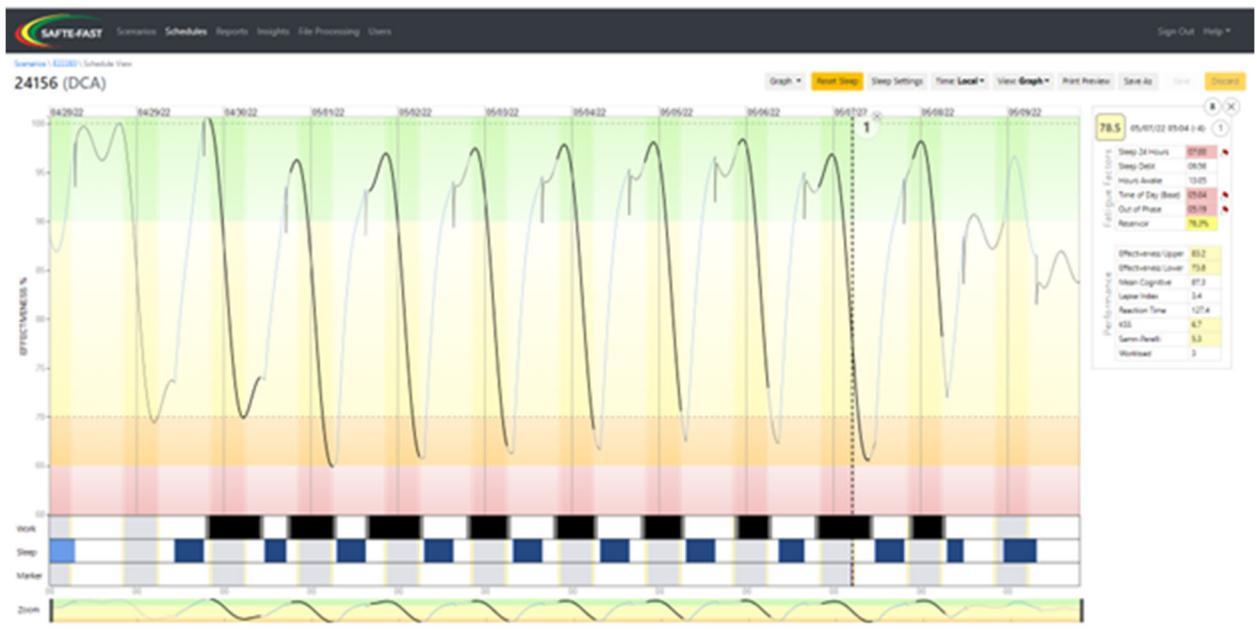
A biomathematical fatigue modelling application (SAFTE-FAST WebSFC) was used to further evaluate fatigue risk factors that may have been present in the Flagman's schedule. The analysis was based on the Flagman's work schedule, reported sleep from the day before the incident, and reported habitual sleep durations. Estimated performance effectiveness at the time of the incident was 78.5%. Specifically, the analysis identified the incident time of day and the circadian effects of night work as factors contributing to an increased risk of fatigue at the time of the incident.

Figure 8: Modeling analysis output shows estimated performance effectiveness during the incident work shift and for the week leading up to the work shift, based on the employee work and reported sleep schedule. Estimates were based on the Flagman's work schedule, reported sleep from the day preceding the incident, and reported habitual sleep durations (8 hours a day). Bold portions of the modeled curve show work (in black) and sleep times (in blue). Effectiveness is shown on the vertical axis, with colored fields in the chart background signifying ranges of effectiveness scores including high effectiveness (>90%) in green, and low effectiveness (<65%) in red. Time is shown on the horizontal axis.

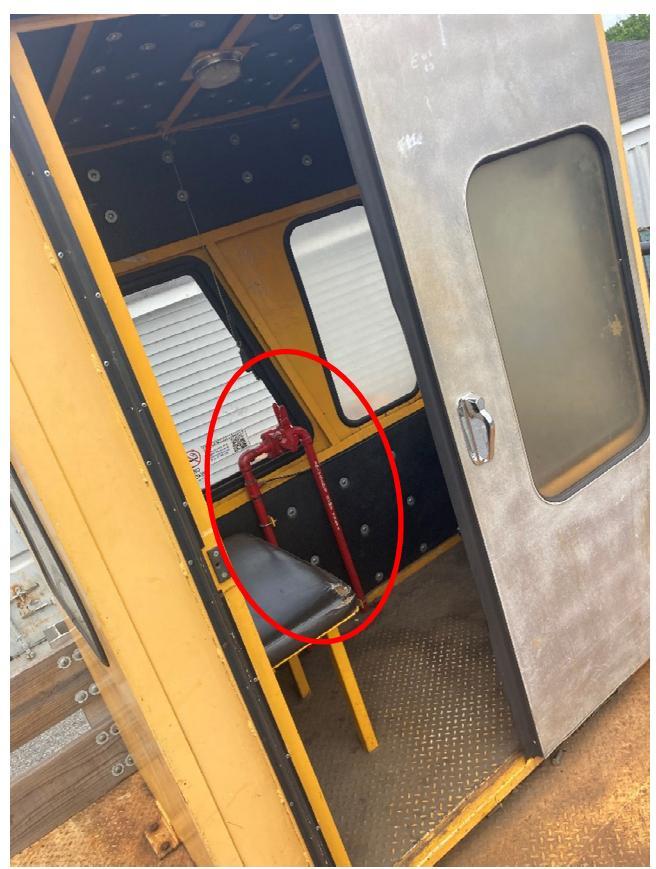
Figure 9: Shows the emergency dump valve located in the Flagman booth on a flat car.

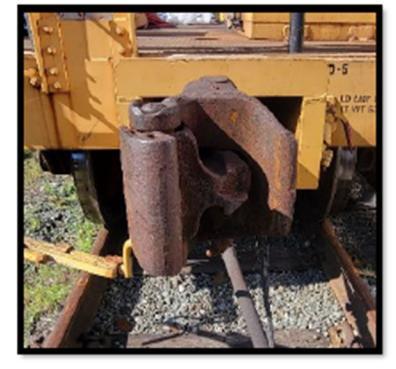
Figure 3 – F531 B-end coupler

CENV personnel inspected both consists on May 9, 2022 and concurs with CTEM reporting (Figure 3 & Figure 4). Neither PM40 nor PM26 is equipped with data or video recorders. No further analysis can be performed.

No damage resulted from this incident. Both CENV and CTEM could not identify deficiencies with any of the units that would have contributed to this incident. Data and video are not recorded on incident units to determine operational activity prior to contact.
