#### WMSC Commissioner Brief: W-0206 - Derailment - Yellow Line - October 2, 2022

# Washington Metropolitan Area Transit Authority Department of Safety (SAFE) Office of Safety Investigations (OSI) FINAL REPORT OF INVESTIGATION A&I E22643

## L'Enfant Plaza, L-Line ACS – Derailment

## October 2, 2022

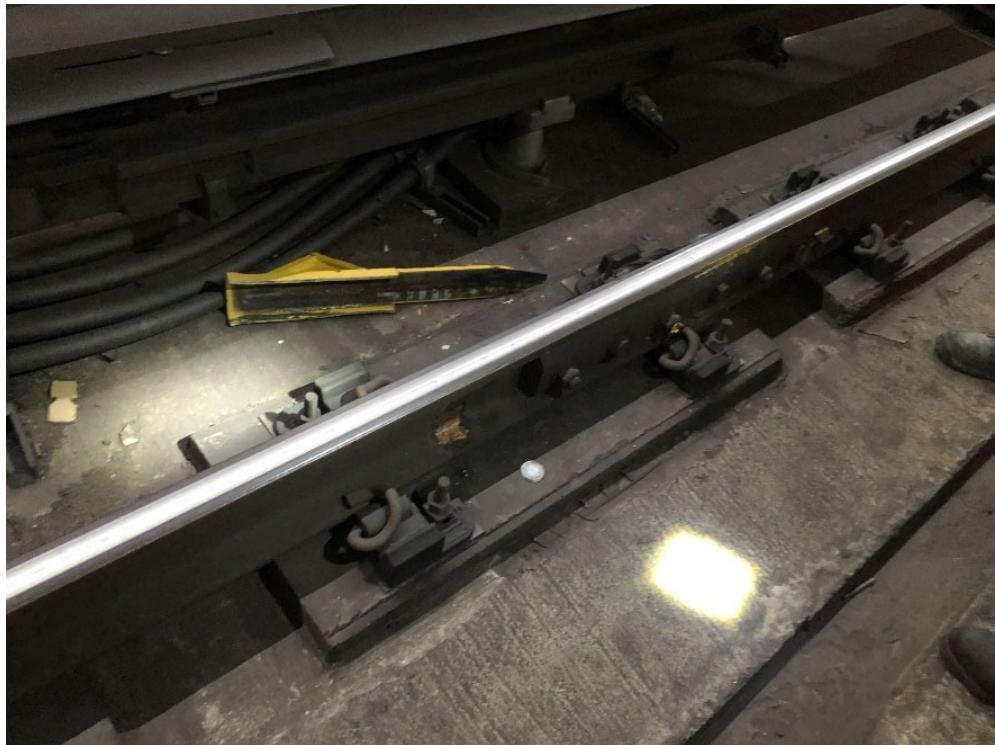
Image 1 - Second wheel stop located at CM L2 94+60's insulated joint.

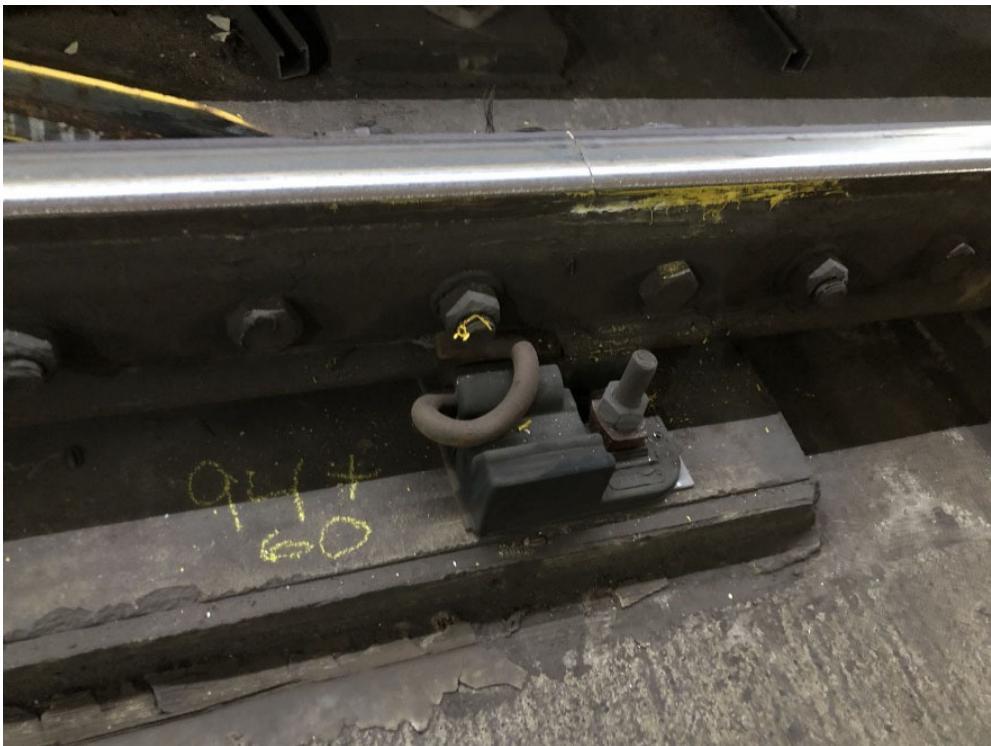
Further investigation and inspection of the event scene identified consistent scrape marks on the top of the right running rail leading to the POD, which included an insulated joint bar and track circuit cabling. Investigators walked towards the vehicle's point of origin and found a second wheel stop next to the left running rail located at CM L2 94+60. This location also included an insulated joint bar and track circuit jumper cabling.

Image 2 - CM L2 94+60 insulated joint damage.

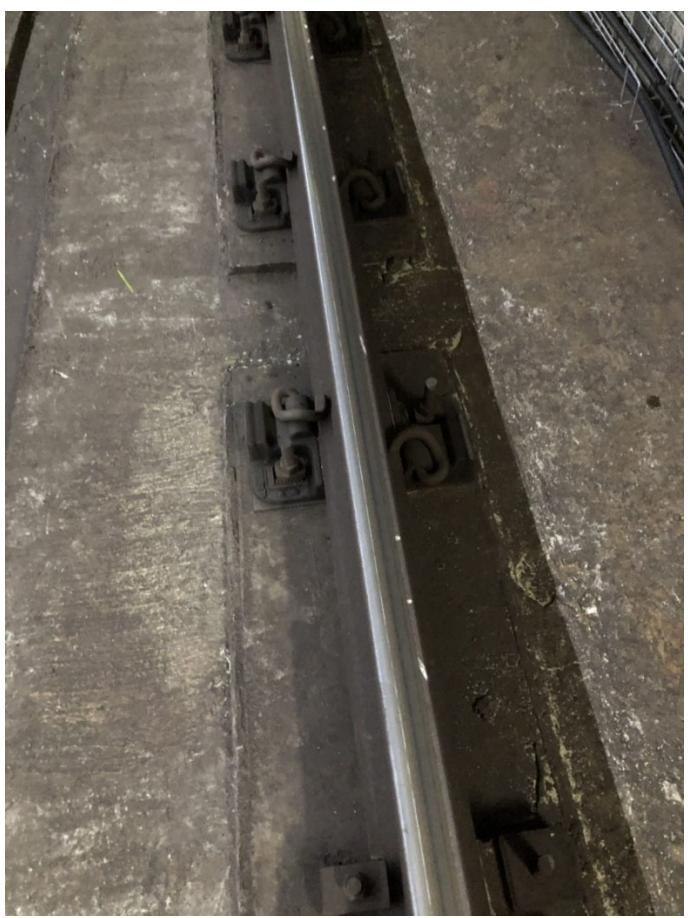
Investigators observed consistent scraping on the top of both running rails from CM L2 94+60 to the vehicle's point of origin at CM L2 103+00. The total area traversed while pushing the wheel stops was approximately 2,000 feet before striking the insulated joint at CM L2 82+20 and derailing. Additional damage, consistent with being struck by the wheel stops, was identified to joint bars at CMs L2 96+45 and L2 96+60.

Image 3 - Example of scraping and rail head damage caused by wheel stop pushing.

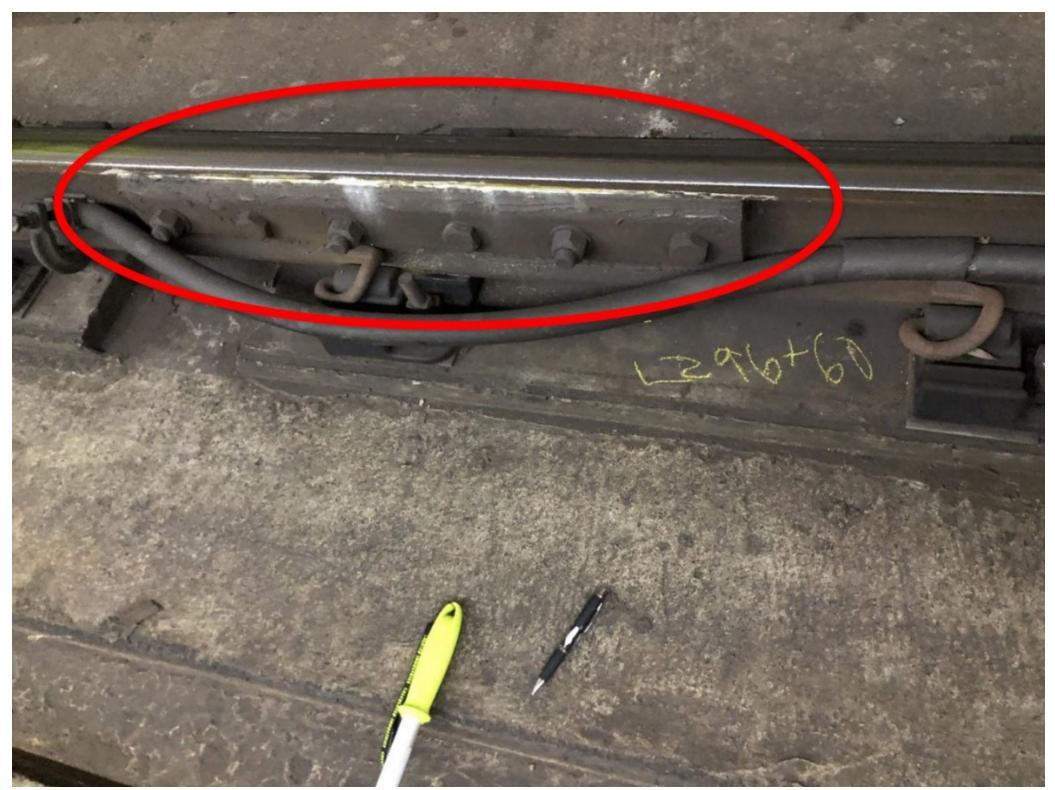
Image 4 - Right running rail non-insulated joint damage and rail head scraping (circled). CM L2 96+60.

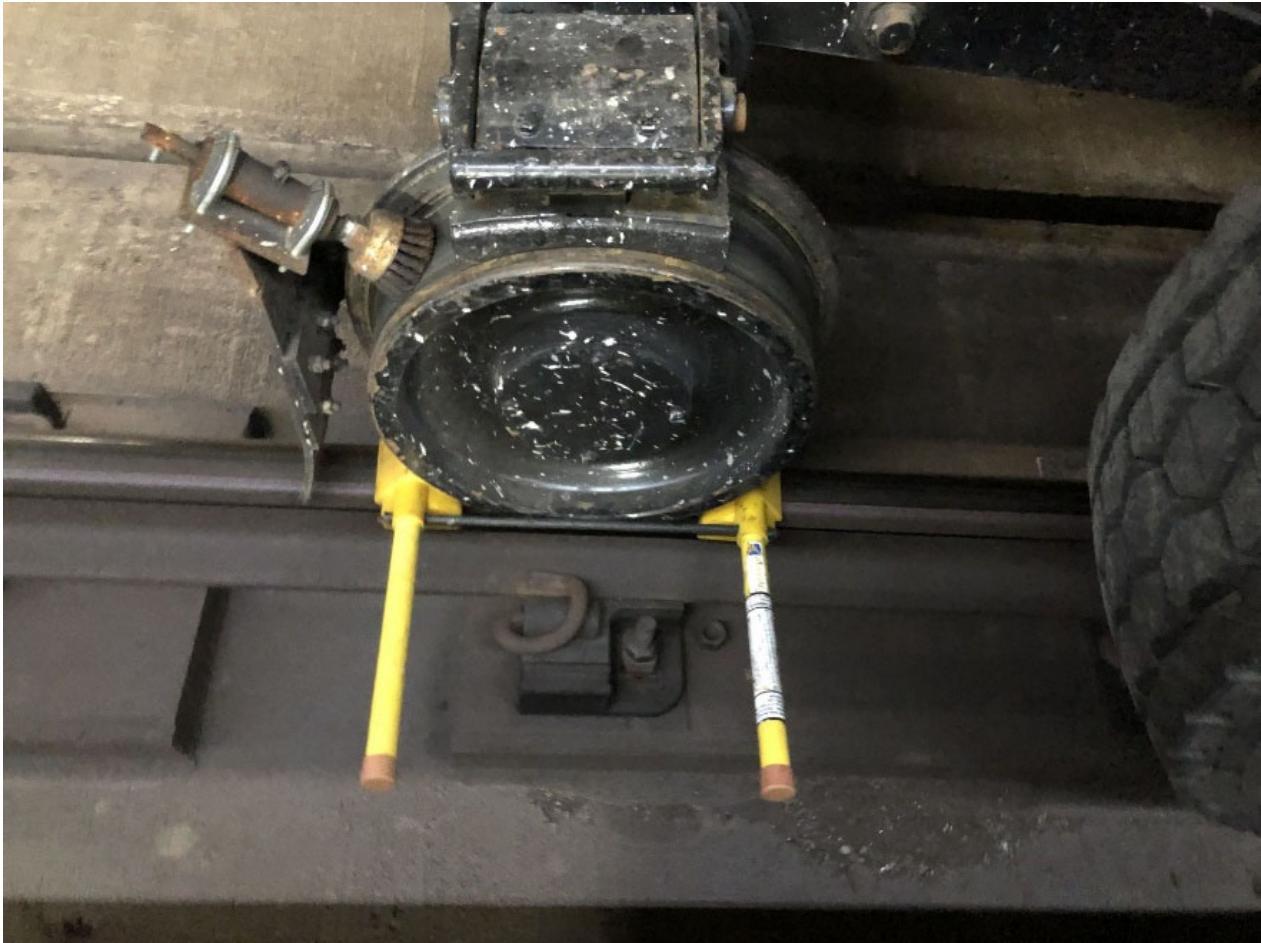
The wheel stops found were not consistent with those used to chock the rail carts and hi-rail vehicles, which have handles that protrude outside the dynamic envelope, making them easier to view. They matched the type associated with tie cranes that were collocated in the temporary yard in the area of CM L2 103+00. The tie crane wheel stops do not have a side handle for easy visual indication and removal; however, the tie crane's wheels are readily visible with a pre-trip walkaround.

Image 5 - Wheel chocks used to secure hi-rail vehicle CR7974.

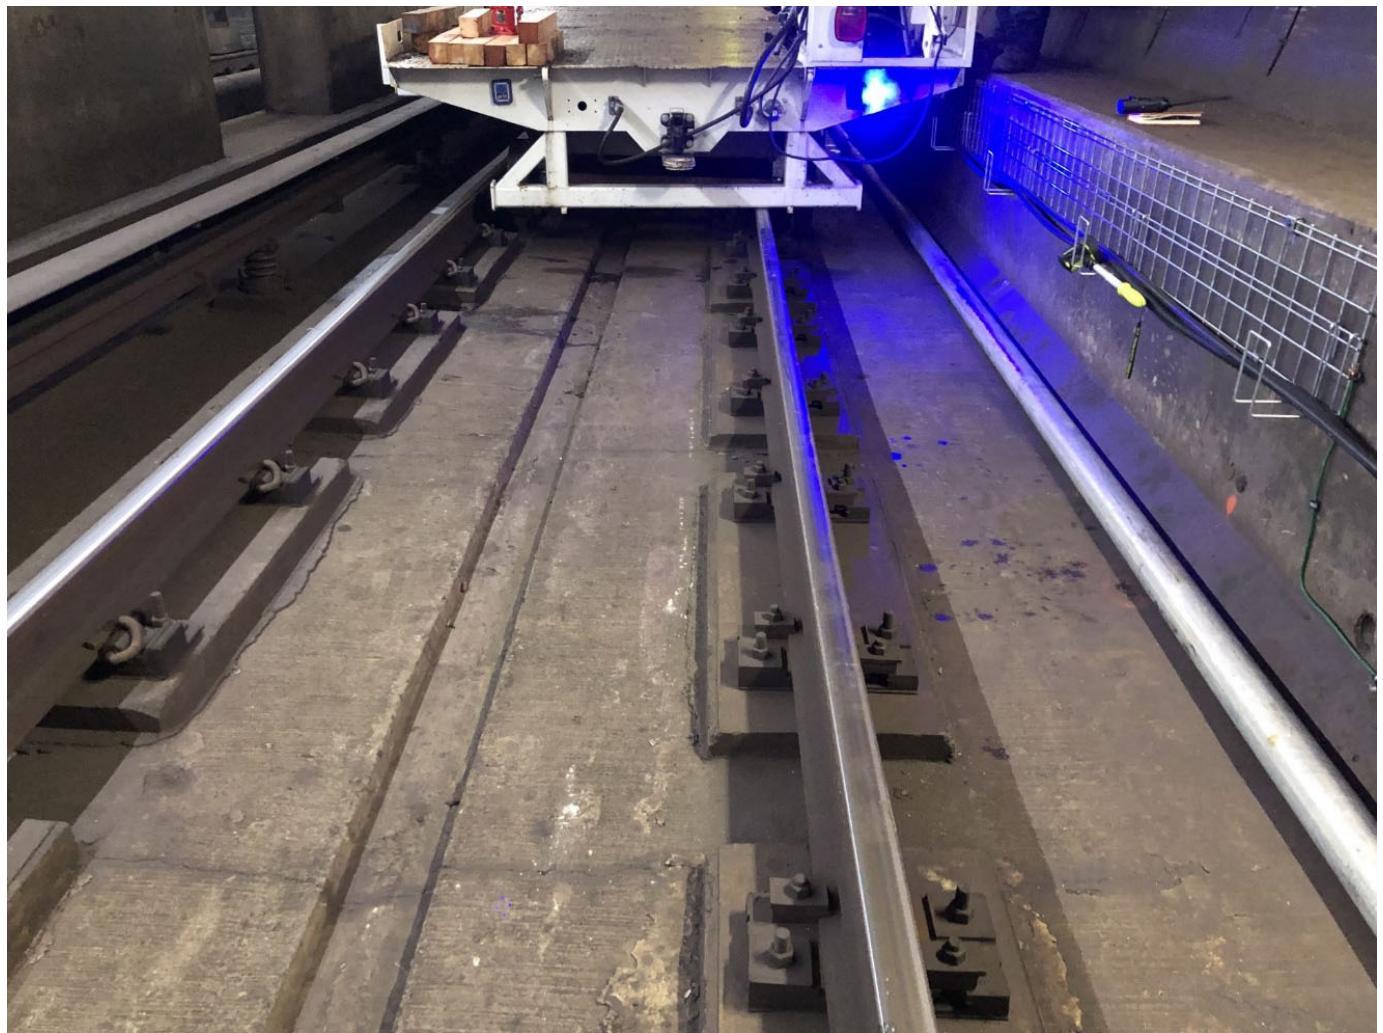
Image 6 - Rail Cart 7725's resting position following the derailment.

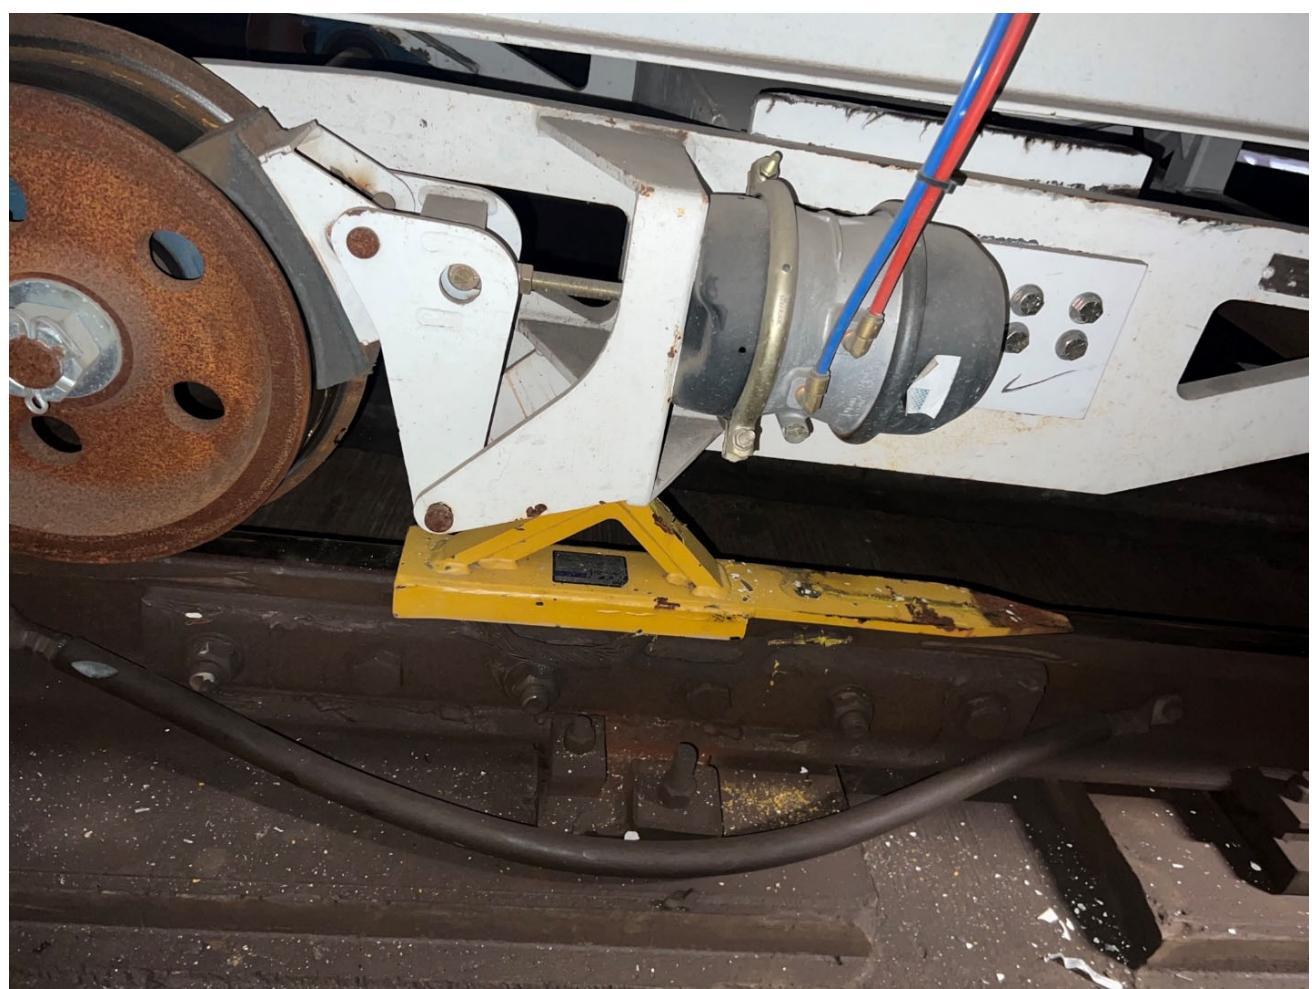
Image 7 – Front axle (second in the direction of travel) of Rail Cart 7725 in contact with wheel stop near CM L2 82+20 at an insulated joint.

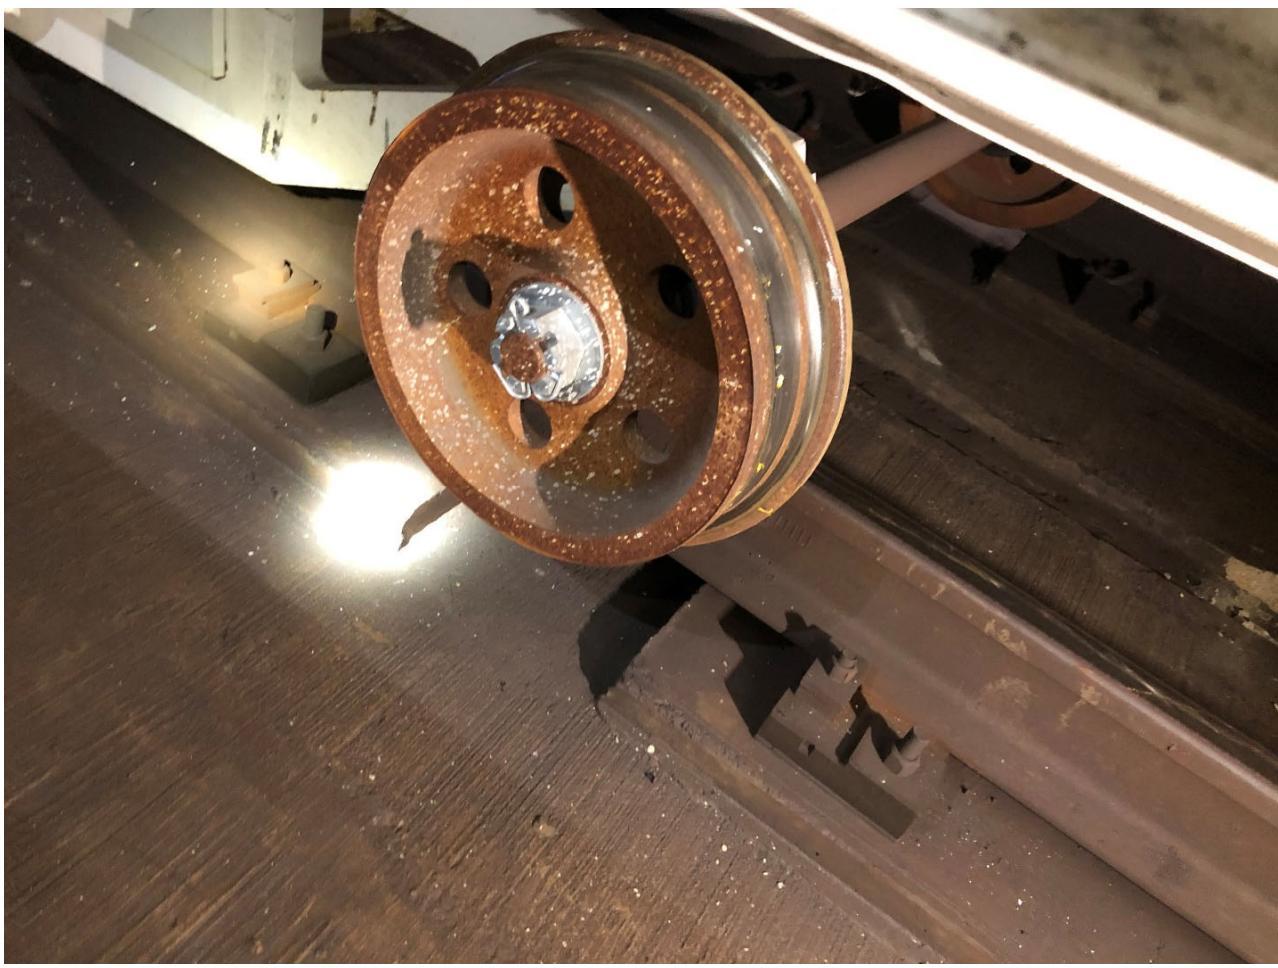
Image 8 – Rail Cart 7725 rear axle (lead axle in the consist) derailed near CM L2 082+20.

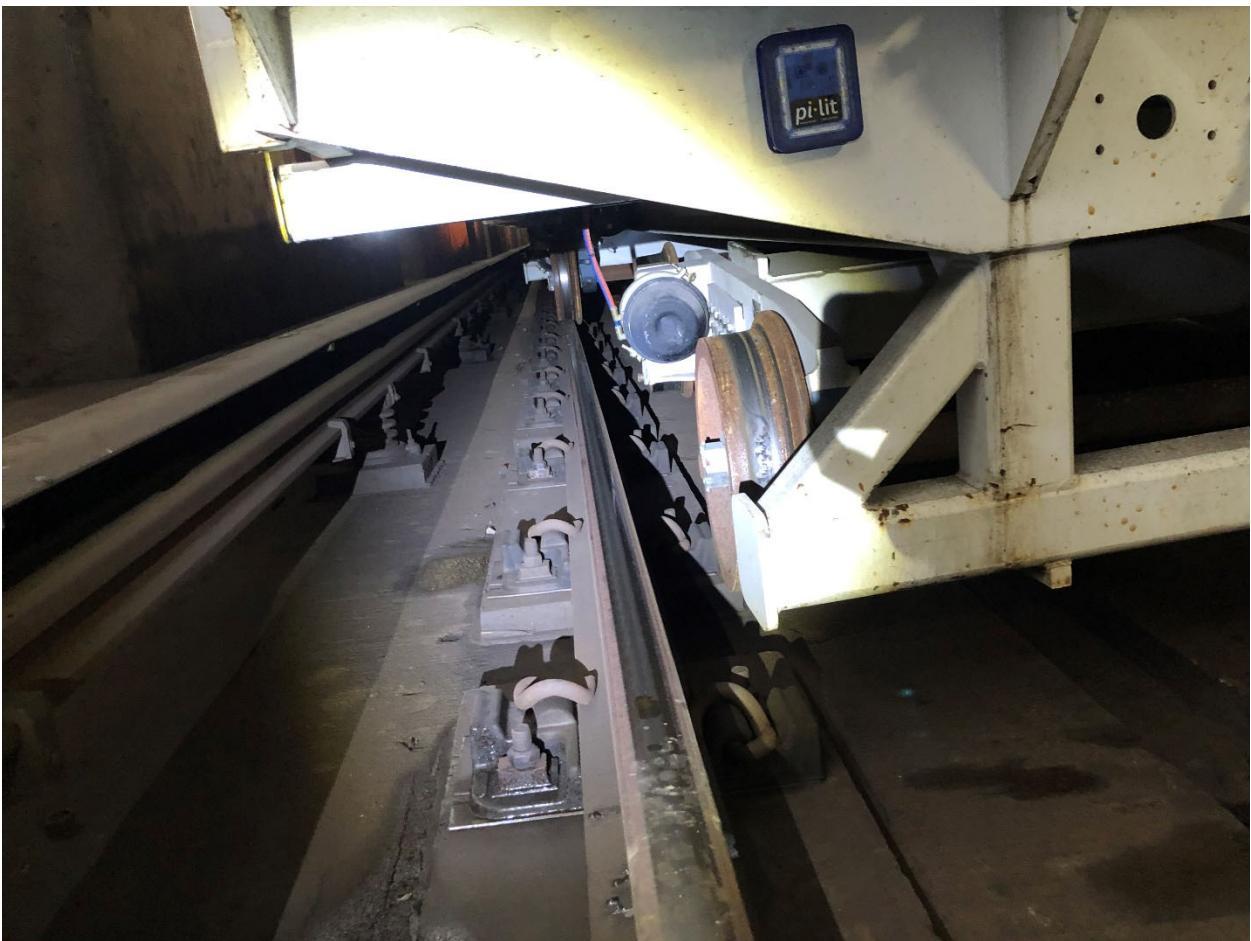
Image 9 – Rear view of derailed Rail Cart 7725 rear axle near CM L2 082+20.

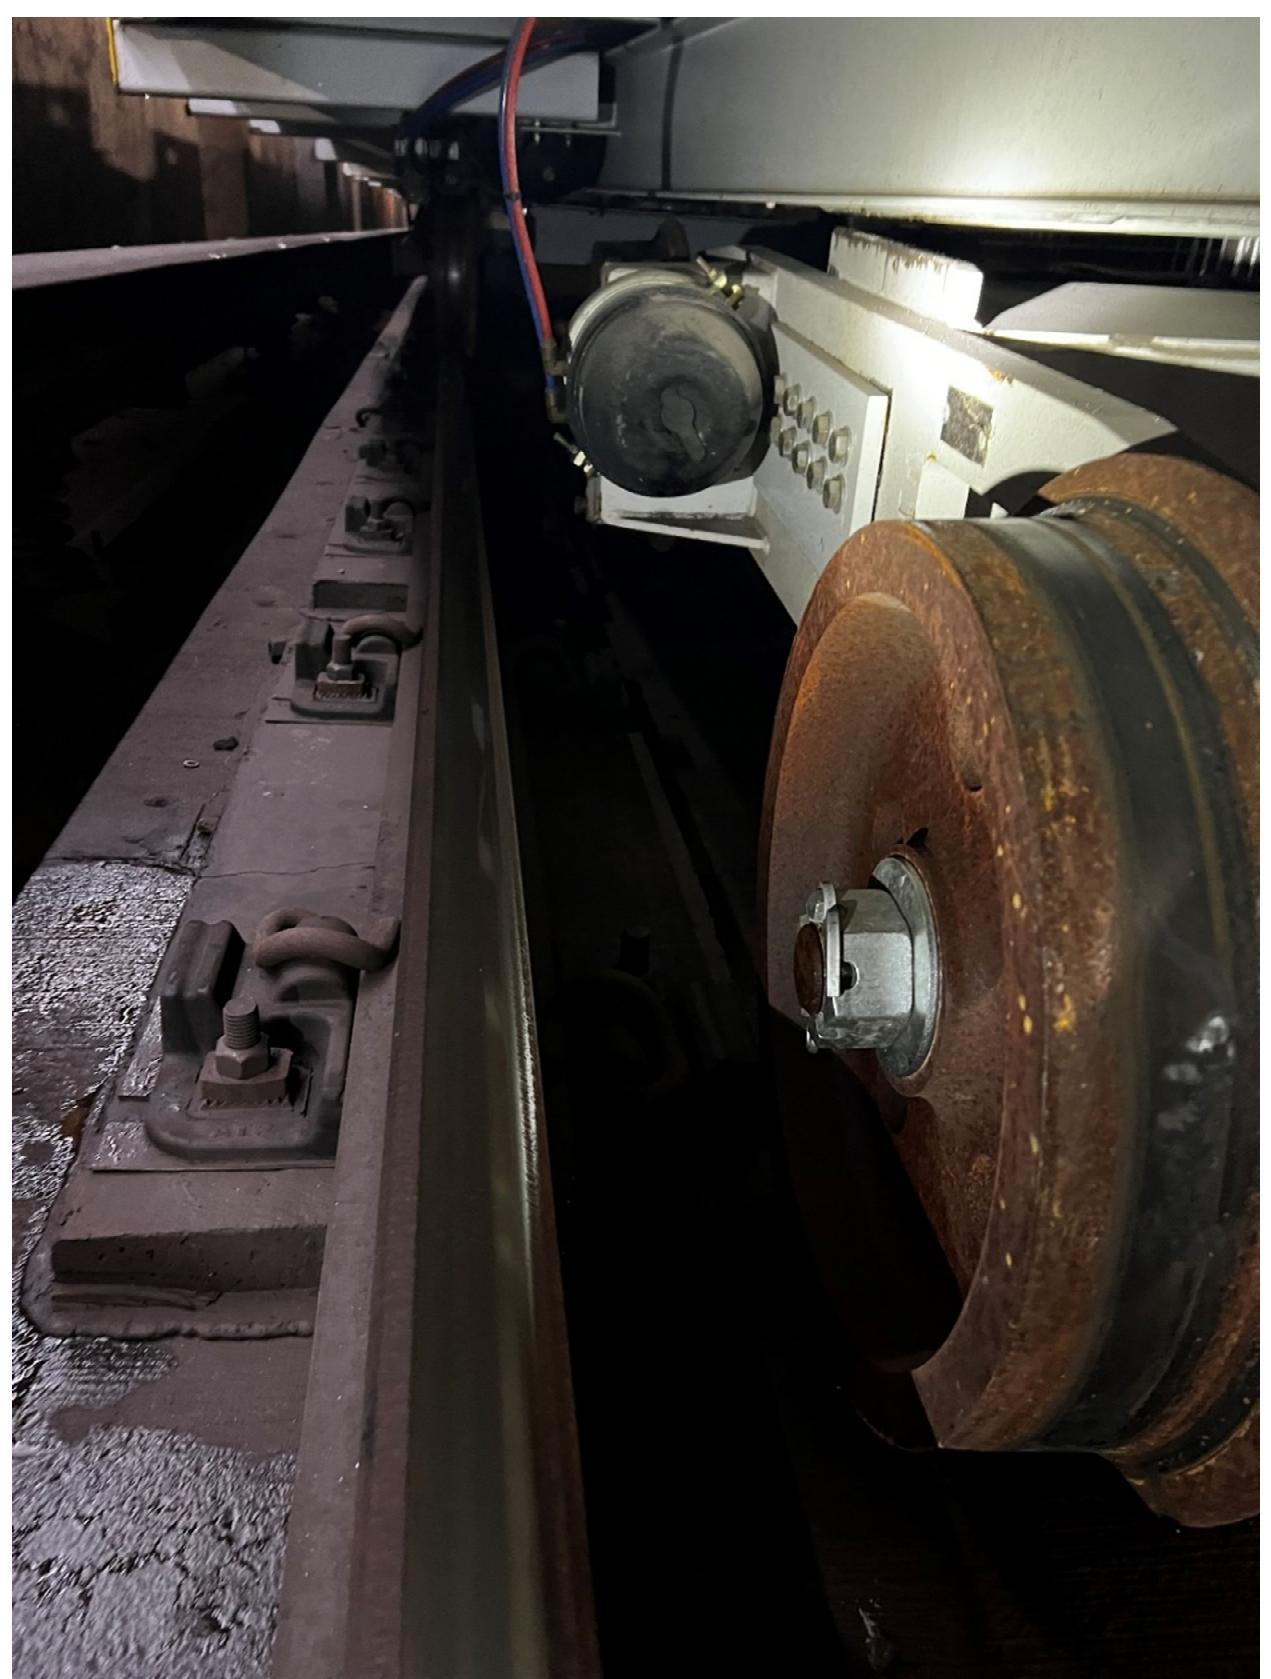
Image 10 – Close view of derailed Rail Cart 7725 rear axle near CM L2 082+20.

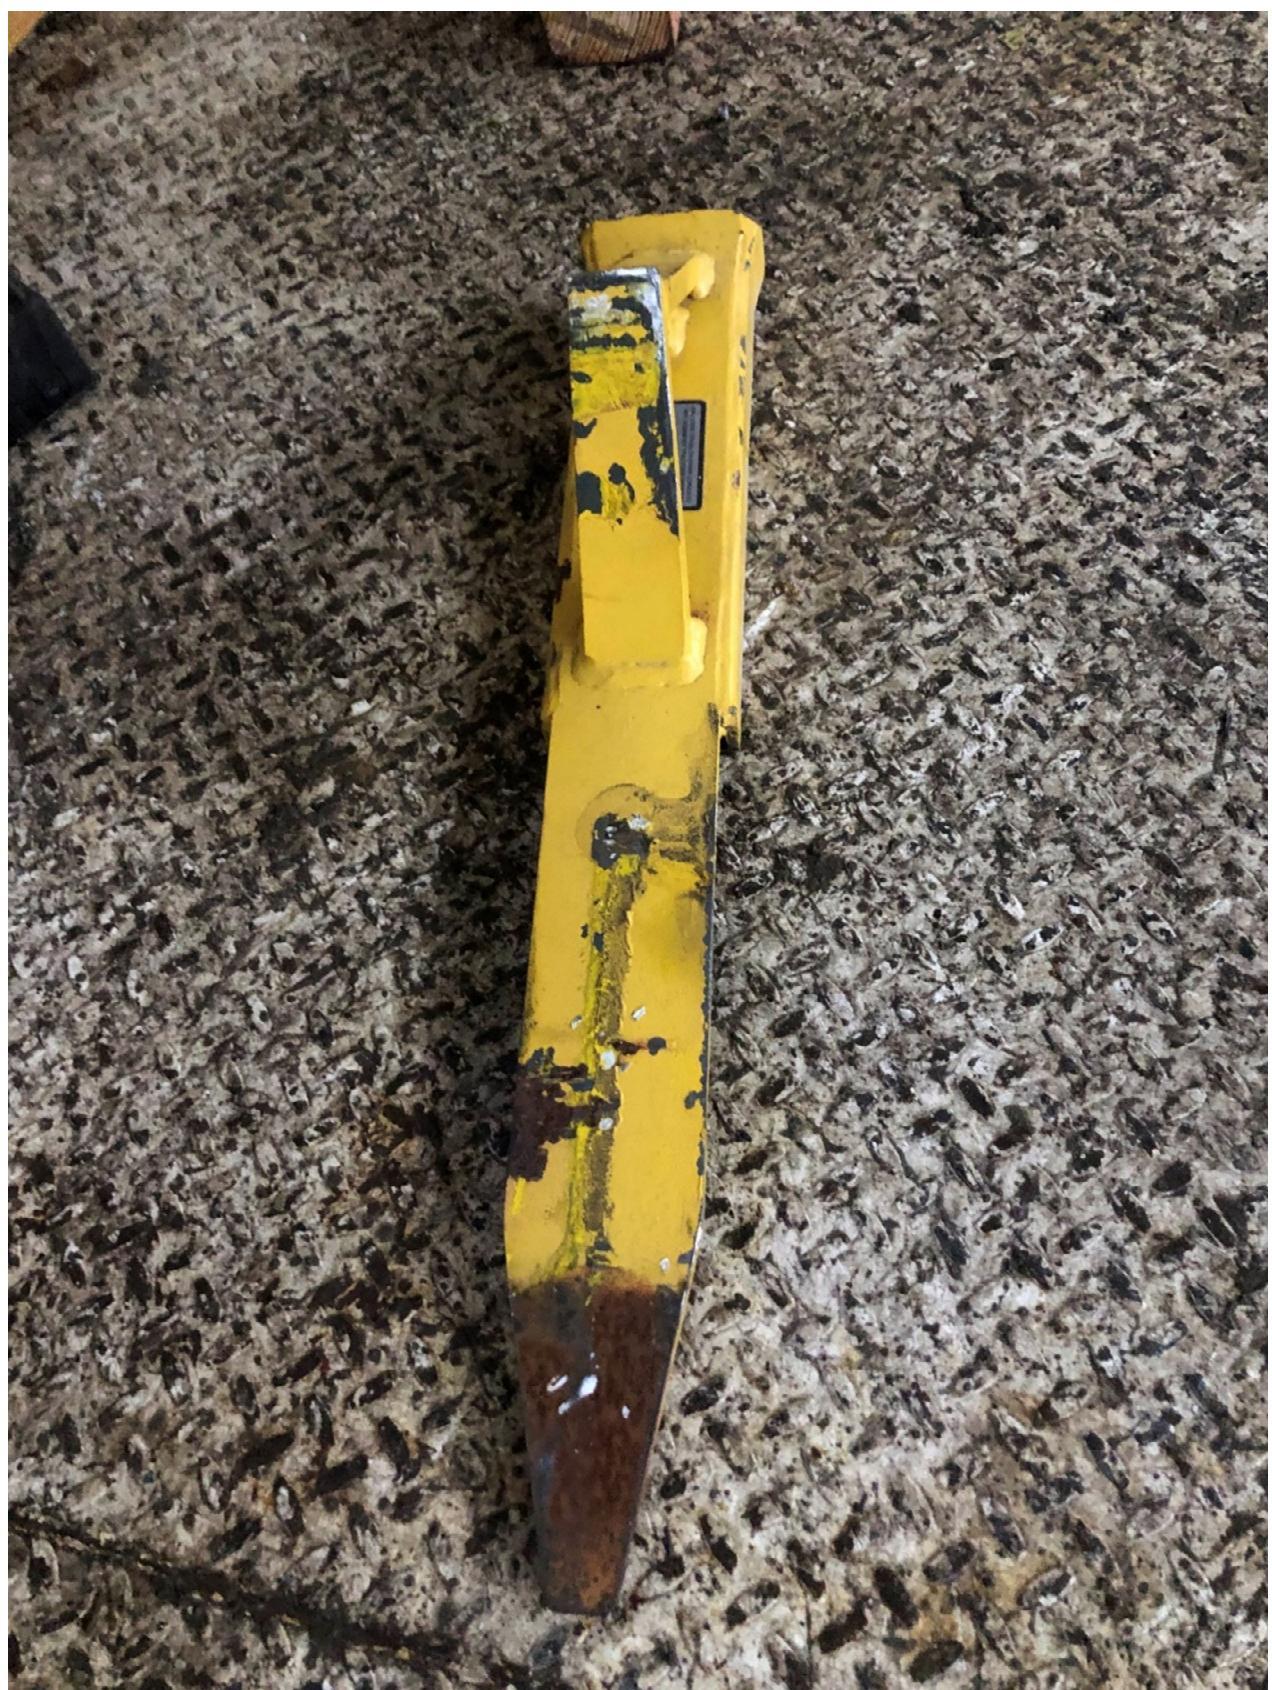
Image 11 – Wheel stop removed from the roadway near CM L2 82+20.

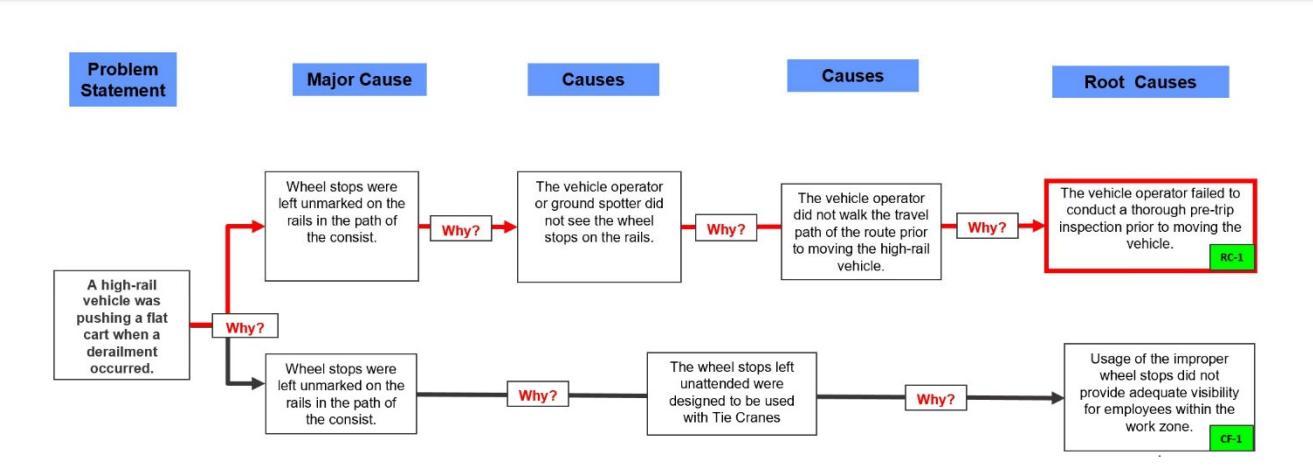
## E22643 – Improper RWP – L'Enfant Plaza, L-Line ACS

The root cause of the derailment was a failure to follow procedures. The contractor personnel involved with the hi-rail vehicle move did not conduct a thorough pre-trip inspection prior to vehicle movement. A contributing factor to the derailment was the improper use of equipment, as the wheel stops were designed for use with the tie cranes and were not easily visible, possibly due to the weather conditions (time of day and rain).

Corrective Action Code	Description	Responsible Party	Estimated Completion Date
103270_SAFE CAPS_CAPD _001	(RC-1) Kiewit Management conducted a safety stand down with all personnel to review the incident, focusing on the proper use of equipment and pre-trip inspections.	CAPD SRC	Completed
