WMSC Commissioner Brief: W-0207 – Derailments – near future Potomac Yard Station – September 13, 2022

Washington Metropolitan Area Transit Authority Department of Safety (SAFE) Office of Safety Investigations FINAL REPORT OF INVESTIGATION A&I E22593/E22595

Date of Event:	September 13, 2022		
Type of Event:	Derailment		
Incident Time:	03:15 & 12:10 hours		
Location:	Potomac Yard Authorized Construction Site (ACS)		
Time and how received by SAFE:	03:59 & 12:58 hours – Mission Assurance		
	Coordinator (MAC)		
WMSC Notification Time:	04:29 & 13:02 hours		
Event Scene Release:	04:29 & 13:05 hours		
Responding Safety Officers:	WMATA: OSI/OSO		
	WMSC: None		
	Other: None		
Rail Vehicle:	Plasser Tamper Unit T006		
Injuries:	None		
Damage:	None		
Emergency Responders:	CTEM, CENV, TRST		
SMS I/A Number	20220913#102838MX

Potomac Yard ACS – Derailment

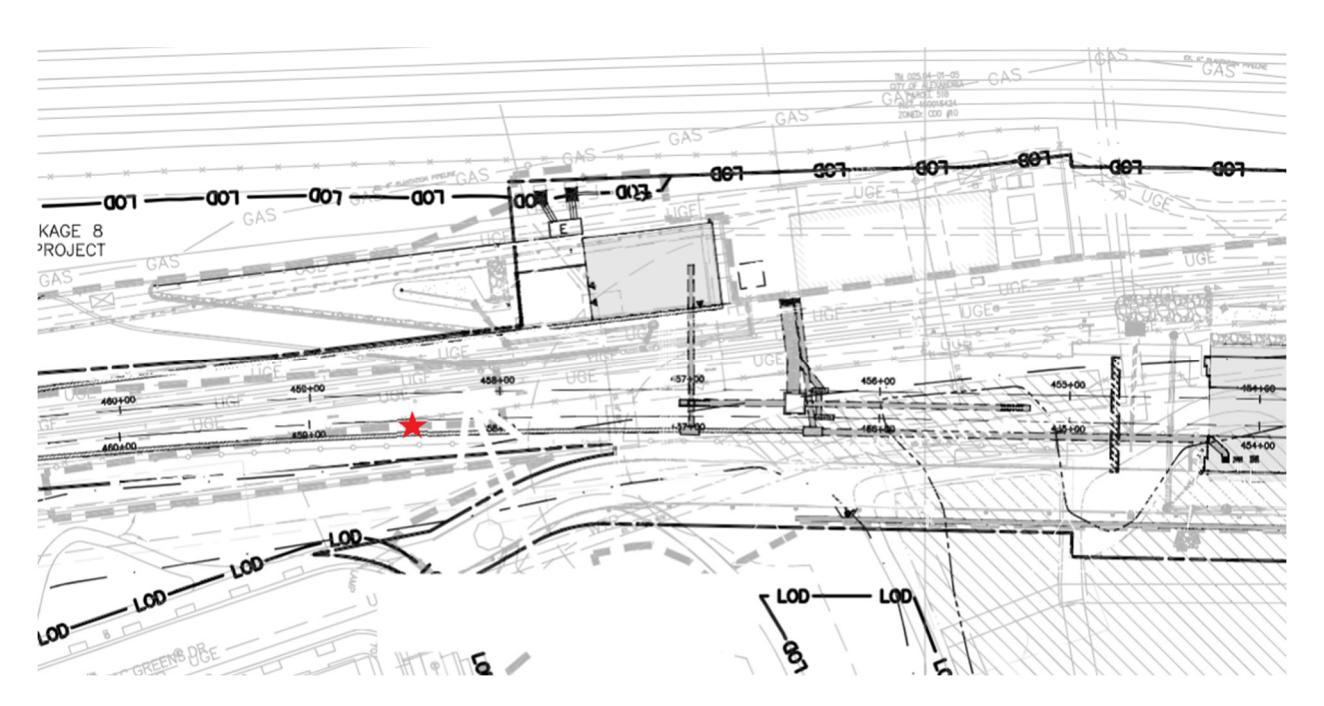
Field Sketch/Schematics

* Not to Scale. Red star notates approximate site of both derailments.

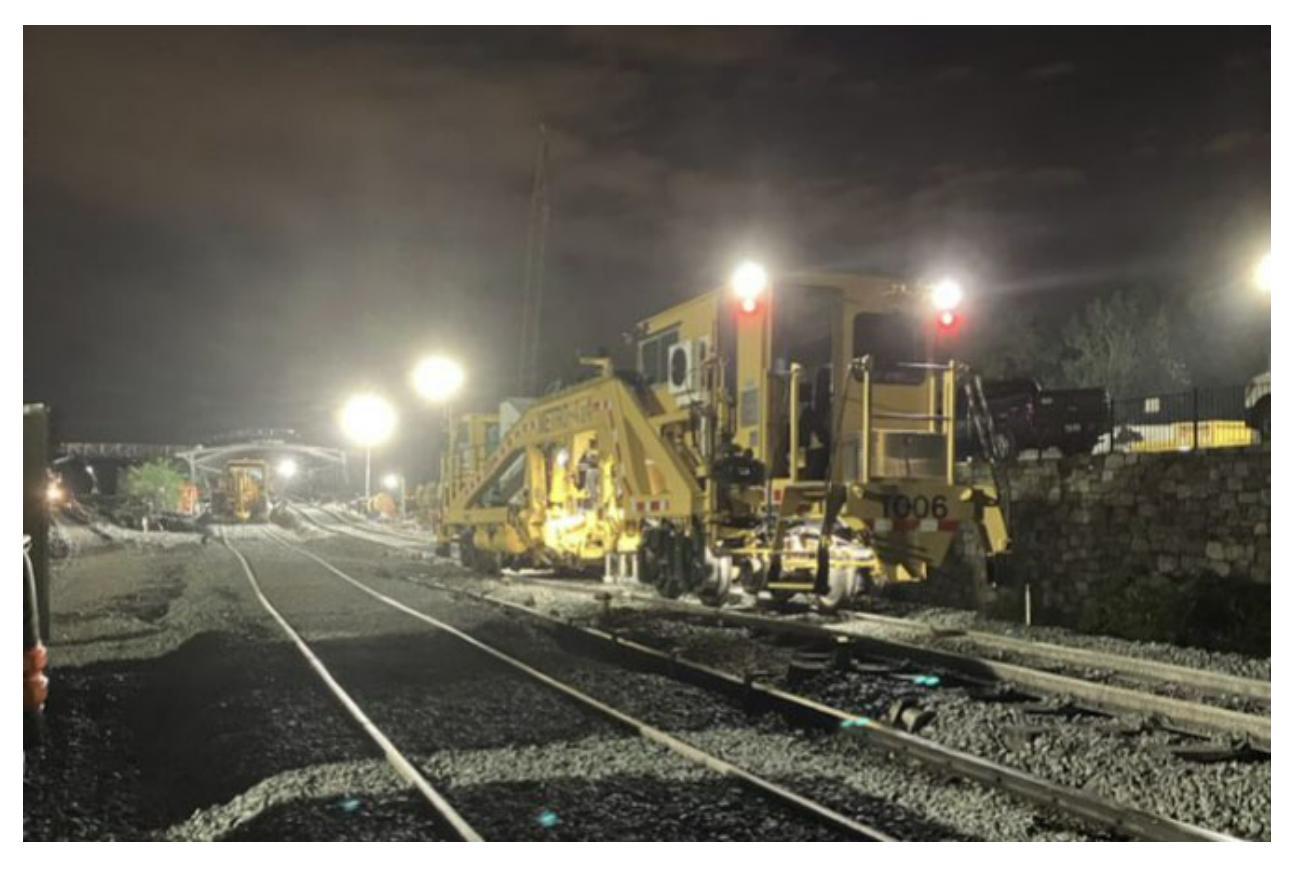
Figure 1: Tamper T006 as it appeared, on scene, oriented travelling south towards the site for Potomac Yard station along Track 1.

Consultation of the ARS and conversations with personnel on scene confirmed that the ACS Supervisor advised that Tamper T006 derailed from Track 1 of the Potomac Yard ACS at CM C1 458+50 at 03:15 hours, while tamping new track.

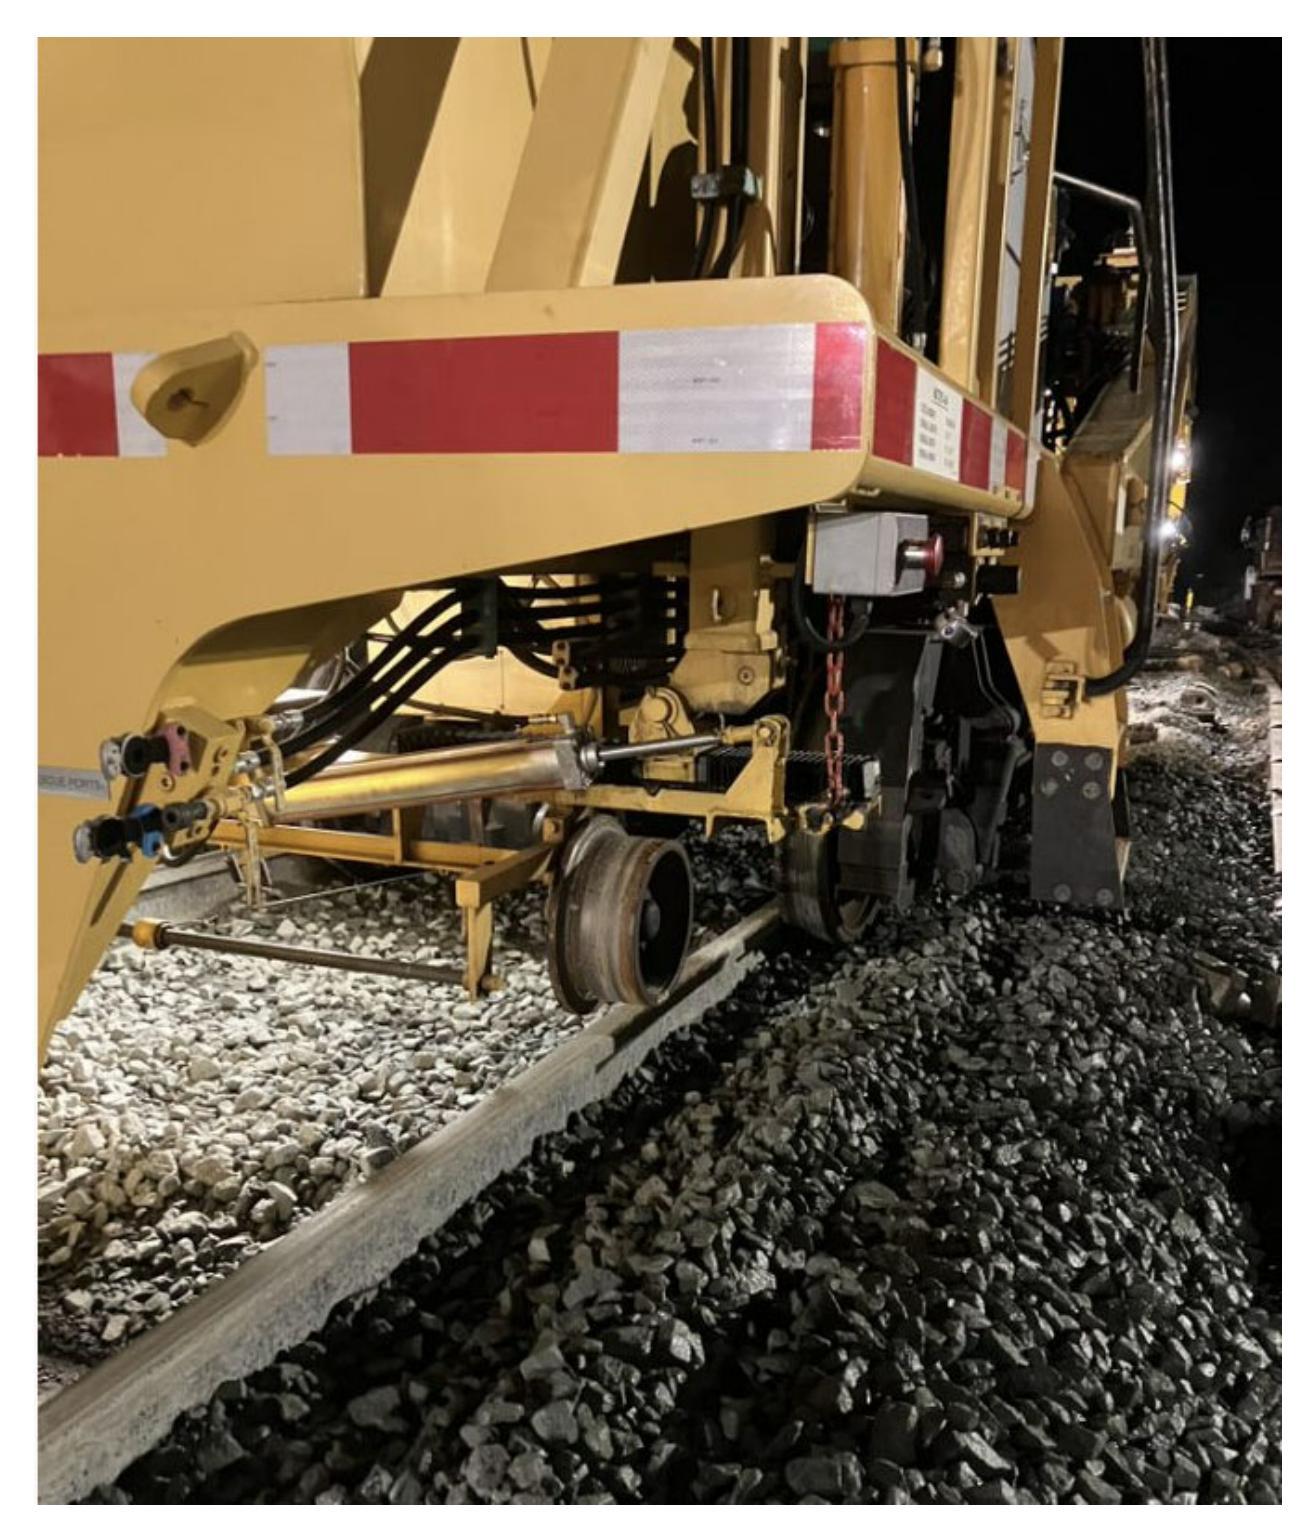
Figure 2: Tamper T006 point of rest, front left side.

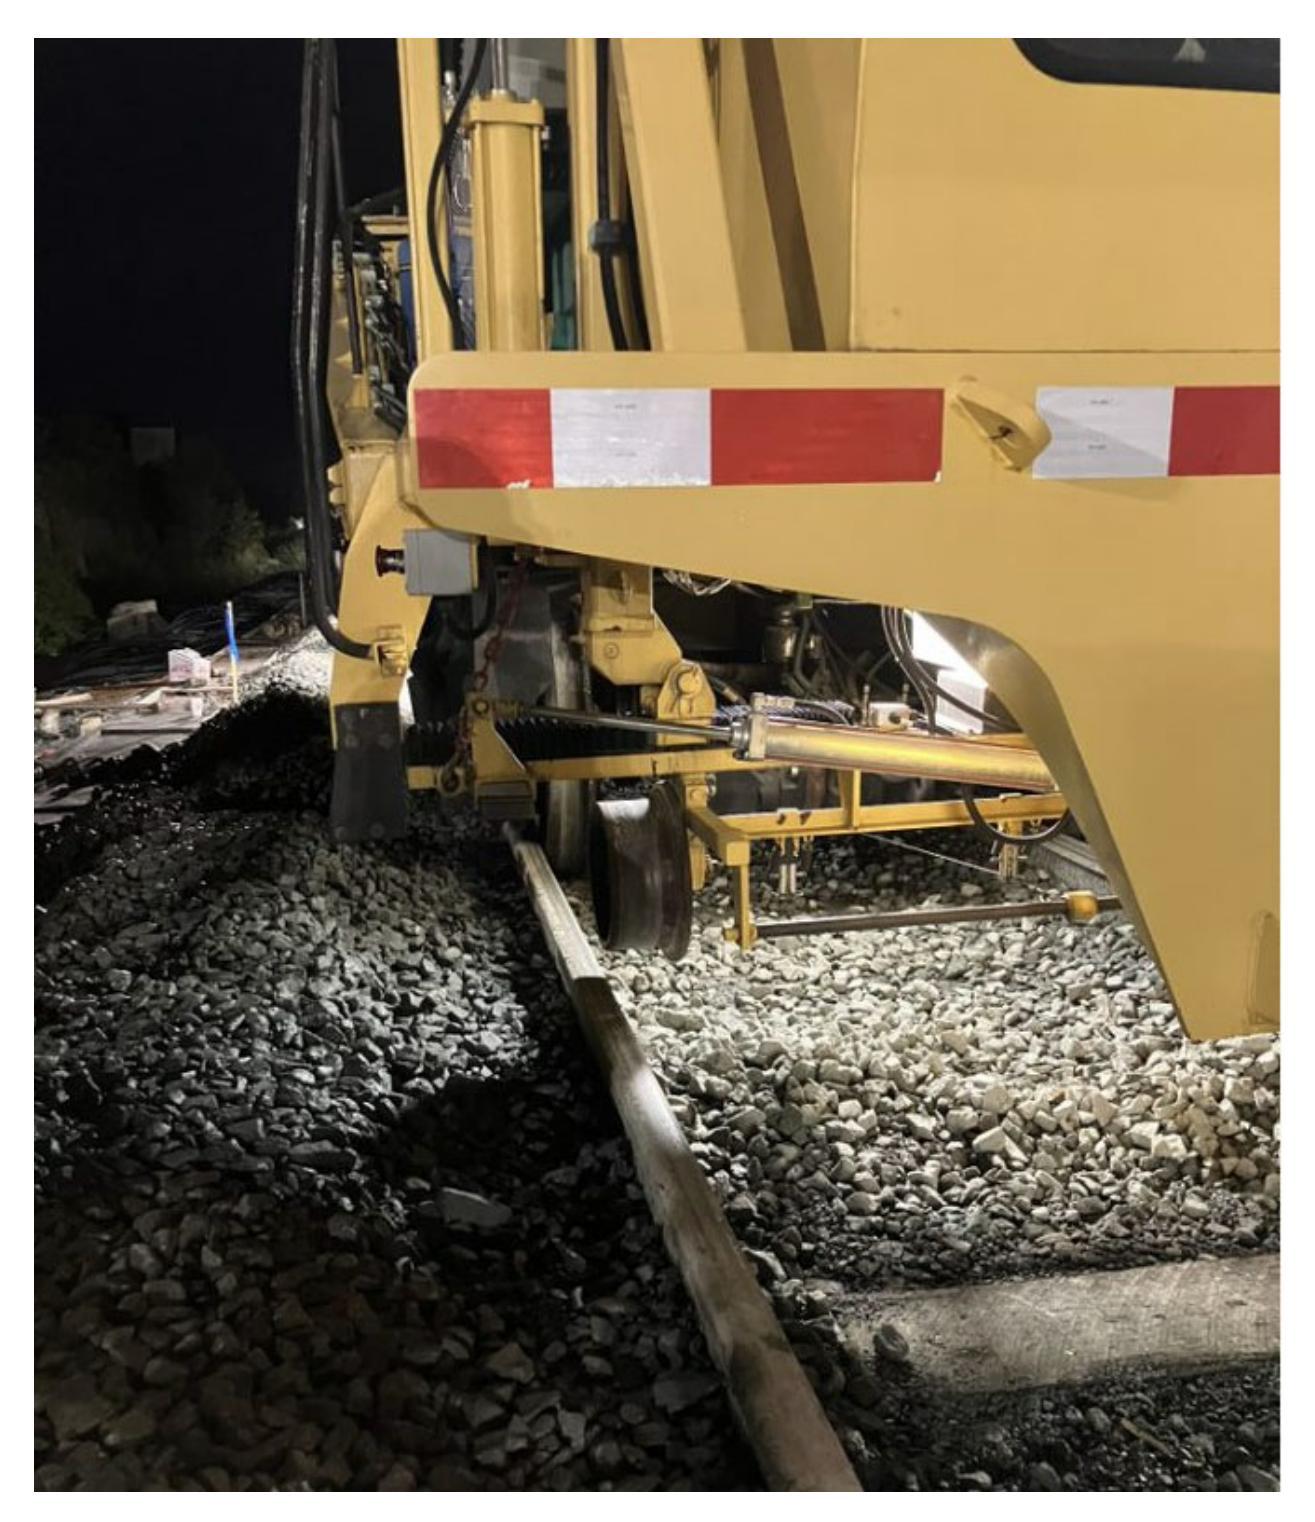
Figure 3: Tamper T006 point of rest, front right side.

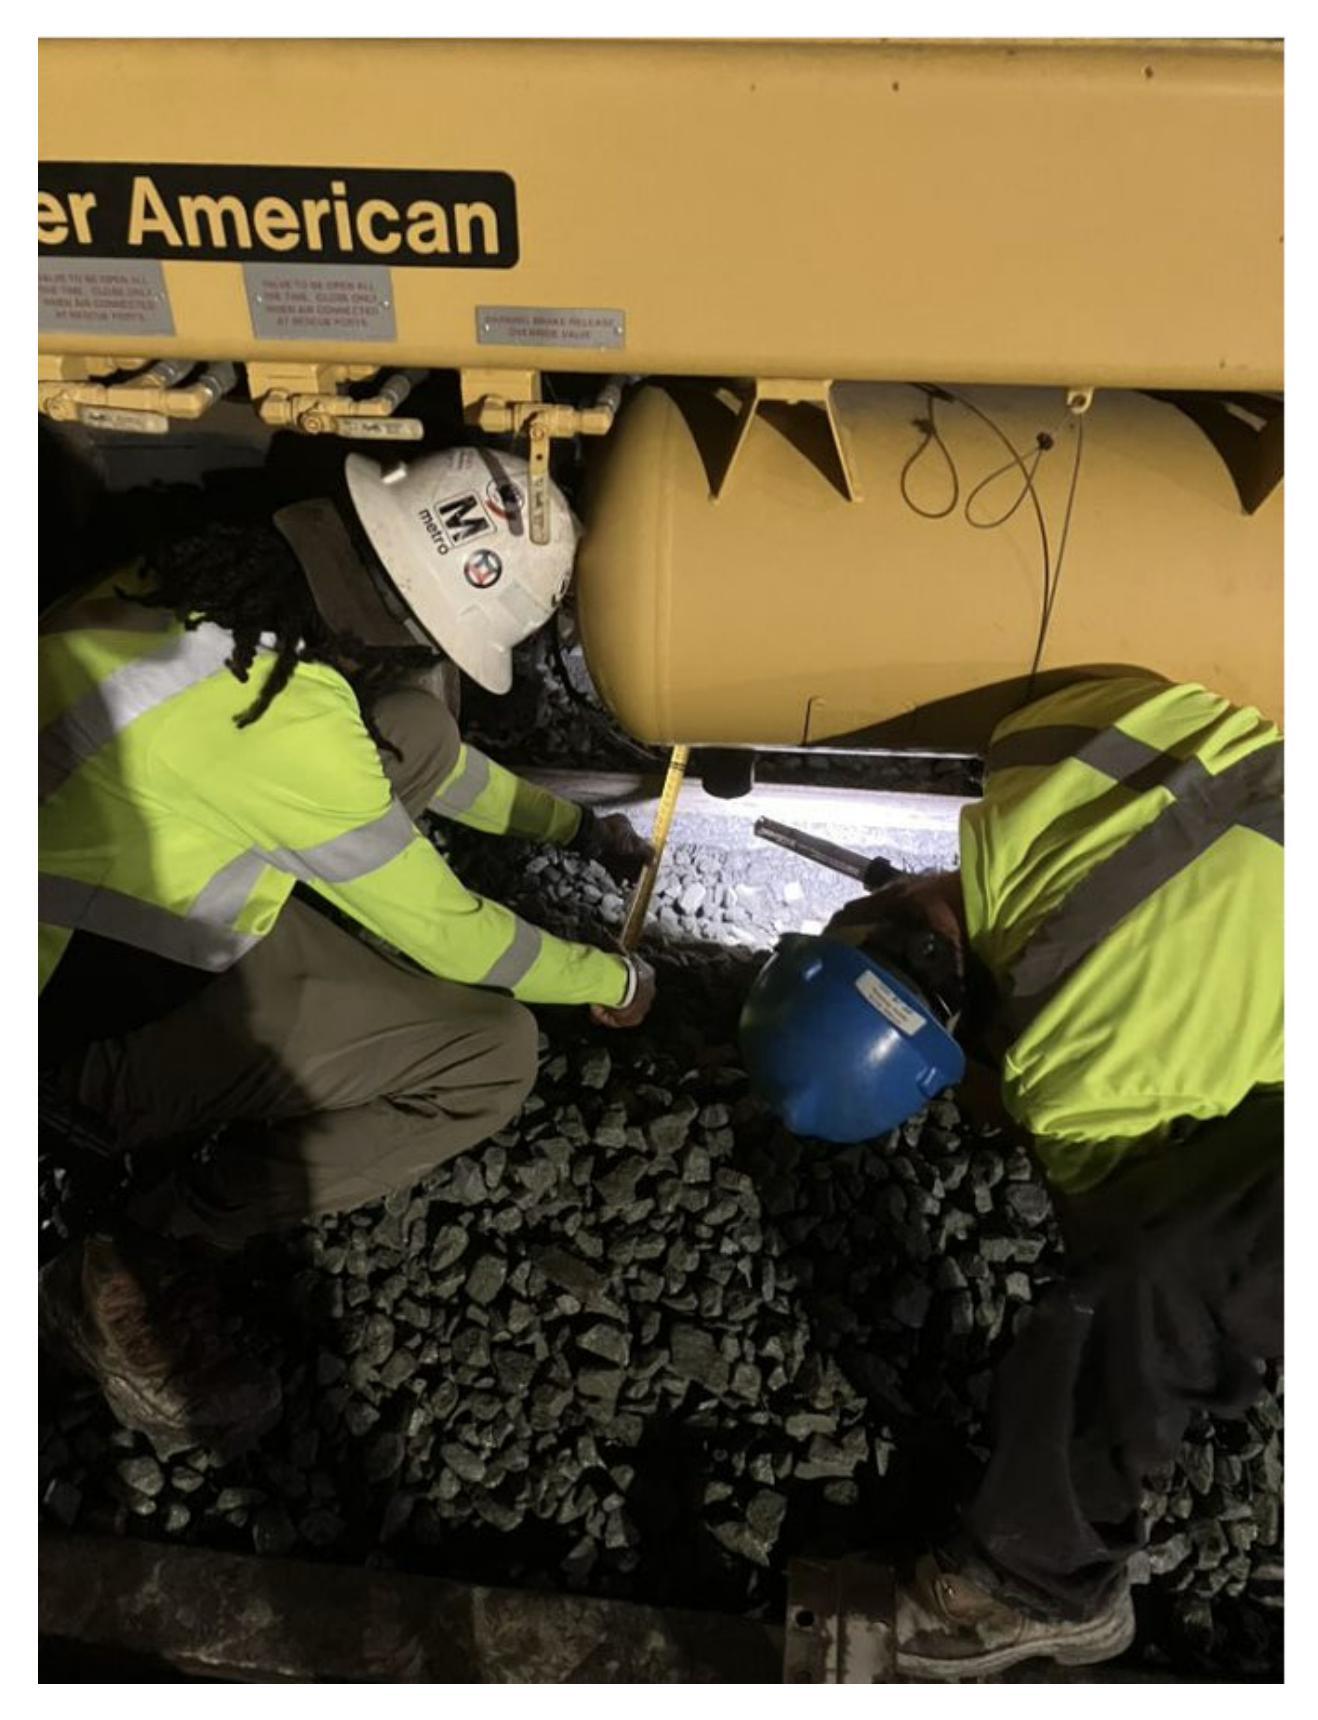
TRST personnel on scene conducted track measurement to assist in determining the root cause of the derailment. Upon measuring multiple points along the track, including the point of derailment, TRST confirmed the gauge (spacing) between each running rail did not contribute to the derailment.

Figure 4: TRST personnel determine the track gauge point of derailment at 56 and 1/6th of an inch distance between the left and right running rail.

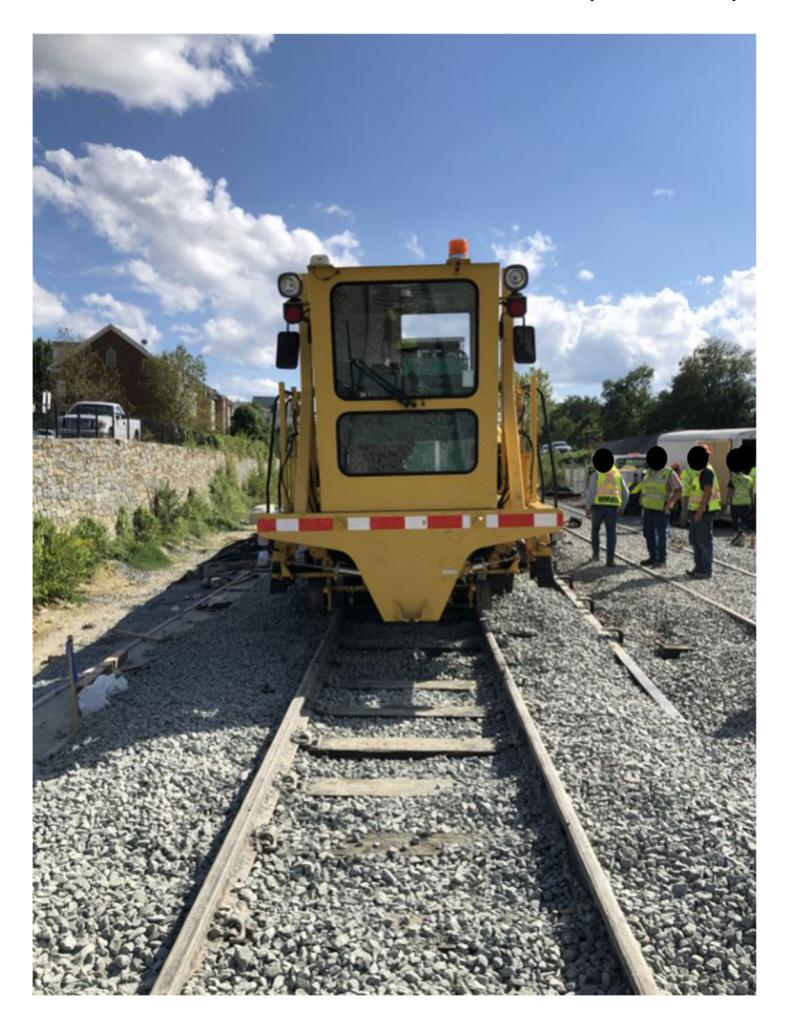
A review of the ARS and the ROIC Report determined at 12:10 hours, the Mobile Command Manager reported that at a speed of approximately three miles per hour (MPH), Tamper T006 derailed between CM C1 454+00 - 460+00. The TRST Supervisor on scene reported that the front trucks of T006 derailed while the Tamper was in performance of its duties.

Figure 6: Tamper T006, second derailment.

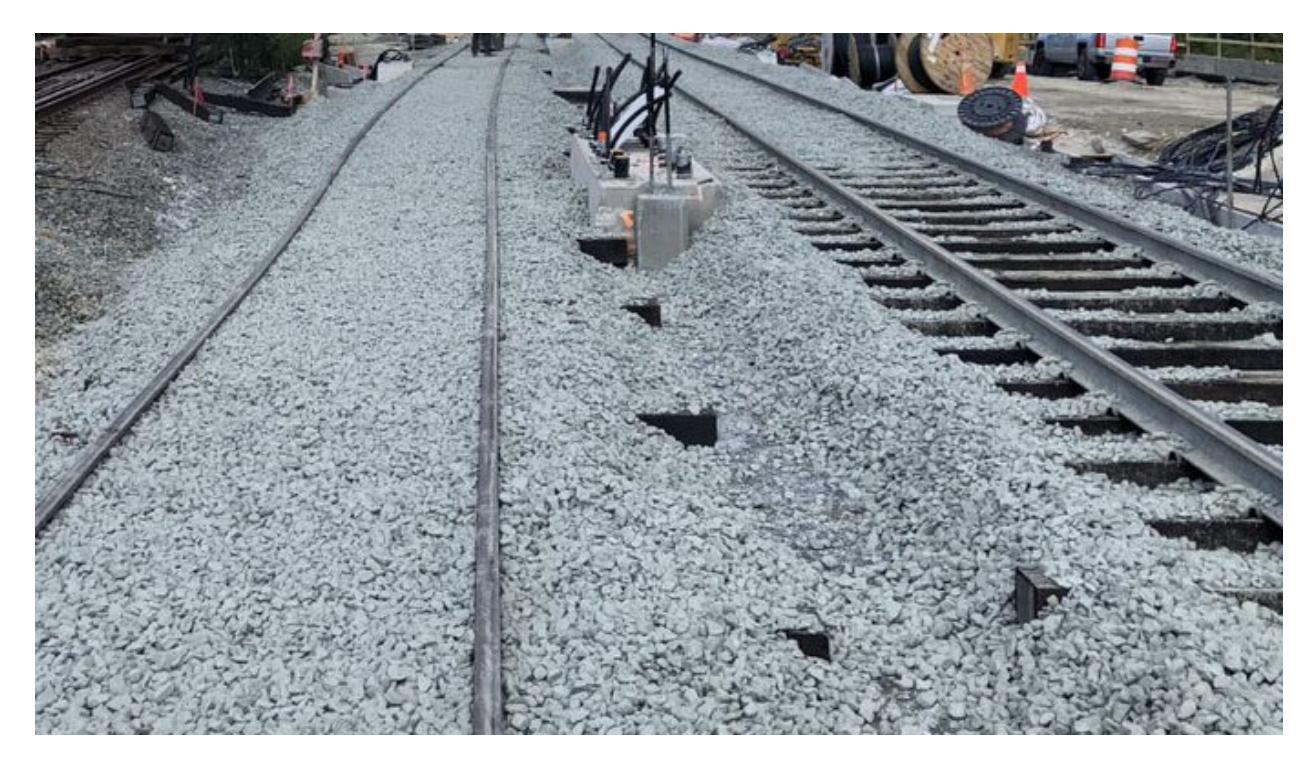
Figure 7: Overage of ballast observed on Track 2 (left side of image) in area opposite of the derailment. Track 1 (right side of image) shows results of tamping activity.

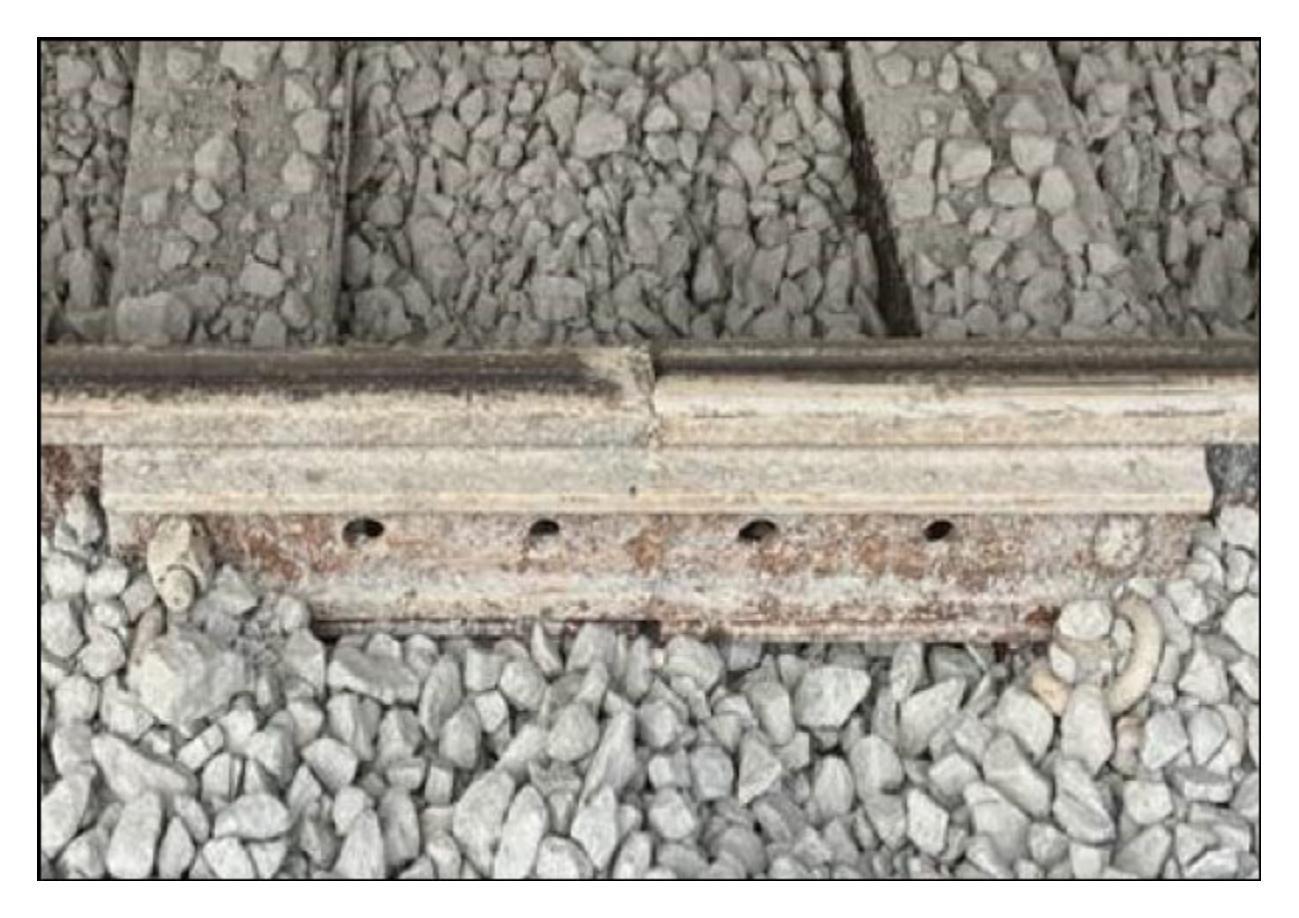
The joint bar was supported by a single bolt on each side of the joint. Field interviews indicated that the Equipment Operator was following the prescribed mitigations following the first derailment. While the unit was at its point of rest, track gauge and cross-level measurements were captured. They indicated that the left running rail was still high and varied through the area of the derailment. This cross-level variation, coupled with the movement at the rail joint likely contributed to the unit derailing again.

Figure 8: Mismatched rail joint, with joint bar at the POD.

The report concluded that excessive cross level change (3.5 inches over 33 feet) and a mismatched rail joint within the work area is likely the root cause of these derailments.

Personnel on site prescribed adding additional bolts to the joint bar to reduce the movement of the joint while the Tamper moves over it. The additional mitigation was shared with the WMSC, who did not object to rerailing and continuing the track construction with the T006 unit. The unit was rerailed again by CTEM personnel. Two additional joint bar bolts were added, and the unit continued to work without issue.

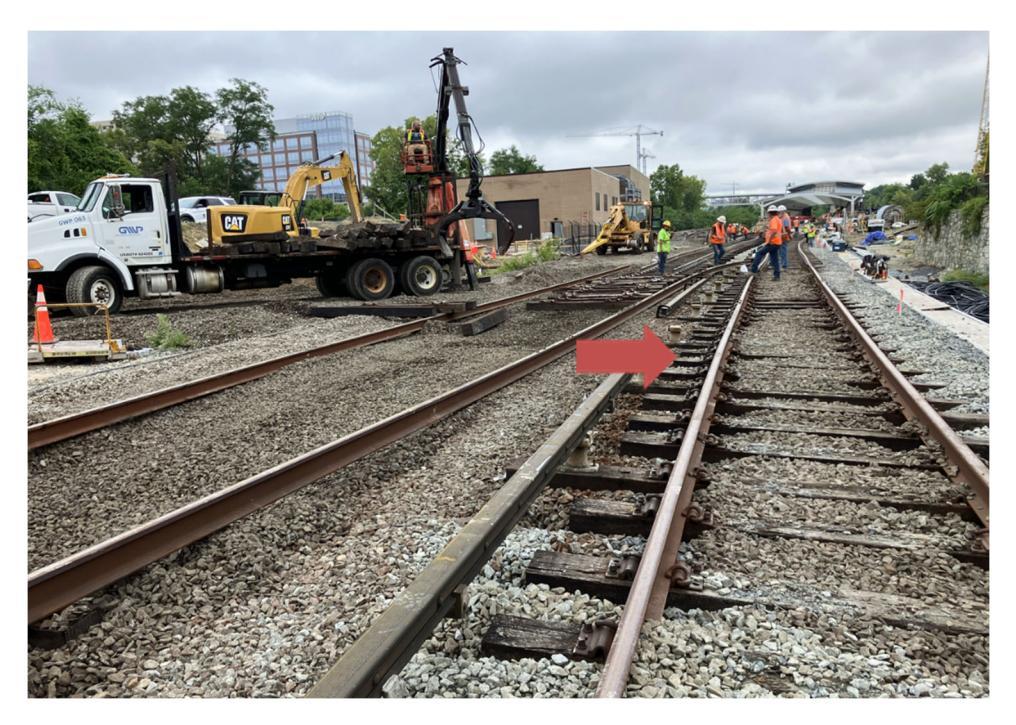
The PYC Project Manager advised G.W. Peoples laid the track and ballast the day prior to the event. The PYC Project Manager stated the ballast laid appeared to be excessive and obstructed the view of the crossties and joint bars.

Figure 10: G.W. Peoples installing track on September 12, 2022, in the area of the derailment. Arrow pointing at Track 1.

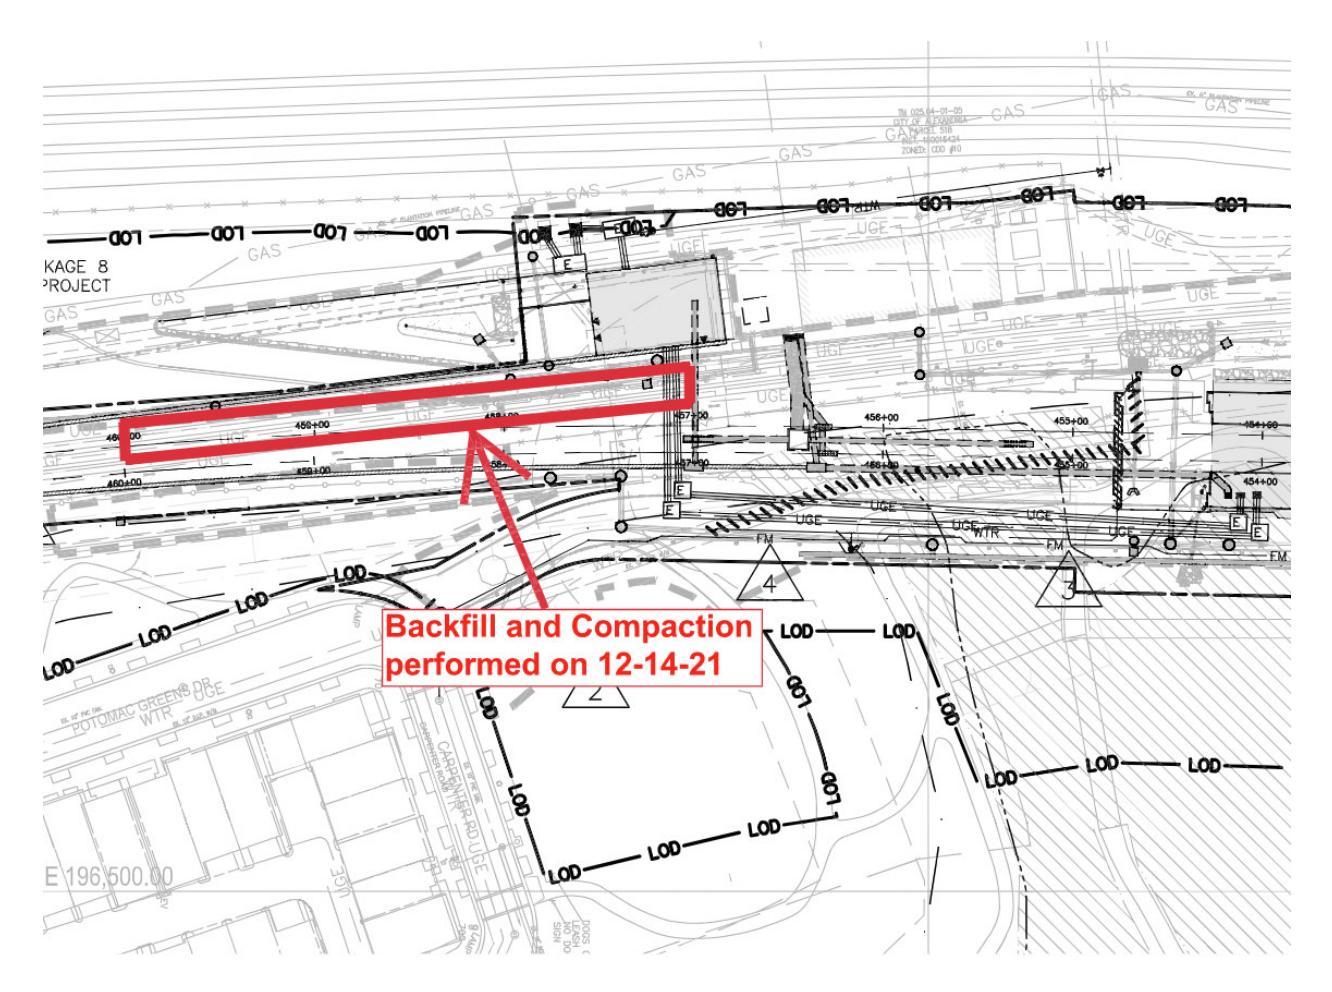
Figure 11: The site of the compaction conducted on 12/14/2021.

- While not found to be contributory to the event, CAPD provided a sub-ballast compaction report that articulated the sub-ballast was installed appropriately; however, the latest assessment was conducted on 12/14/2021.

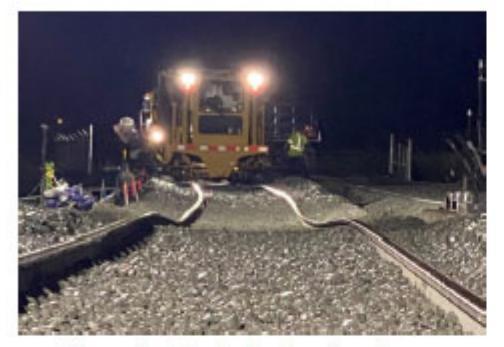
Figure 1 – Tracks in derailment area

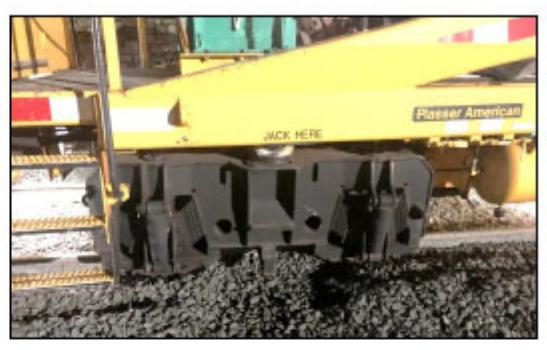
Figure 1 - T006 Derailed truck

At approximately 0315 hours on the morning of September 13th, 2022 Tamper T006 Derailed near chain marker 458+00 while tamping within the Potomac yard station tie-in ACS. SAFE released the vehicle to CTEM at approximately 0600. CTEM rerailed the vehicle at approximately 0730, after which a post incident inspection and track test was conducted. No issues or damage were reported during rerailing or inspection.

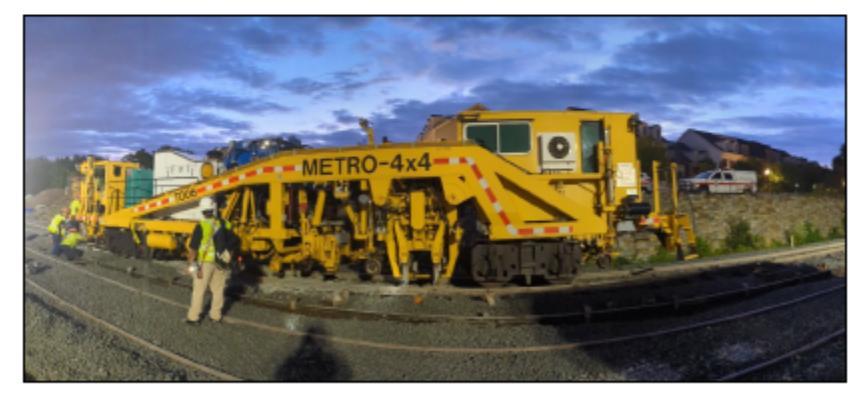
Post incident inspection of the vehicle was conducted with no damage found. The track was inspected using a track gauge and it was found that the area leading to the point of derailment (POD) had a change in cross level of 3 1/2 inches over 33 feet in the direction of travel. This area is depicted below in Figure 3.

Figure 3 - Derailment area

- CENV to request the operational limits, specifically the maximum allowable cross level of the vehicle while in work mode, from the manufacture.
- It is recommended that prior to track installation, new track sub ballast is graded to within the tamping vehicles capabilities to reduce tamping time and derailment risk.
- In areas with excessive cross level change, it is recommended that the operator use a spotter to check for flange climb or suspension unloading.
- When track geometry is at or beyond the reading limit of the vehicle, it is recommended that TRST operators lift the track in multiple passes.

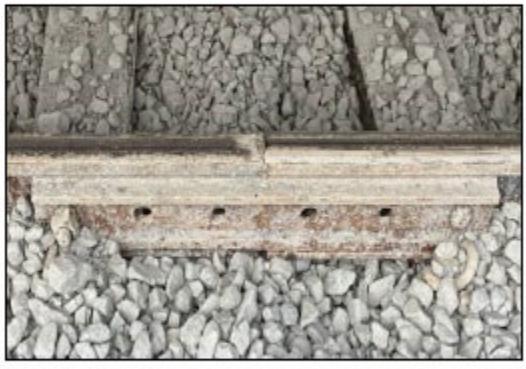
This information is proprietary to the Washington Metropolitan Area Transit Authority (WMATA). No reproduction is allowed without prior written consent. Track testing conducted after rerailing the vehicle and inspection of the suspension found that the suspension, on the side of wheel climb, appeared to be unloaded. Once the vehicle was moved to a less extreme area the suspension loaded normally. Additionally, a joint with mismatched rail ends was located approximately two feet away, on the opposite rail of the initial POD (Figure 4).

Figure 4 - Mismatched rail ends at joint

Excessive cross level change and a mismatched rail joint within the work area is likely the root cause of these derailments.
