Red Signal OVERRUNS

At or Near Brentwood and Shady Grove rail yards

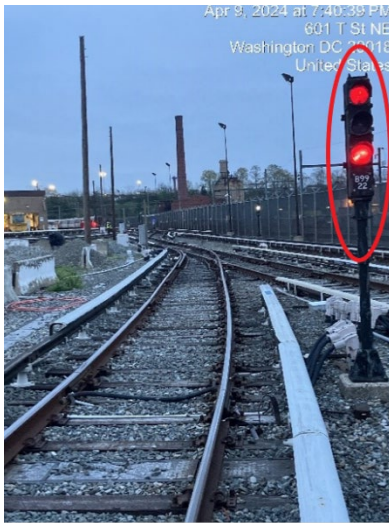
Image 1 – Train ID 805 approaching signal B99-22 displaying a red aspect.

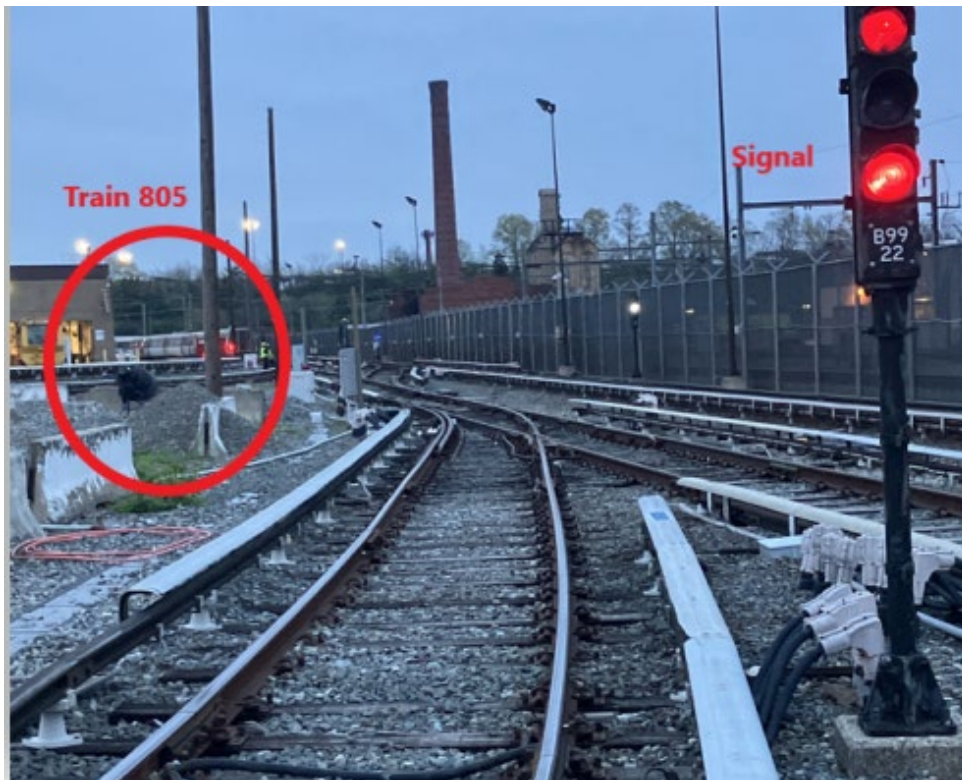
Image 2 – Train ID 805 stopped after passing signal B99-22 displaying a red aspect.

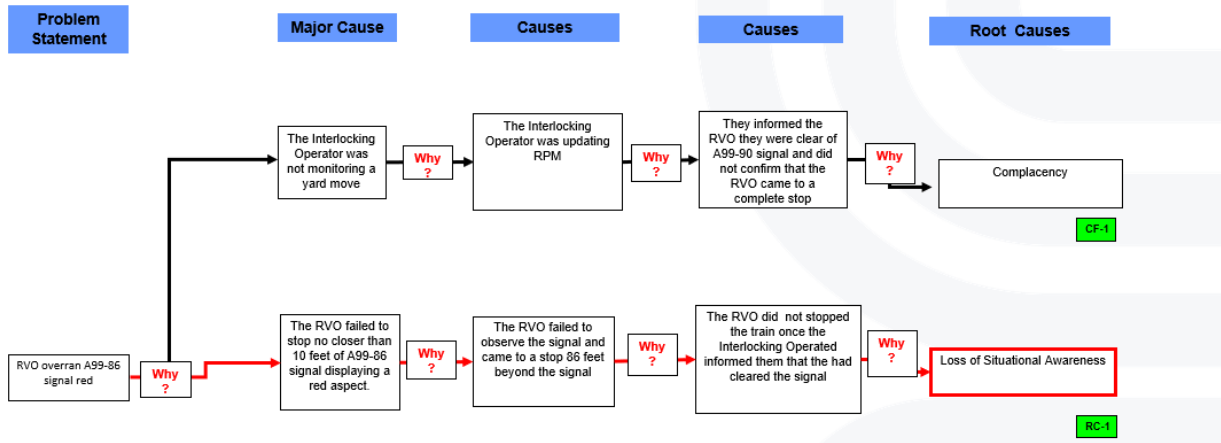
Drafted By: SAFE 708 - 06/01/2024
Reviewed By: SAFE 704 06/27/2024
Approved By: SAFE 707 – 07/11/2024
