Red Signal Overruns

At or Near New Carrollton, Dulles, Brentwood and West Falls Church rail yards, and King Street-Old Town and Downtown Largo station

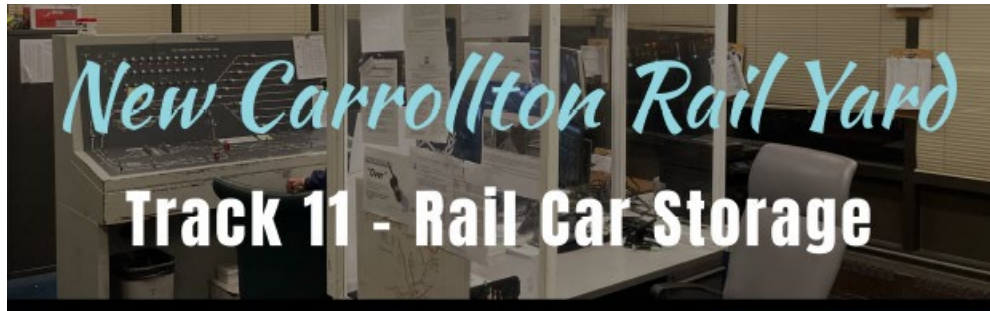
Track 11 Red Signal Overrun Prevention Strategy

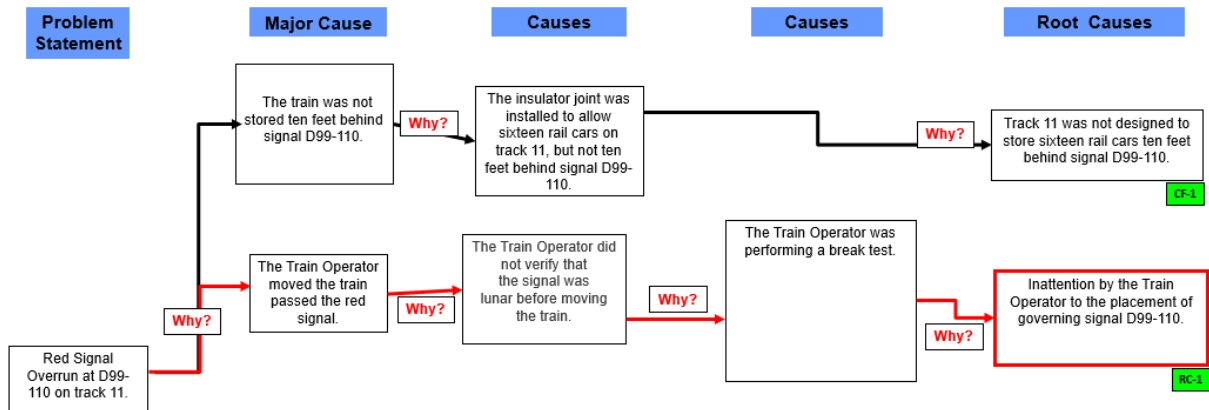
Appendix F – Why-Tree Analysis

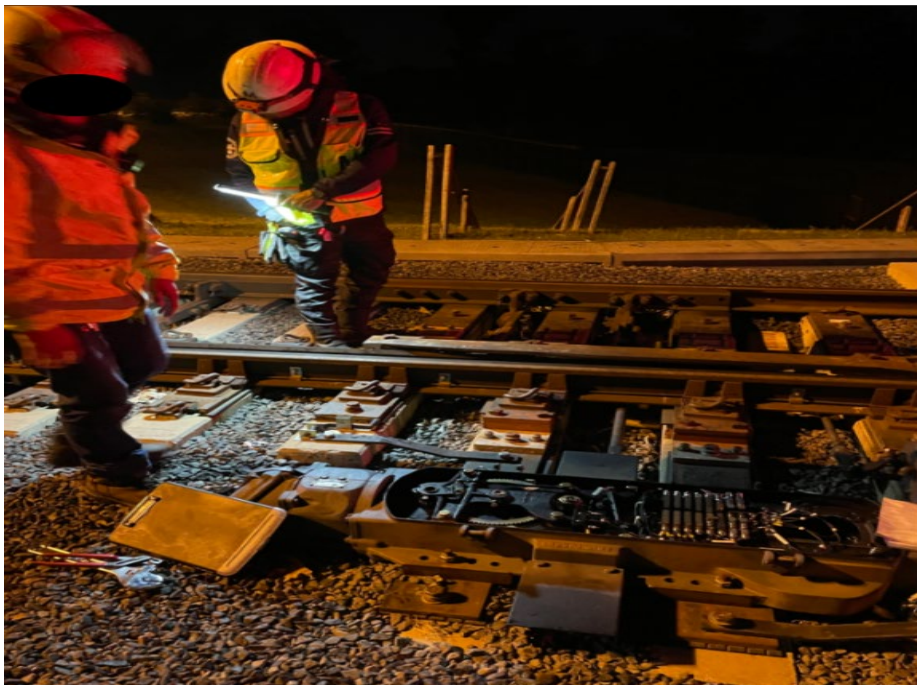
Image 4: Shows ATCM performing repairs on switch 17.

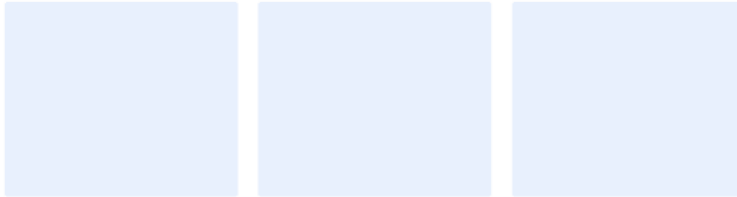
Report Prepared
by: _____

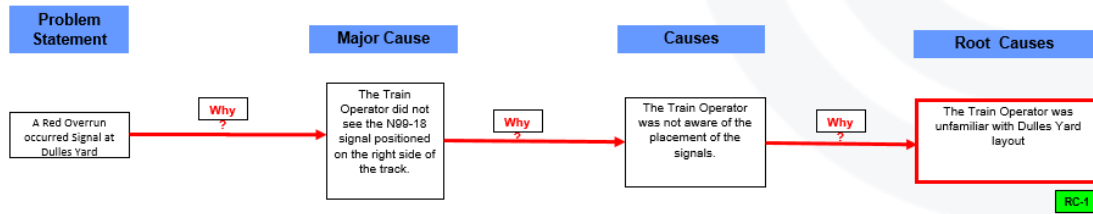
Appendix F – Why-Tree Analysis

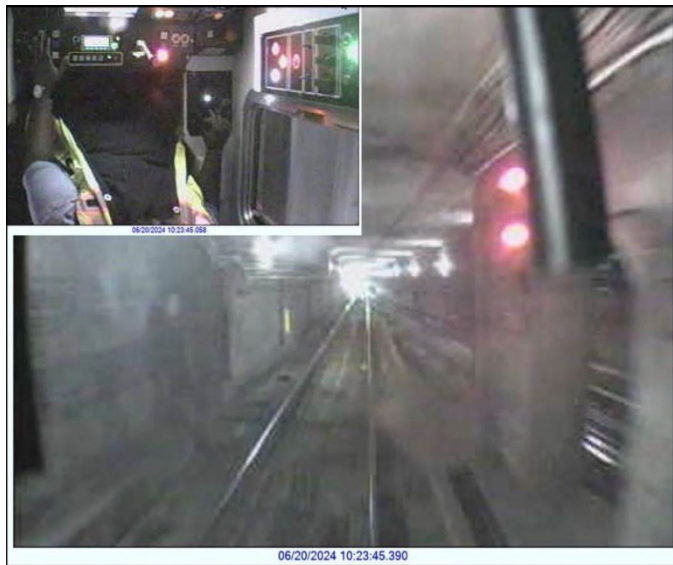
CMOR IIT confirms that Car 7732 was the Lead Car at the time of this Incident.

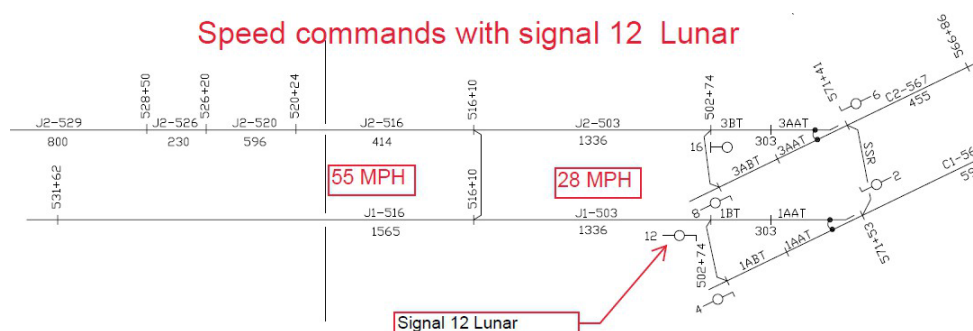
Speed trains get on approach to C97 interlocking on Track 1 when signal 12 is lunar.

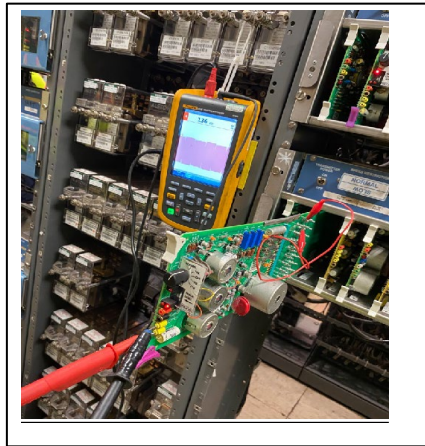
Results of the testing

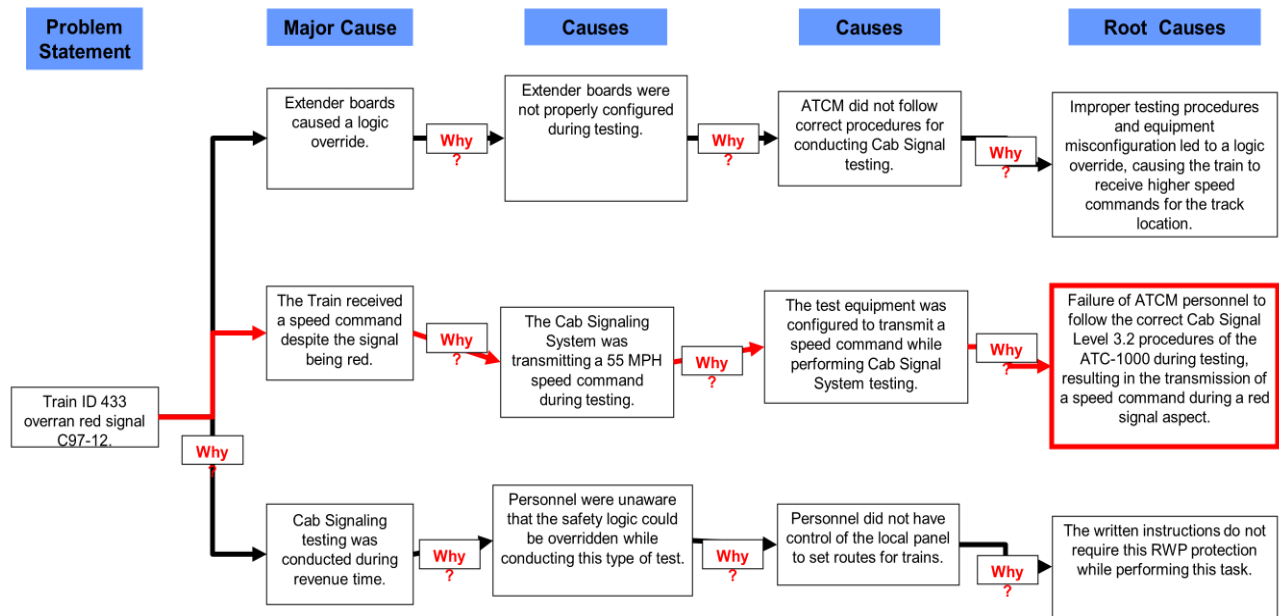
Appendix E – Why-Tree Analysis

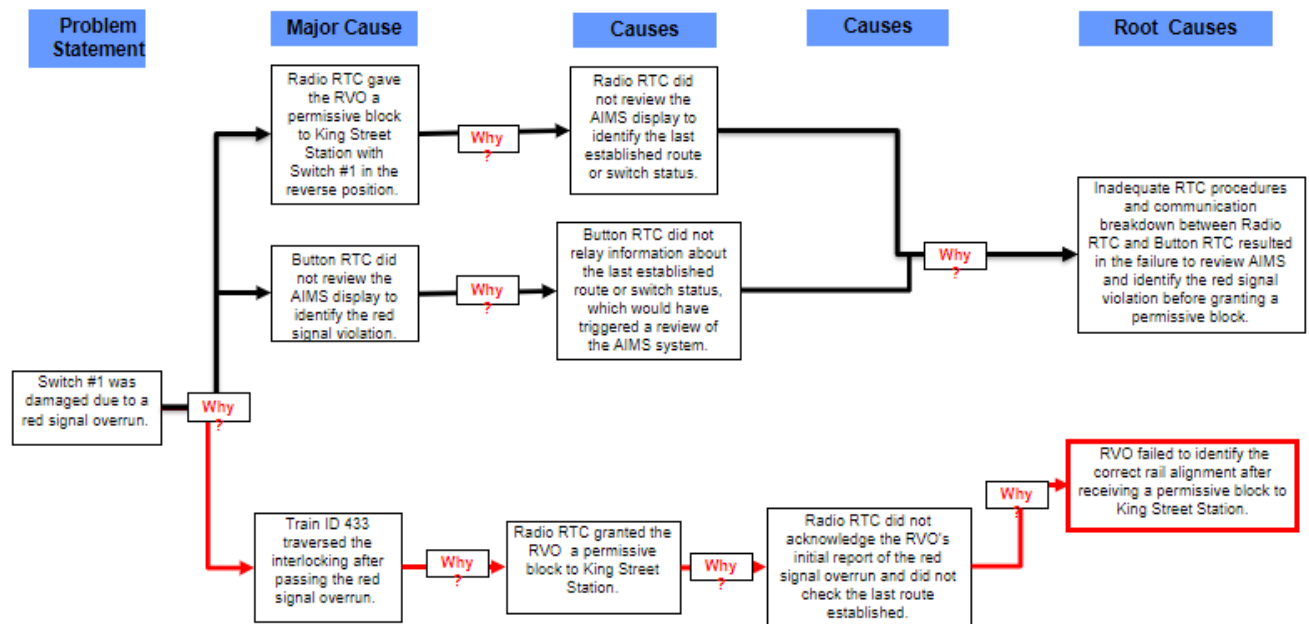
Figure 9 – Root Cause Analysis (page 1 of 2).

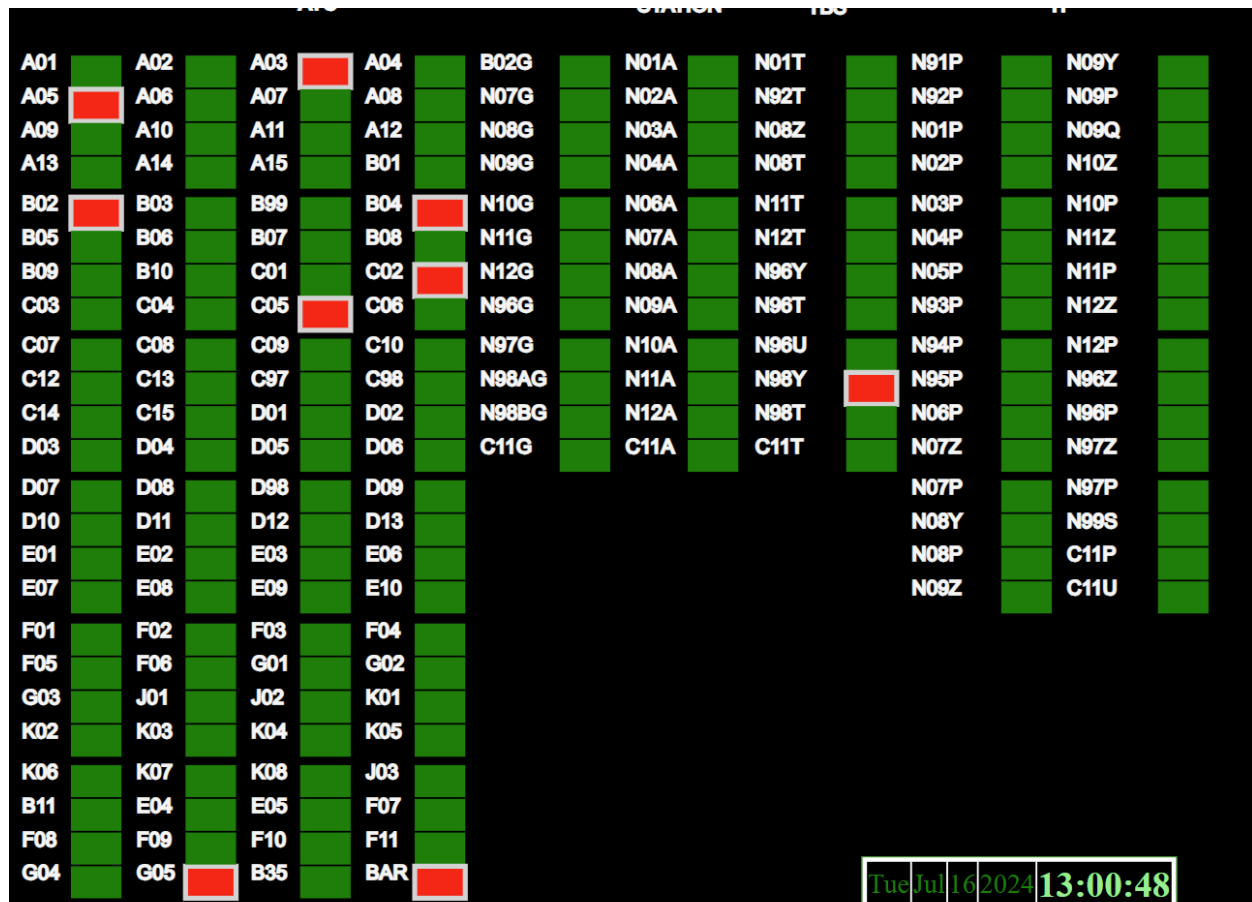
Image 1 – RTU Dashboard 20240716 13:00 hours with red status off-line indication.

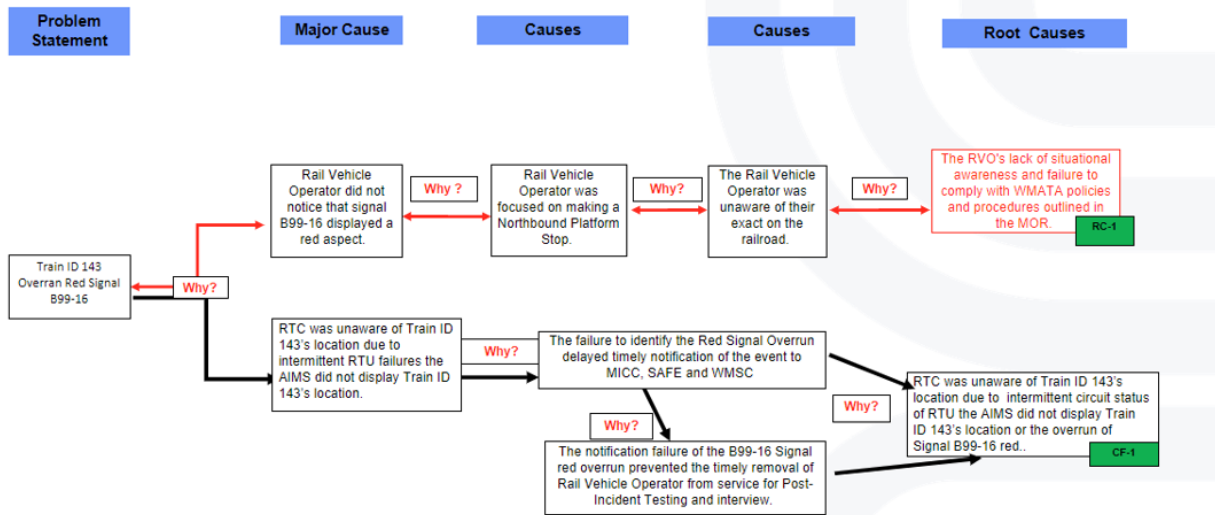
Appendix E – Why-Tree Analysis

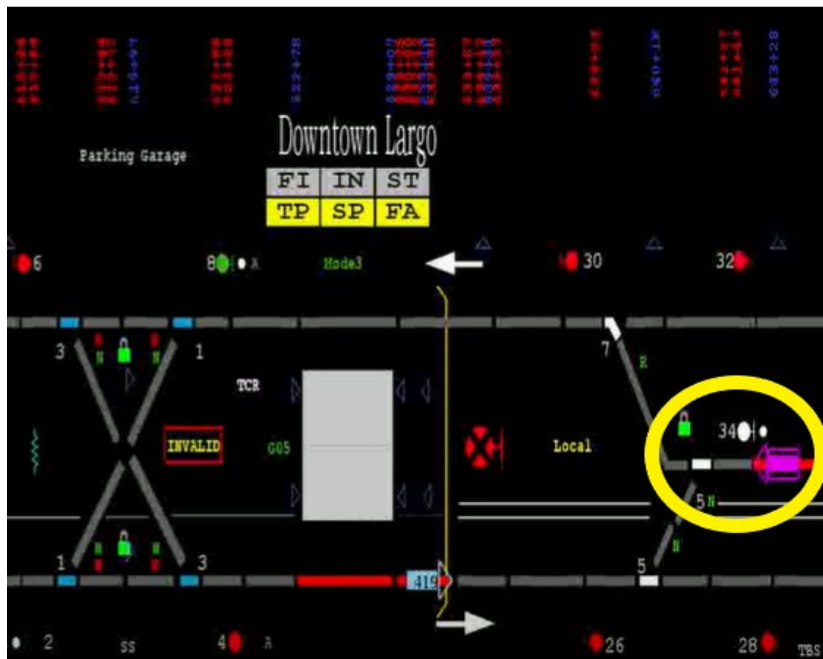
Image 4: The yellow circle depicts Train ID 719 with a route set to Downtown Largo Station track 2 at 21:47 hours.

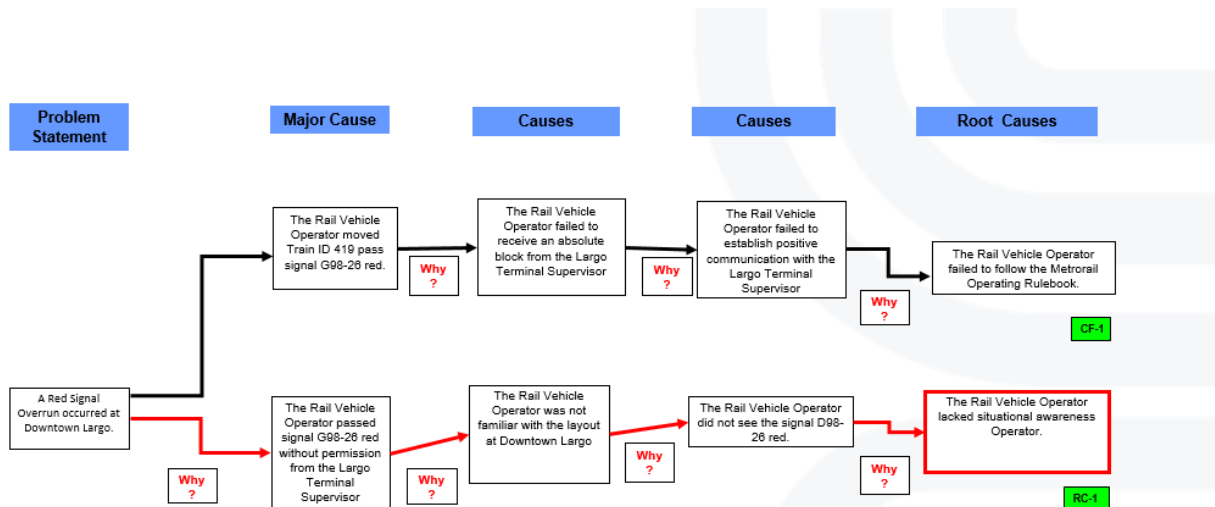
Appendix E – Why-Tree Analysis

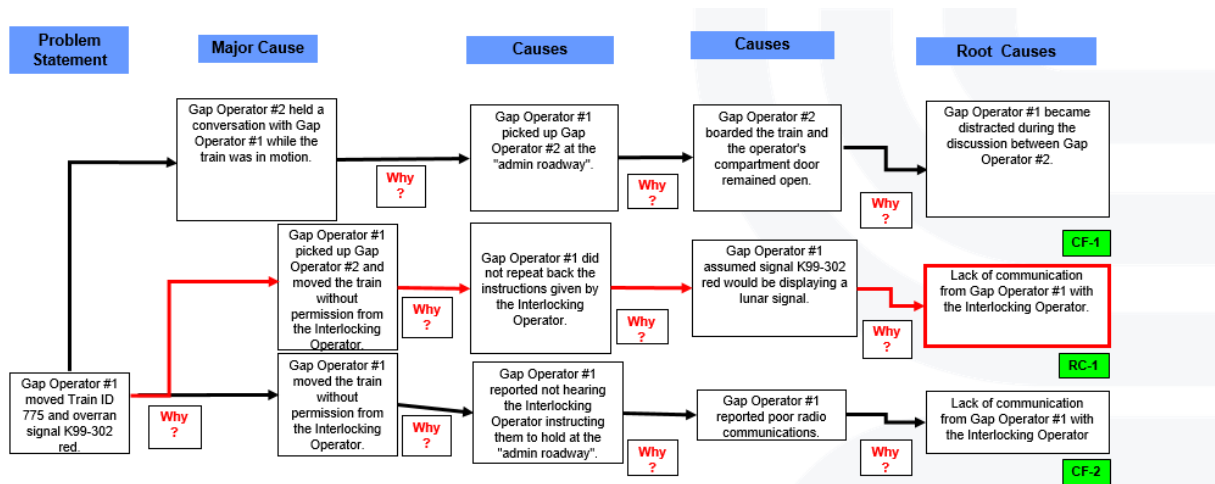
Appendix E – Why-Tree Analysis
