# WMSC Inspection Report 20260421

ISSUED 4/24/2026

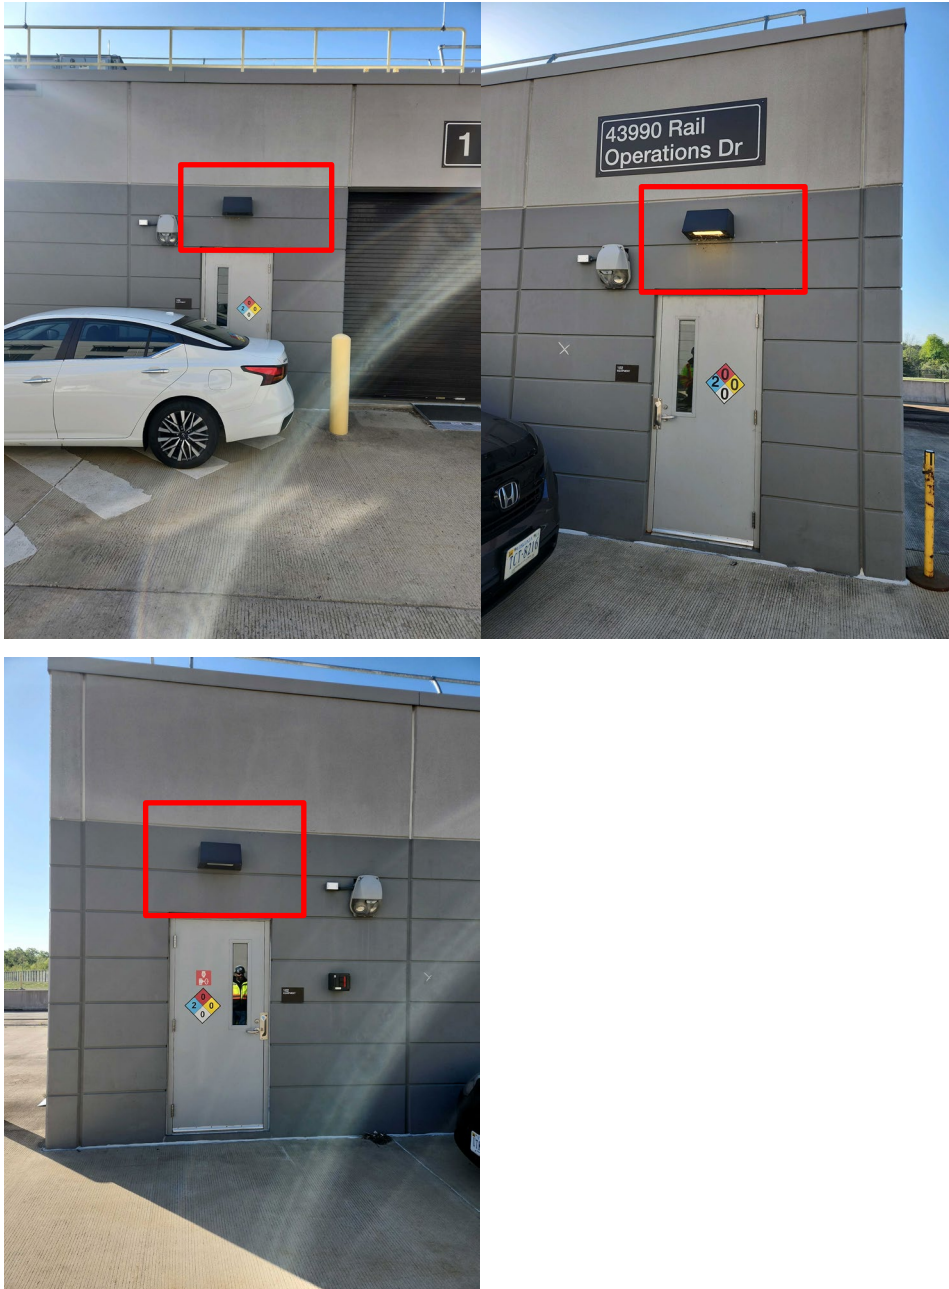
Photos 1-3: Direct access to the Dulles Yard (N99) car wash with no warning system that a train may be transiting through the wash when entering the facility via these doorways.

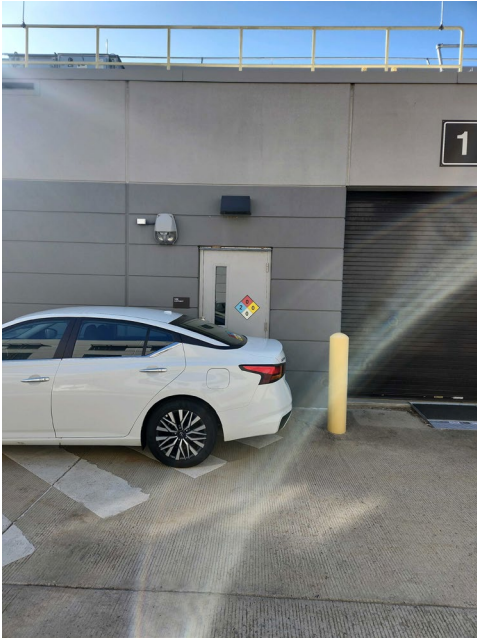
Photo 4: Personal vehicle blocking ingress or egress to and from the car wash.

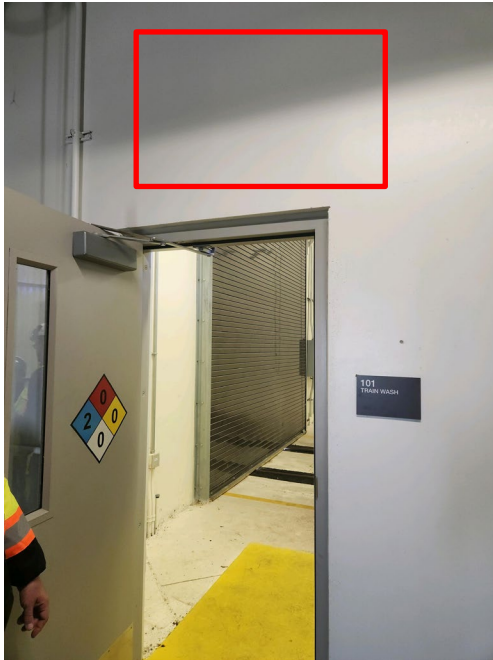
Photo 5: Doorway missing any warning system to alert workers they are entering an area of the building with potential rail vehicle movement.

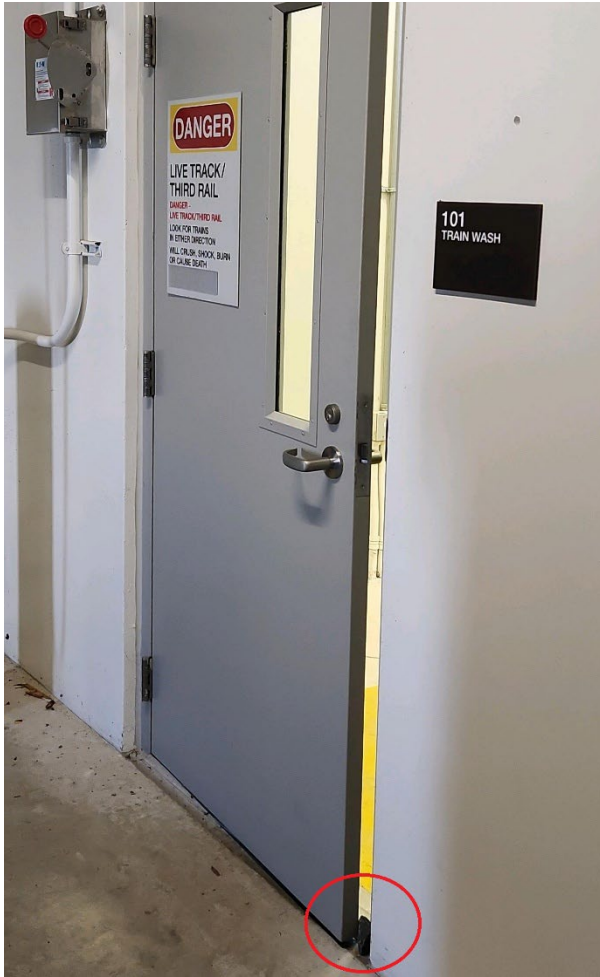
Photo 6: Door propped open that should remain secured and closed because of hazards on other side.

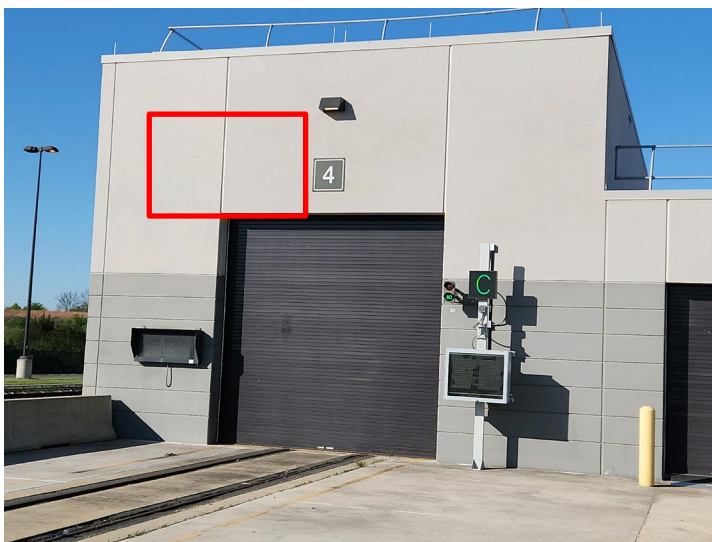
Photo 8: Entrance (facing east).
