FINAL REPORT OF INVESTIGATION A&I E18438

October 10, 2018
Columbia Heights Fatality

Columbia Heights (E04), Escalator X01

ELES ENGINEERING REPORT - FOR COLUMBIA HEIGHTS STATION (E04X01)

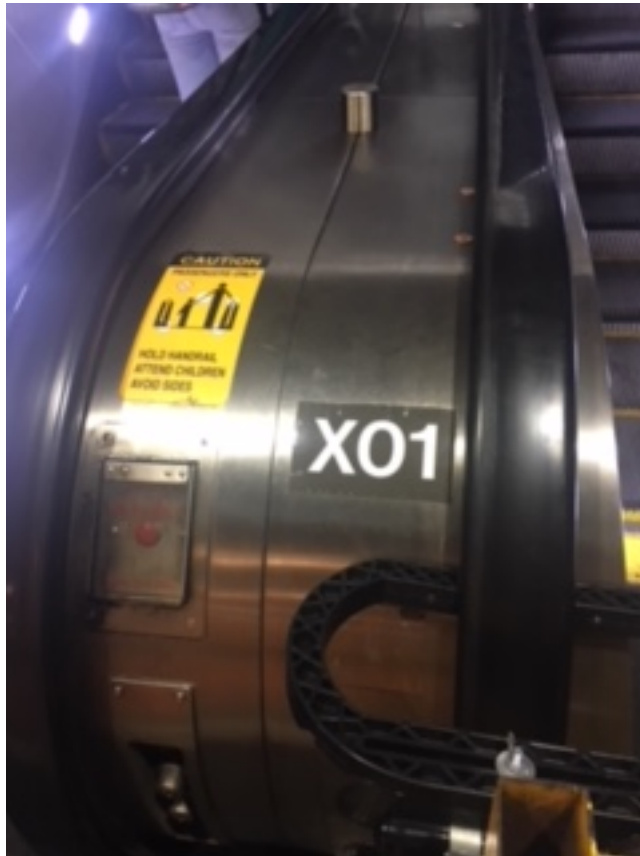
Photo 1 – Escalator X01

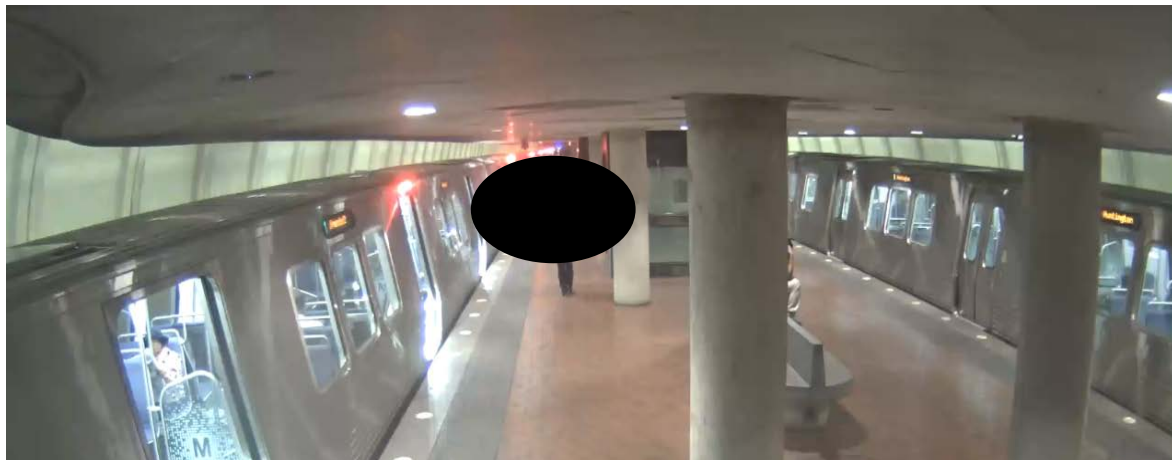
Photo 2 – Customer seconds after alighting from a Greenbelt bound train and making his way to the platform elevator

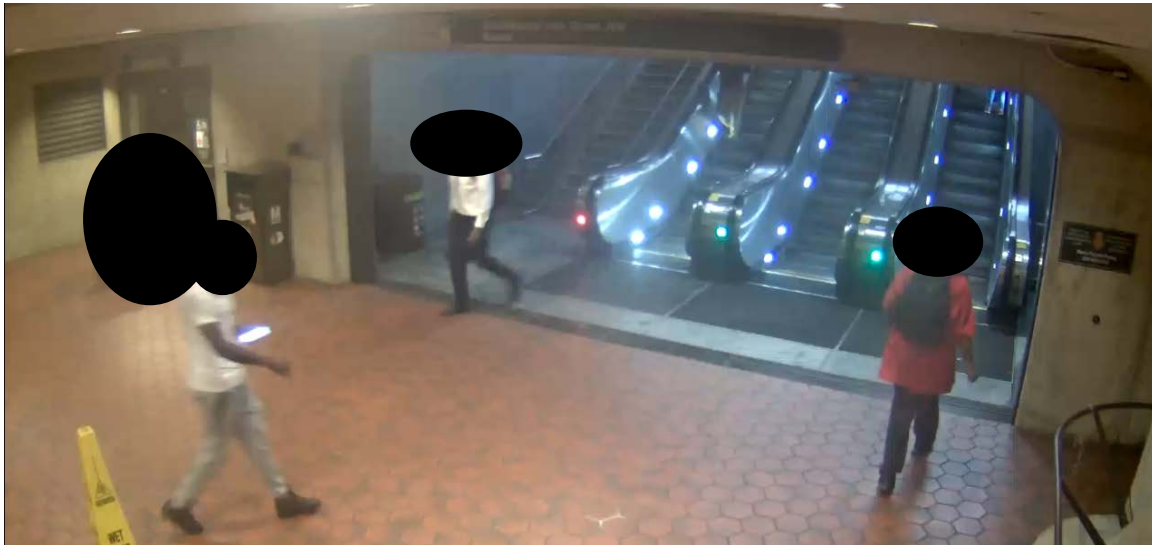
Photo 3 – Customer Calling Elevator

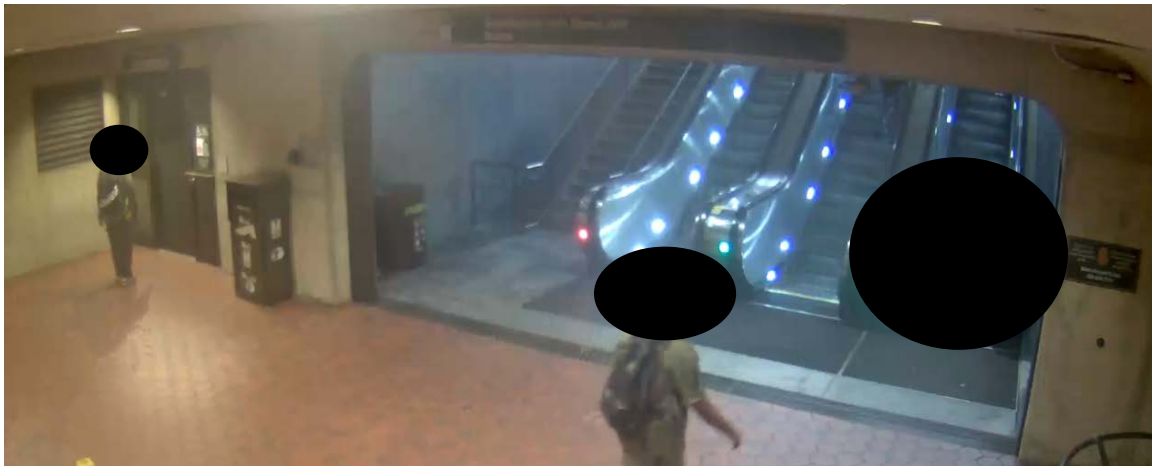
Photo 5 – Customer going up on escalator

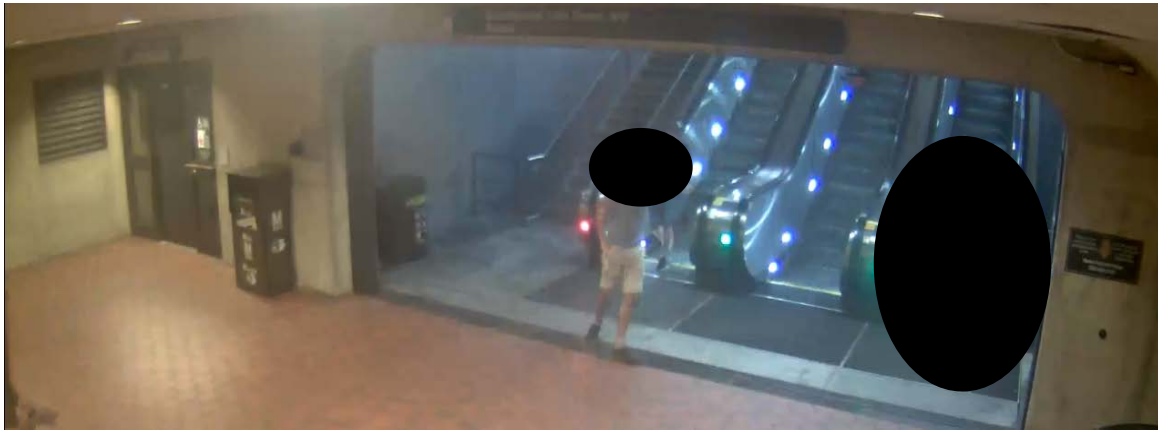
- Wheelchair customer alighted from a Greenbelt bound train and made his way to the platform elevator at E04
- Wheelchair customer was traveling alone
- Wheelchair customer was positioned at the elevator (E04) located on the station's West entrance and depressed the call button. Approximately 15 seconds later, the customer turned and drove onto the ascending escalator (X01) before the elevator arrived.
- Once the wheelchair customer made it to the top of the escalator, the customer and wheelchair fell backward, landing at the bottom of the escalator, the escalator

then dragged the customer up from the bottom a short distance, until an unidentified customer depressed the Emergency Stop Button.

Photo 6 – Customer and wheelchair after falling down the escalator

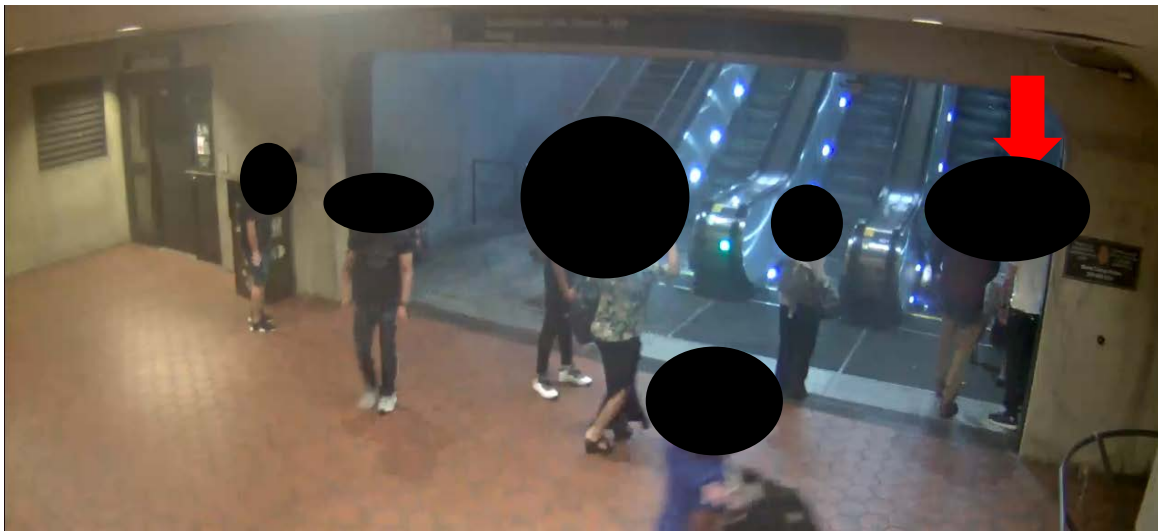
Photo 7 – Unidentified customer depressing the Emergency Stop button

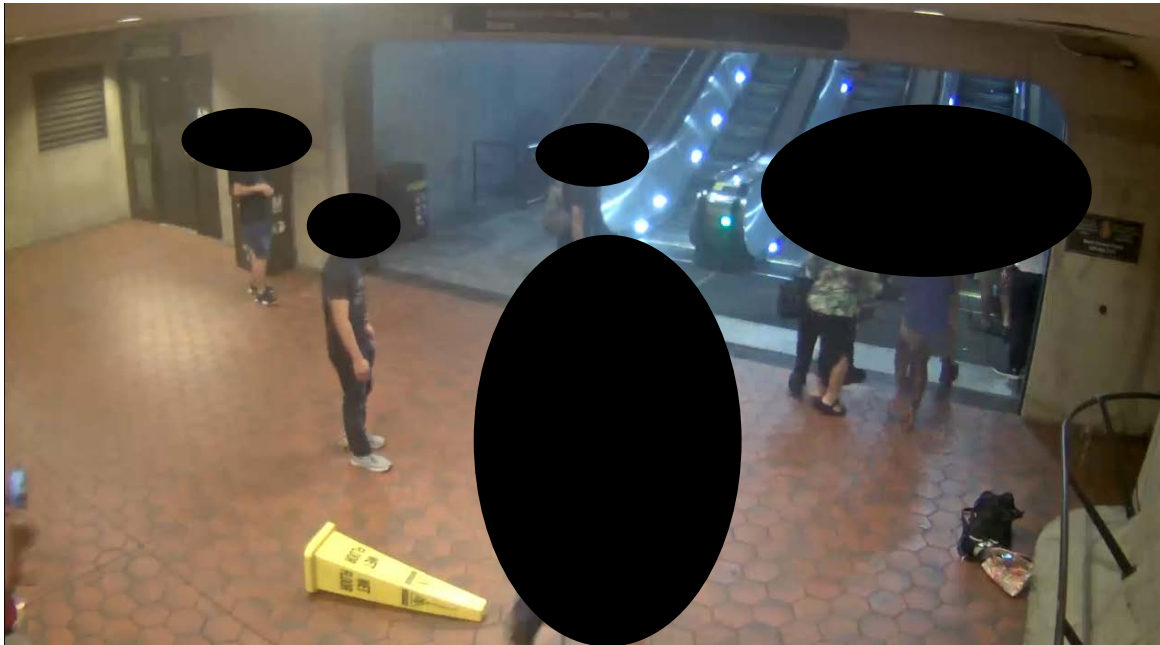
Photo 8 – Station Manager arriving to assist injured customer

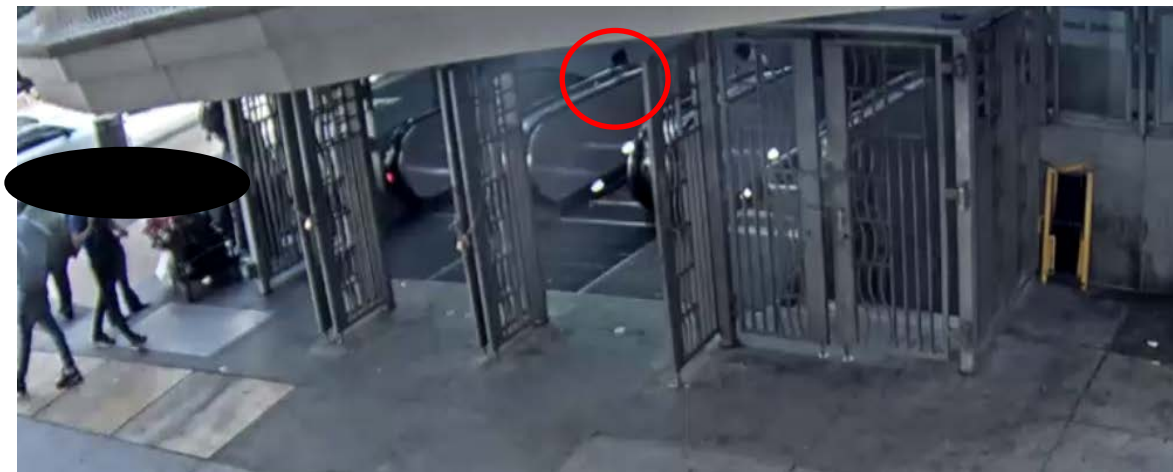
- It took the elevator approximately 52 seconds to arrive from the street level once it was called
- Once the customer neared the top of the escalator, the customer and the wheel chair fell backward down the escalator
- The customer was transported to Med Star Hospital by emergency personnel where he was pronounced dead from his injuries
- One other customer sustained minor injuries to his right and left ankles, however, medical assistance was not requested
- The escalator was functioning properly at the time of the incident.
- The area was well lit, dry and free from any tripping hazards
- An inspection was performed by ELES and DCRA
- No anomalies were found
- Escalator type – Kone 180 Transit grade heavy duty

Photo 9 – Customer reaching the top moments before falling backwards
