### FINAL REPORT OF INVESTIGATION A&I E18292

July 16, 2018 Incidents-occurrences involving individuals working in the transit

Adopted by the Washington Metrorail Safety Commission at its meeting on February 13, 2020.

#### SMS 20180716#72760

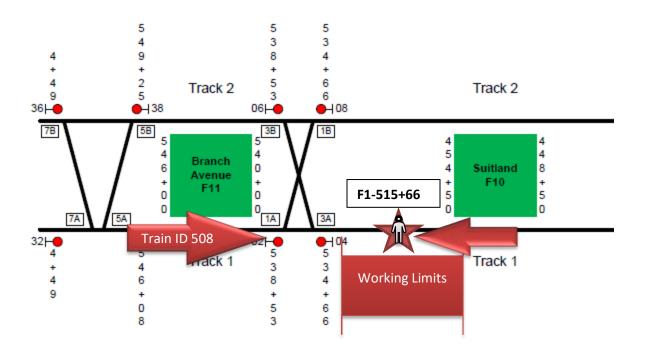
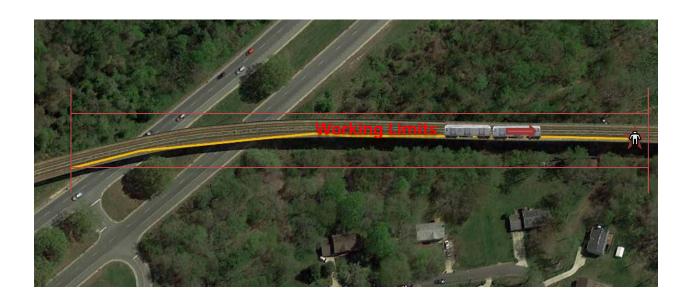
#### Field Sketch/Schematics

Between F11 to F10 Track 1, CM F1 515+66

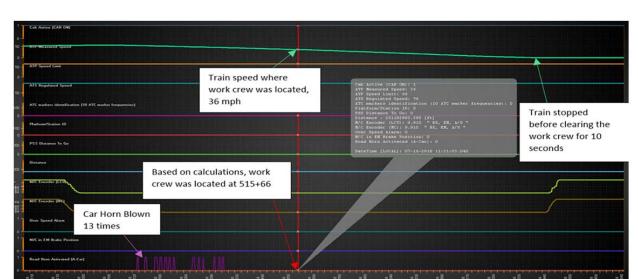
After further investigation and Vehicle Monitoring System (VMS) analysis, CENV determined, the work crew was positioned at CM F1-515+66. Car 7492 reported to be the lead car; later identified as the trailing and Car 7462 as the lead car operating between F11 and F10 stations. Based on the Forward-Facing video, Train ID 508 passed the work crew at 11:33:07 at 36 Mph. Train ID 508 stopped 220 feet past the work crew and dwelled for 10 seconds before resuming operation. CENV data shows, the T/O blew the horn 13 times prior to reaching the incident location.

Note: Actual C/M location identified through data analysis F1-515+66

VMS data determined the affected consist was traveling at 36 Mph at F1 CM

• VMS data revealed Train ID 508 stopped 220 ft. past the Work crew.

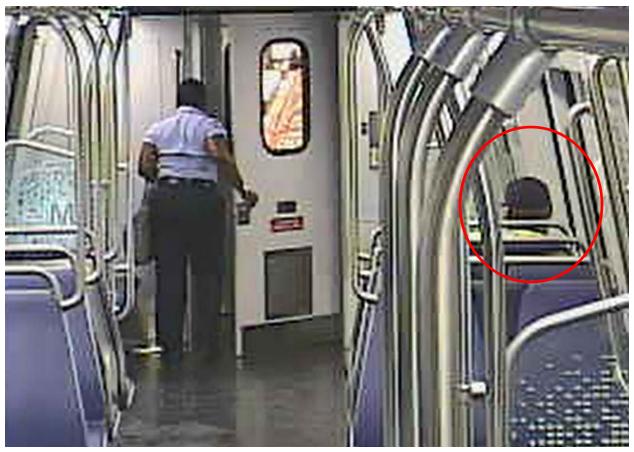
Photo 1 - CCTV Car-borne still footage showing T/O boarding Train ID 508 with AMF present.

After review of CCTV Car-borne footage, it was revealed, the T/O boarded lead Car 7462 and no verbal conversation was initiated from the AMF to the T/O. The T/O entered the cab as stated, performed door operations, and departed the F11 station. Refer to Photo 1.

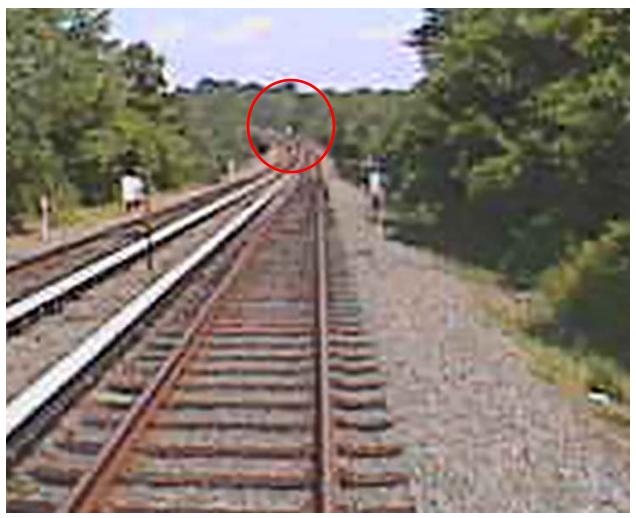
Photo 2 – The affected-consist at approximately 832 ft. away from the Work crew.

Note: Approximate distance determined by Rail Ties in conjunction with the Emergency Telephone System (ETS) Box

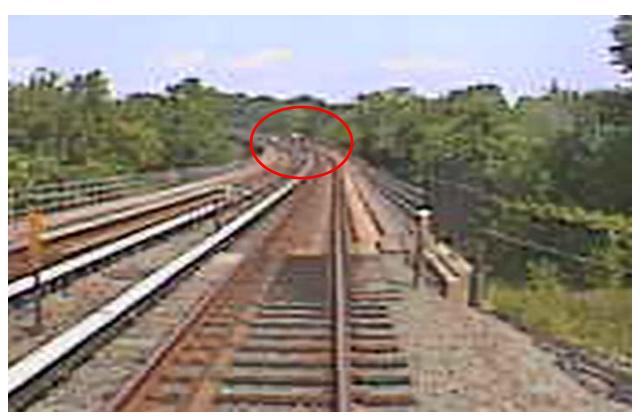
Photo 3 – Affected consist approximately 700 ft. away from Work crew

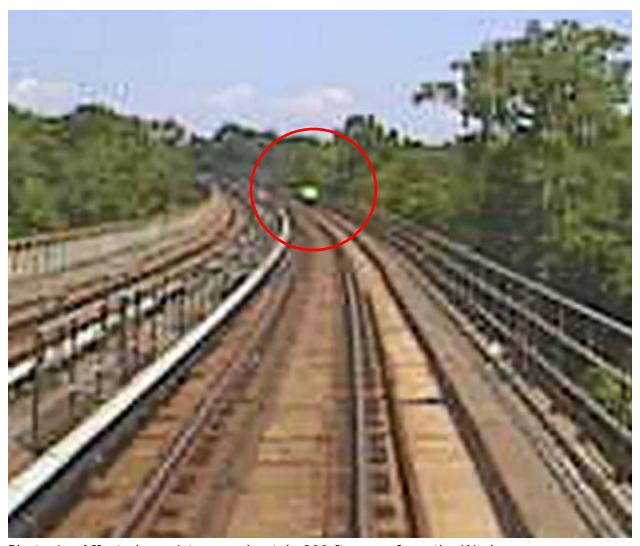
Photo 4 – Affected-consist approximately 300 ft. away from the Work crew

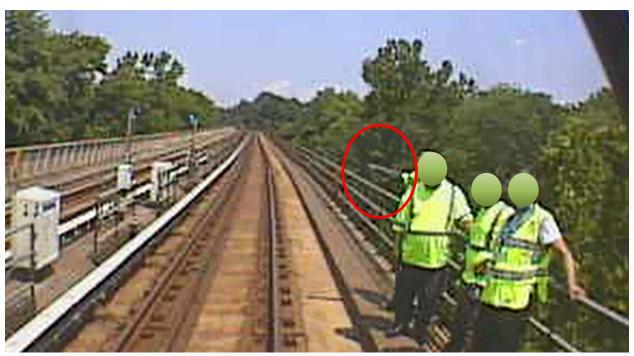
Photo 4 – RWIC giving Slow Down Hand Signal behind the Work crew; obstructed view.
