Inspection Form

Washington Metrorail Safety Commission

Inspection Date	YYYY	MM	DD	Report Number	20191211-WMATA-KEK-12		
	2019	12	11				
Rail Agency Name	Washington Metropolitan Area Transit Authority			Rail Agency Department	ATC	Sub- Department	ATC
Rail Agency Department Contact Information	Name		Email	Office Phone		Mobile Phone	
	██████████		██████████	██████████		██████████	
	██████████		██████████	██████████		██████████	
	██████████		██████████	██████████		██████████	
Inspection Location	Orange Line – D06: – Eastern Market, 15903 Somerville Drive, Rockville, Md 20855 CM; 135+07 – 144+70

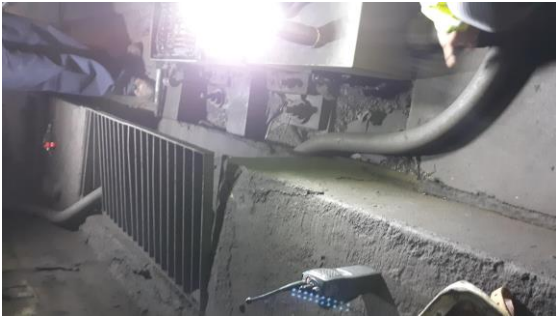
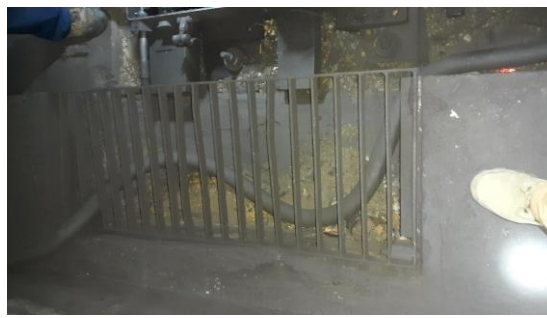
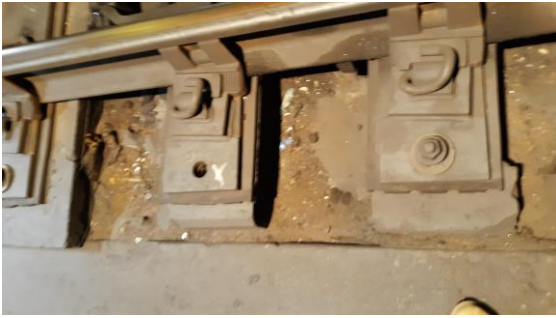
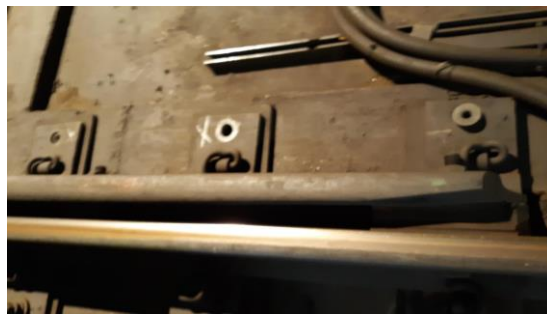
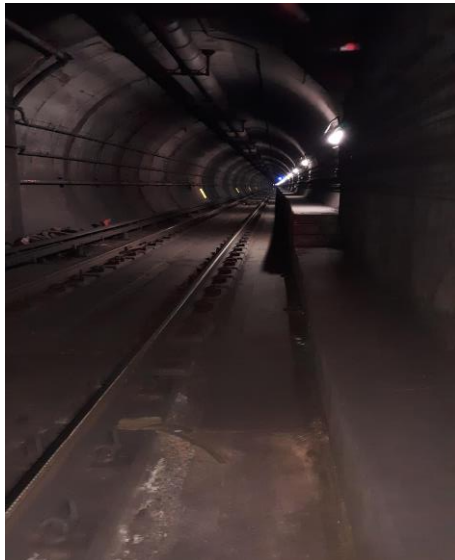
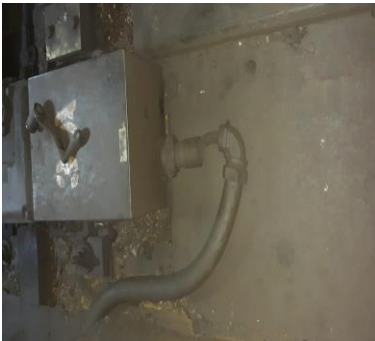
Vehicles	Head Car Number	Number of Cars	Equipment	No train equipment involved in inspections		
	N/A	N/A				
Description	<p>WMATA personnel under the protection of a WMATA RWIC, ATC department performed the required Job Safety Briefing for performing 1008 – Switch Obstruction Test, and 1007 – Switch Hand Crank Cut-out Restoration, CWP and Point Detector Test and Lubrication; in accordance with WMATA ATC— 1000 Switch Inspections.</p> <p>RWIC informed all personnel that work being performed would take place at D06, within the interlocking, under non-revenue service using ETO, and Local Control, and Watchman Lookout. Additionally, assuring that area around switches are free of debris, and observing for faulty operation.</p> <p>Other work groups were; Track Department, and the Power Department – replacing lights within the ATCR.</p> <p>Test Location: D06, Eastern Market Interlocking Pennsylvania and 7th St. SE (DC). With permission requested and granted by ROCC for local control, the inspection commenced at approximately 0135am hours. Inspection and testing concluded approximately 0330am.</p> <p>Notable Observations:</p> <ol style="list-style-type: none"> 1. All testing was performed without any abnormalities. Work crew exhibited skill and confidence in performance of all duties 2. Each switch required approximately 30 minutes for complete lubrication, adjustment and testing. 3. Recommend continued testing to be performed Mid-night to early morning hours for complete quarterly service of ATC track switches and equipment within WMATAs interlockings 4. 3 employees refuse to wear appropriate PPE – safety glasses or face shields during testing 5. 1 Helper set the bar for all the others by properly and appropriately wearing of PPE throughout inspection 6. During switch movement 1 employee was standing on the point guard shield (location 1B-Tk #2) while the switch point was in motion (rev and norm moves). I advised employee that the shield’s intended purpose was not designed to support his weight but designed to protect the point from objects that may become logged into point by moving trains. 7. 2 switch lights were inoperable at Switches 1A & 3A. 8. 4 missing Track Department bolts marked with an “X” in vicinity of switch points on Tracks 1 & 2. Photos attached. 9. Liquid Tight exposed wires and components to rodents and water. 			Number of Defects	6

Remarks: SW 1A TRACK LIGHT IS OUT / SW 3A TRACK LIGHT IS OUT / 1B and 3A Switch Cable Connection Loose / 1B Switch Track 1 Stud ball Missing

Recommended Finding?	Yes	
				Remedial Action Required?	Yes	
				Recommended Reinspection?	Yes	
Remedial Action	<ol style="list-style-type: none"> 1. Supervisors must reinforce of proper ware of PPE by all employees for their own protection while in performance of their duties. 2. Supervision must reinforce proper foot placement by employees in and around movable switch points, for protection of equipment and unnecessary employee injuries. 3. Replace insufficient lighting immediately; for employee safety and appropriate lighting for repairs to switch apparatus when the need arises 4. Replace missing bolts around switch point areas or explain why they are being removed 5. 1 grate presents itself as a tripping hazard in the tunnel near a switch on Track #1. If work crews are in this interlocking working under revenue service, this could become a life altering tripping hazard and should be fixed immediately. Photos attached.
