Inspection Form

Form WMSC-IR-1

Inspection Date	YYYY	MM	DD	Report Number	20191213-WMATA-KEK-13		
	2019	12	13				
Rail Agency Name	Washington Metropolitan Area Transit Authority			Rail Agency Department	ATC BASIC	Sub- Department	STC - Maintenance
Rail Agency Department Contact Information	Name		Email	Office Phone		Mobile Phone	
	██████████		██████████	██████████		██████████	
	██████████		██████████	██████████		██████████	
	██████████		██████████	██████████		██████████	
Inspection Location	Orange Line – D99 New Carrollton Yard – 4700 Garden City Dr., New Carrollton, Md 20784

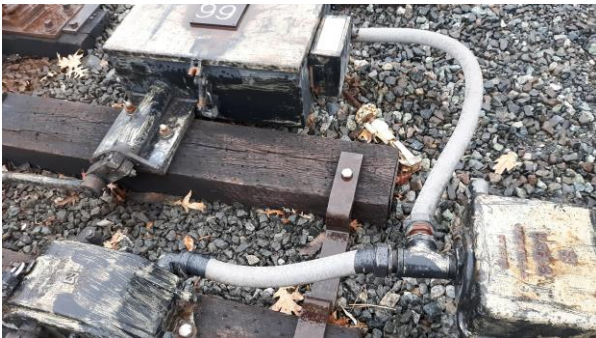
Vehicles	Head Car Number	Number of Cars	Equipment		
	N/A	N/A			
Description	<p>WMATA personnel under the protection of a WMATA RWIC, Asst. Superintendent, ATCM performed the required Job Safety Briefing for performing 1008 – Switch Obstruction Test; in accordance with WMATA ATC— 1000 Switch Inspections.</p> <p>RWIC informed all personnel that work being performed would take place in the yard, within the interlocking, using ETO, via Local Control, and Watchman Lookout. Additionally, assuring that area around switches are free of debris, and observing for faulty operation.</p> <p>No other work groups were out in the yard performing maintenance.</p> <p>Test Location: D99, New Carrollton Rail Yard, 4700 Garden City Drive, New Carrollton, MD 20784.</p> <p>With permission requested and granted by Yard OCC for local control, the inspection commenced at approximately 0845am.</p> <p>Notable Observations:</p> <ol style="list-style-type: none"> 1. Employees still refuse to wear appropriate PPE – glasses 2. U5 Box latch broken. Request welding of broken latch loop. Switch unsecure with lock dangling. SMS issue. 			Number of Defects	1

Recommended Finding?	No
				Remedial Action Required?	Yes
				Recommended Reinspection?	YES
Remedial Action	<ul style="list-style-type: none"> WMSC to revisit yard for reinspection (30 days). Looking for repair of U5 box for safety and security of switch. All recommendations from the 20191105-WMATA-KEK-3 implemented and or corrected.
