FINAL REPORT OF INVESTIGATION A&I E19456

Serious Injury

Date of Event:	8/29/2019
Type of Event:	Serious Injury
Incident Time:	02:22 hrs.
Location:	Huntington Station
Time and How received by SAFE:	22:09 hrs., SAFE on Call Phone
Safety Officer Response:	Yes
Time of Safety Officer Arrival:	8/30/2019 – 10:00 hrs.
Time of Safety Officer Departure:	8/30/2019 – 11:30 hrs.
Rail Vehicle:	No
Injuries:	TRST employee suffered a severe burn injury to left foot
Damage:	No
Emergency Responders:	No

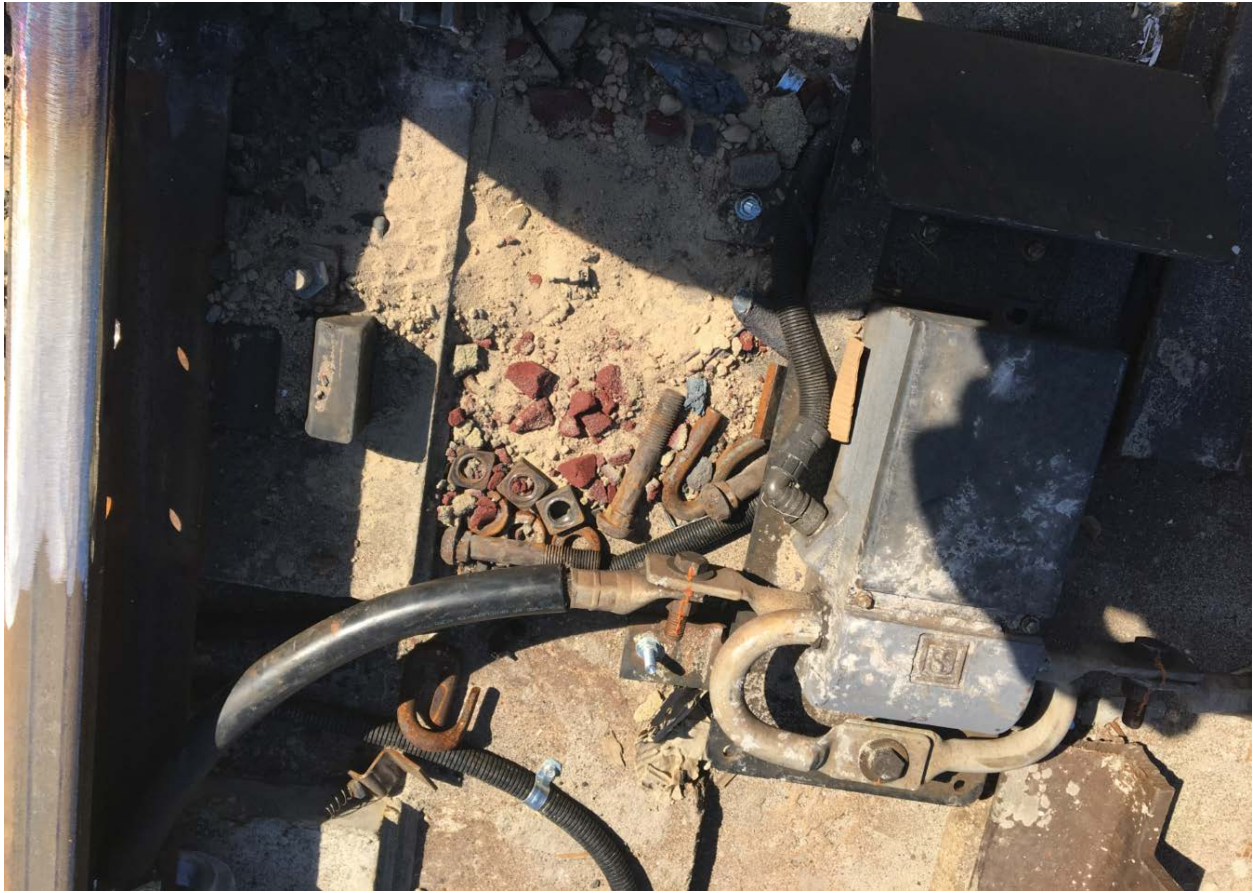
Note: SAFE performed an inspection of the area and identified inadequate housekeeping practices. Refer to photo 1

Photo 1 – Housekeeping at work location

- SAFE identified inadequate housekeeping practices, tripping hazards and foot entrapment areas within the work location
- TRST personnel failed to address immediate hazards and inspect the area for proper lighting before performing work

Additionally, SAFE concluded that inadequate house-keeping practices, lack of management oversight, and TRST personnel's failure to recognize immediate hazards associated with the work location contributed to the accident event. These causal factors may have contributed to the event which subsequently contributed in the injured employee's foot contacting hot materials from welding process.

3. TRST Management shall must provide transcript of TRST Supervisor that reveals that "Reasonable Suspicion" training requirement has been fulfilled.
4. TRST shall develop an SOP for Thermite Welding that ensures that relevant hazards such as housekeeping concerns and the hazards associated with the job (JHA) are identified through the SOP.

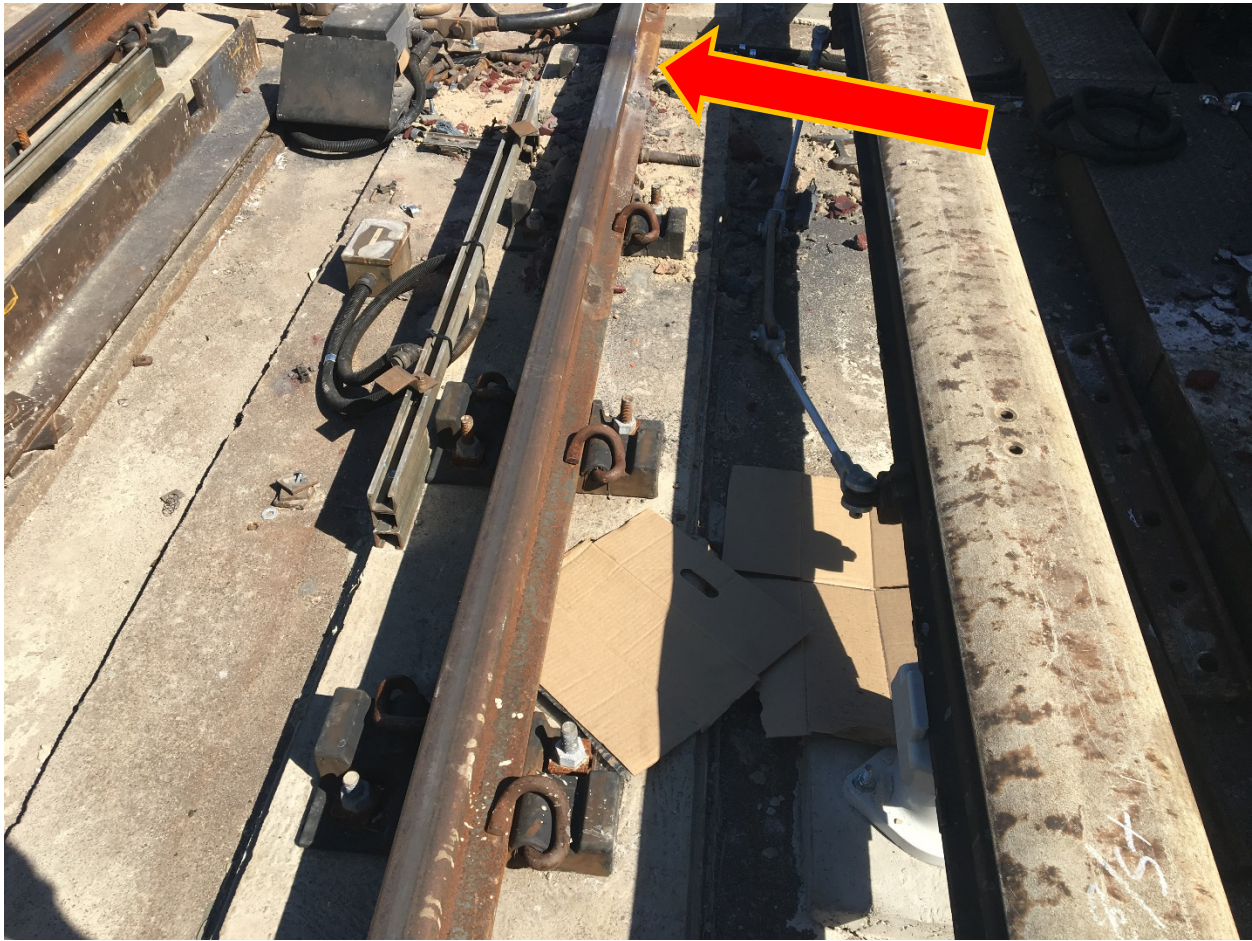
Photo 2 - Arrow indicates weld location

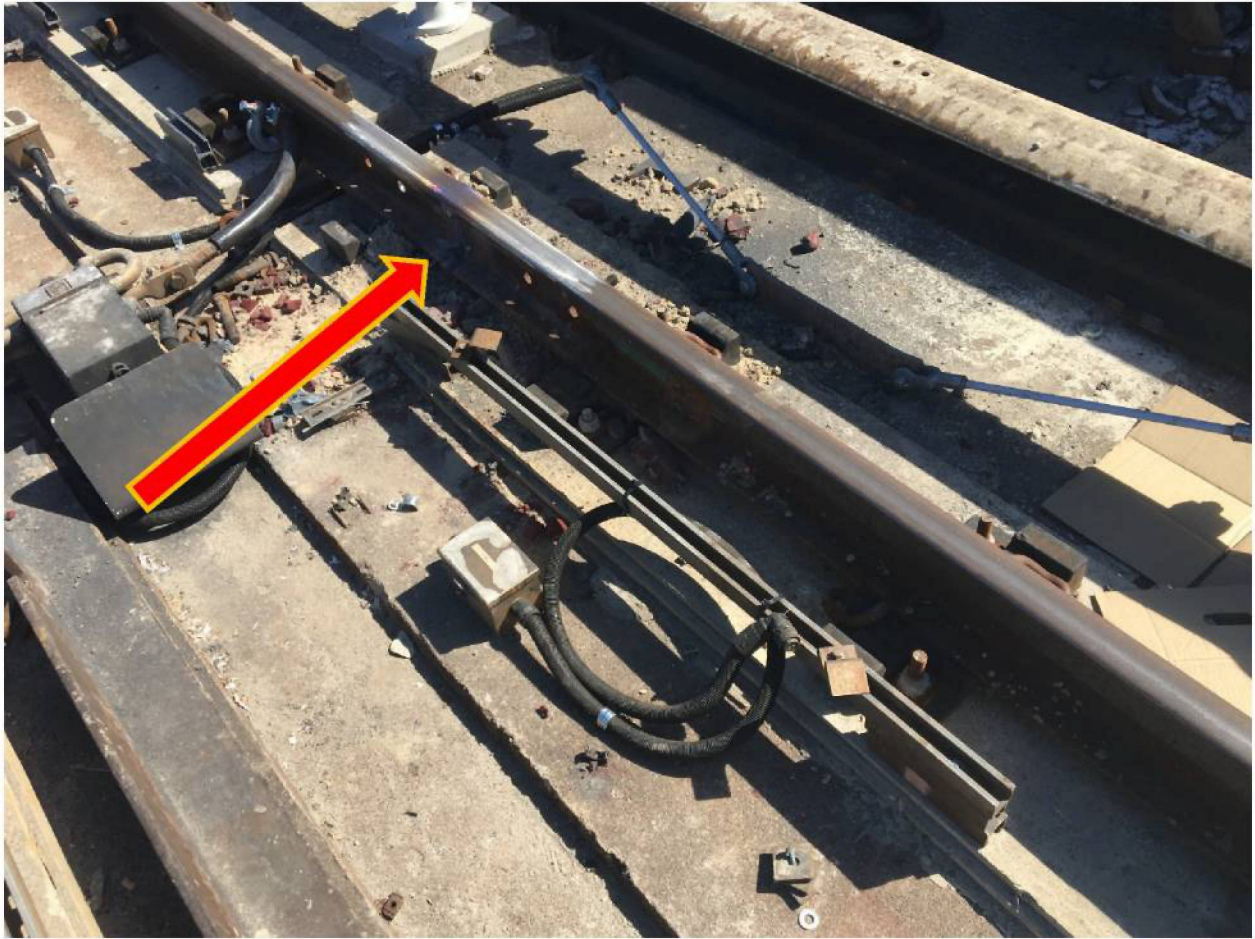
Reportedly the affected employee’s left foot became wedged between an ATC bracket and the running rail in the area of the weld. During a post incident interview with the affected TRST employee, it was stated that the piece of the hot Thermite slag fell inside their boot through the open zipper on the left side of the boot. This updated information was contrary to the initial report that the hot Thermite slag only made contact with the outer shell of the boot. The employee stated they were wearing the appropriate footwear

Photo 3 -Accident location
