**FINAL REPORT OF INVESTIGATION A&I E19205**

RWP Event

**SMS 20190425#79484**

<b>Date of Event:</b>	April 25, 2019
<b>Type of Event:</b>	Occurrences involving individuals working in the transit agency-controlled right-of-way
<b>Incident Time:</b>	10:11 hrs.
<b>Location:</b>	Outside of Pentagon City Station at Chain Marker (CM) C1 297+00
<b>Time and How received by SAFE:</b>	10:15 hrs., SAFE-On-Call Phone
<b>WMSC Notification Time:</b>	11:07 hrs.
<b>Responding Safety Officers:</b>	WMATA SAFE: No WMSC: No Other: N/A
<b>Rail Vehicle:</b>	Train ID 308, 7K 8-Car consist Lead Car 7380
<b>Injuries:</b>	None
<b>Damage:</b>	None
<b>Emergency Responders:</b>	None

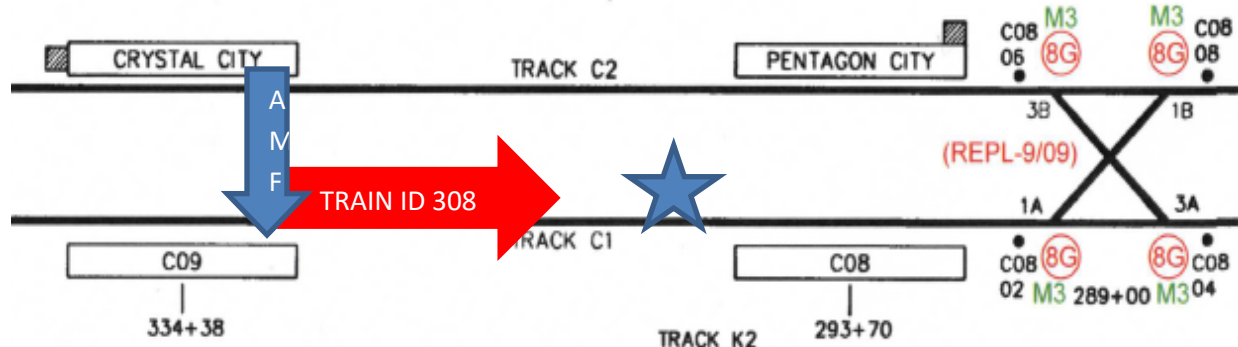
### Field Sketch/Schematics

The incident area was located at Chain Marker (CM) C1-297+00.

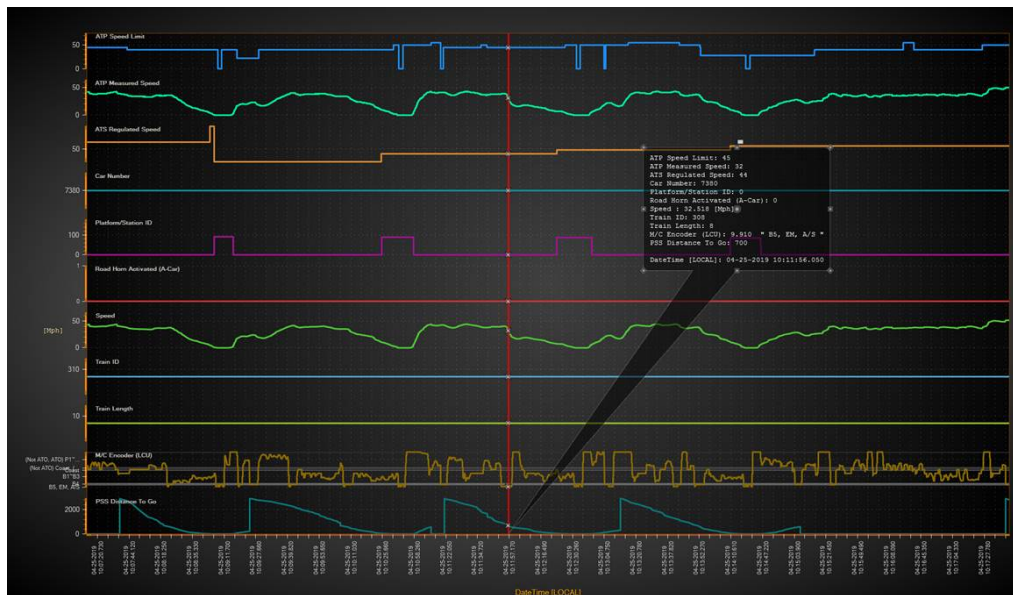
## Vehicle Program Services (CENV)

CENV analyzed the data from Train ID 308, Lead Car 7380. The data indicated the train speed was 39 to 40 mph through the work zone area with Automatic Train Protection (ATP) speed limit set at 45 mph. The front facing playback video from lead car 7380 indicated an approximate separation between the Watchman/Lookout and workers Mobile Work Crew of 100 ft. There wasn't a road horn activation by the operator based on event log data from the rail vehicle.

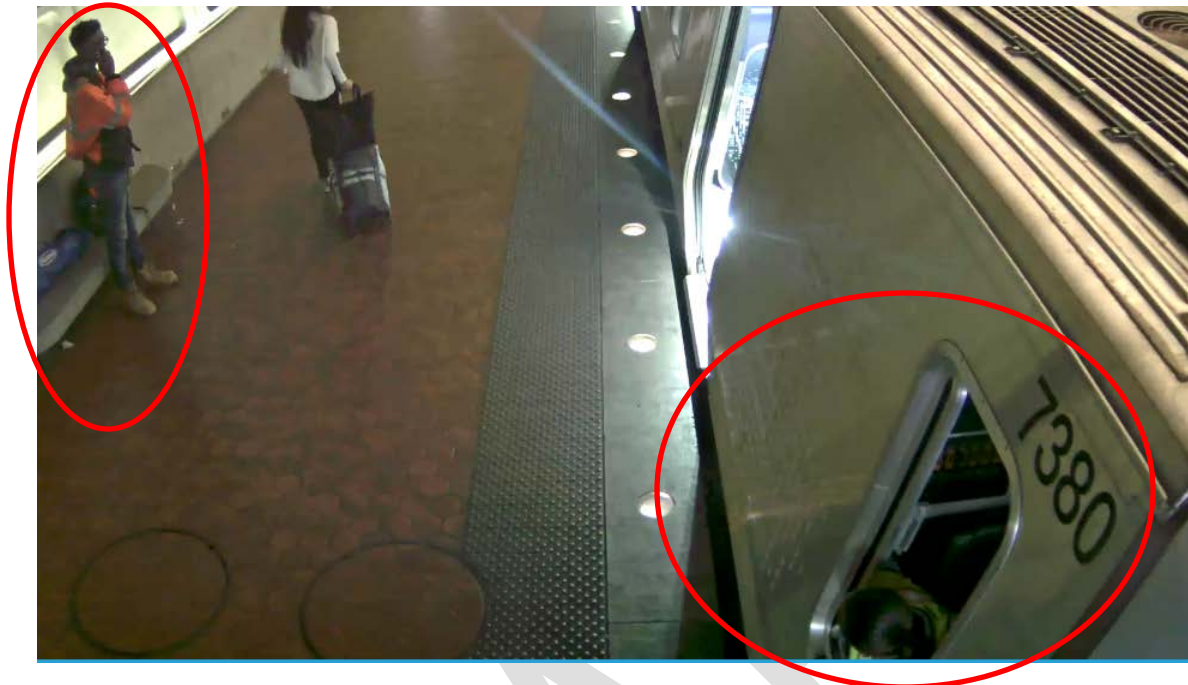
Photo 1 - 10:10:47 hrs., - Train ID 308 enters Crystal City Station platform and AMF is seen on cell phone simultaneously. AMF did not walk up to the Operator's cab to inform the T/O of personnel on the roadway.

1. TRST shall take the appropriate action to include, but not limited to, re-training and any other action deemed necessary to support prevention of repeated recurrence:
  - a. **RWP retraining of the RWIC will commence on 5/31/2019.**

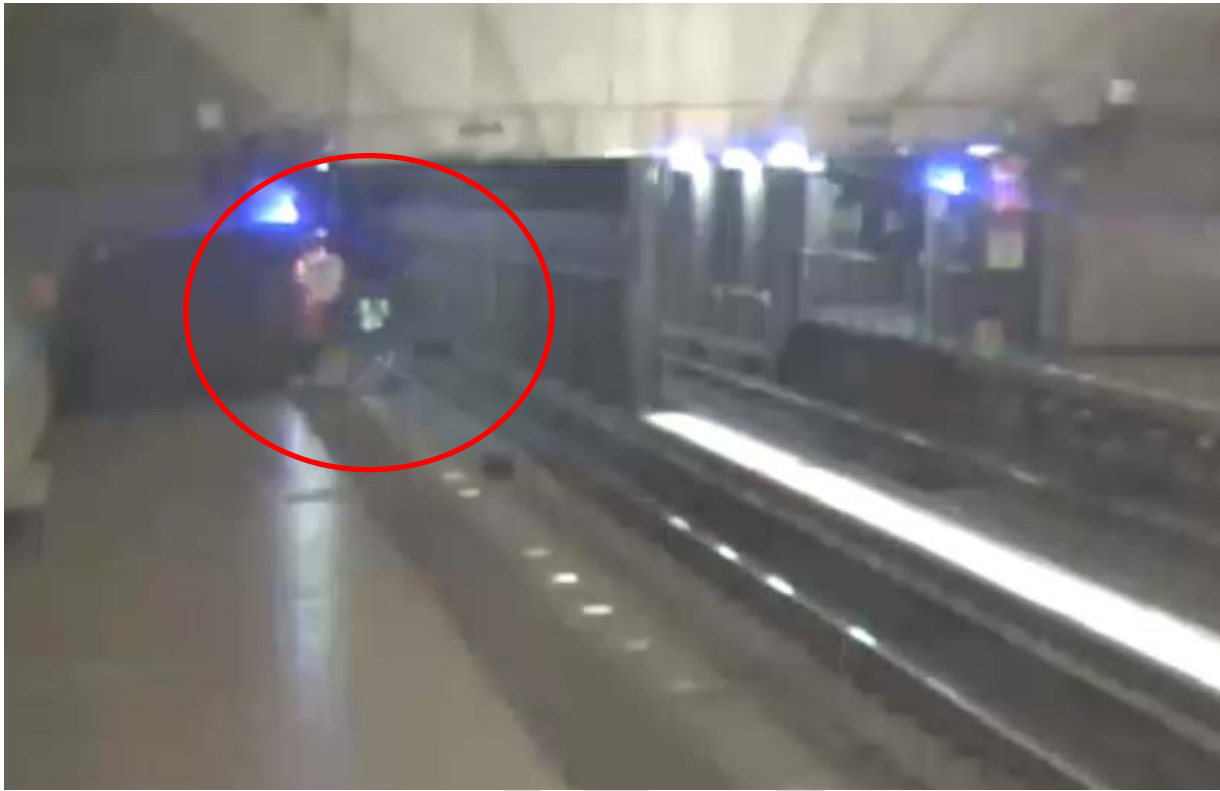
Photo 2 - 10:09:12 hrs., - Track Inspectors enter the roadway via end gate heading in the direction of Crystal City Station, Track 1

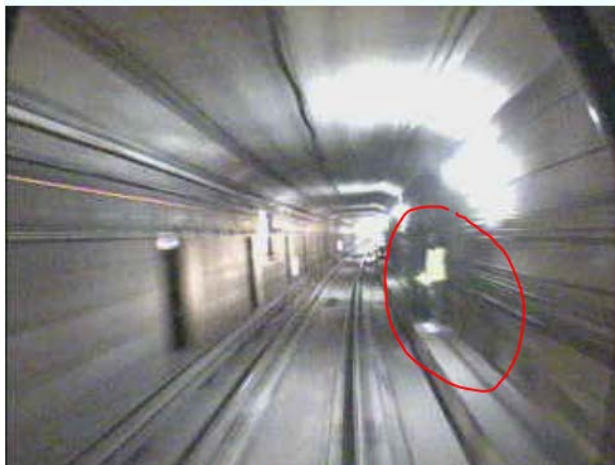
04/25/2019 10:11:54.157

Photo 3 – Train ID 308 forward facing camera captured the watchman/lookout

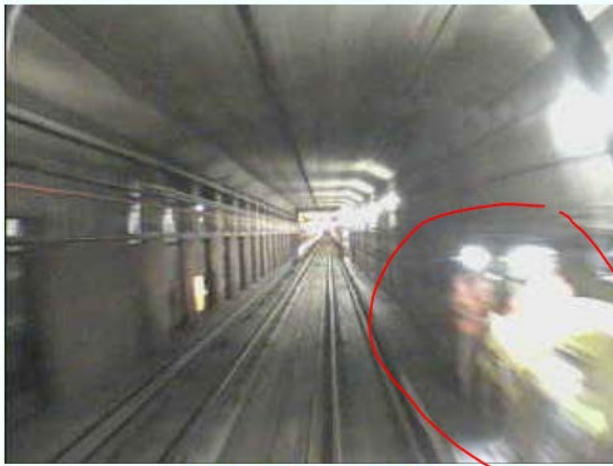
04/25/2019 10:11:56.663

Photo 4 – Train ID 308 forward facing camera captured TRST Mobile Work Crew 2 seconds later.
