**WMSC Commissioner Brief: W-0040 – Collision at New Carrollton Yard Grade Crossing on October 23, 2019**

**FINAL REPORT OF INVESTIGATION A&I E19563**

**SMS 20191023#83815**

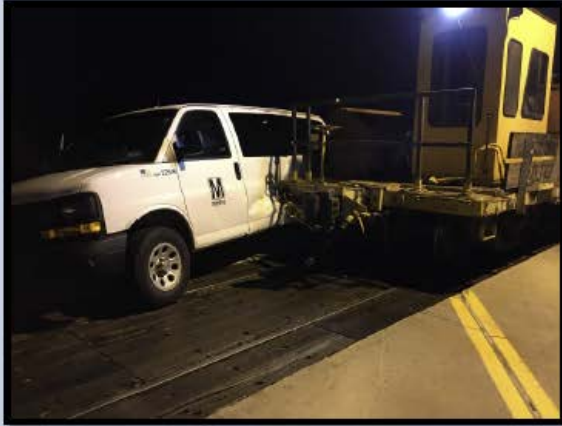
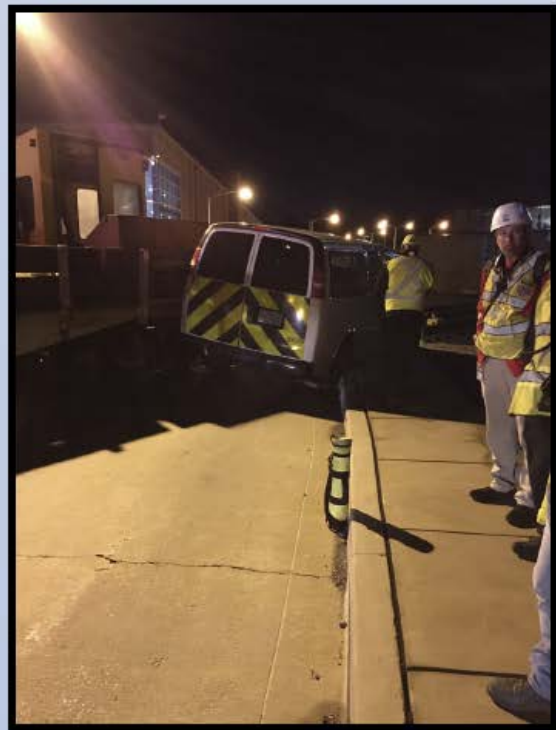
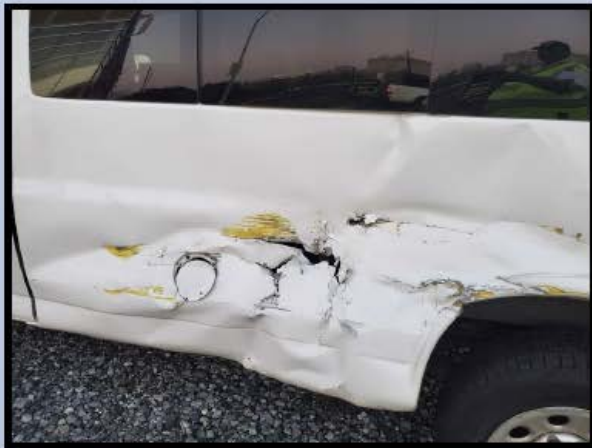
On Wednesday 10/23/19 at approximately 0530 in the morning there was a collision between a WMATA motor vehicle (#22516) and a Rail Track vehicle (Prime Mover 47). The collision occurred at the railroad crossing in New Carrollton Yard. Fortunately there were no injuries however there was substantial damage to the motor vehicle. The driver of the motor vehicle (ATC employee) reported that he visually saw the PM47 stopped in advance of the crossing. He also reported receiving the proceed signal from the flagman of the Prime mover. Personnel on PM47 reported making a complete stop before entering the crossing. The operator of PM47 received the proceed signal from his Flagman, honked the horn and proceeded through the crossing. PM47 collided (plowed) with the motor vehicle. After colliding with the motor vehicle the PM continued pushing the motor vehicle several feet before coming to a complete stop. Pictures of accident are located on page 2.

The results of the investigation (video) revealed that the driver of the motor vehicle (#22516) did not obey the Traffic sign (STOP). The driver did not make a complete stop before entering the railroad crossing.

- Improve skills of driver by attending "Defensive Driving Training Class"
- Create and distribute Lessons Learned explaining the importance of following all Traffic Signs (including WMATA Rail Yards).

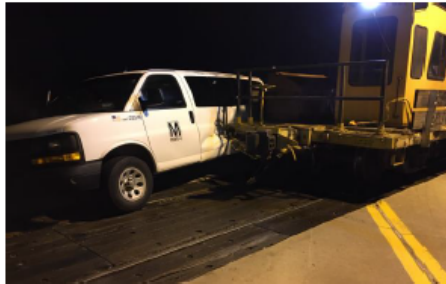
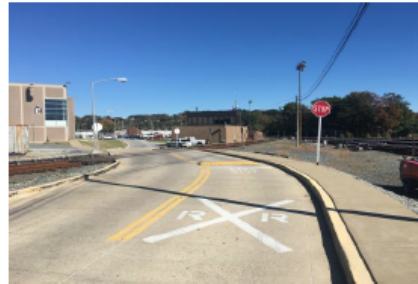
During the morning hours of October 23, 2019, a WMATA Non-Revenue vehicle made contact with a moving Class II Rail Vehicle within the New Carrollton Yard roadway crossing. Fortunately, there were no injuries reported as a result of this incident; however, there was significant damage to the WMATA Non-Revenue vehicle.

All employees are required to adhere to posted and painted traffic signage (e.g., speed limit, fire lane restrictions, etc.), including stop signs posted at roadway crossings within rail yards. Class I and Class II Rail Vehicles **always** have the right of way; all other vehicles must stop and yield the right of way to the Rail Vehicles.

1. Bring WMATA Non-Revenue and other automotive vehicles to a complete **STOP**, check that Rail Vehicles are clear of the crossing area and approach, then slowly proceed across the track(s).
2. If crossings are equipped with crossing gates, **STOP** WMATA Non-Revenue and other automotive vehicles at stop sign on approach to roadway crossing. Slowly proceed across the track(s) only after the crossing gates have been fully raised, the flashing lights and audible bells are off, and ensuring tracks are visually clear.
3. Equipment Operators and Flag Persons shall use positive radio communication when traversing yard roadway crossings. When applicable, Flag Persons must remain in a position of safety within the Flag Person's booth and be prepared to place the rail vehicle's brakes in the emergency position by utilizing the emergency brake valve positioned in the booth.

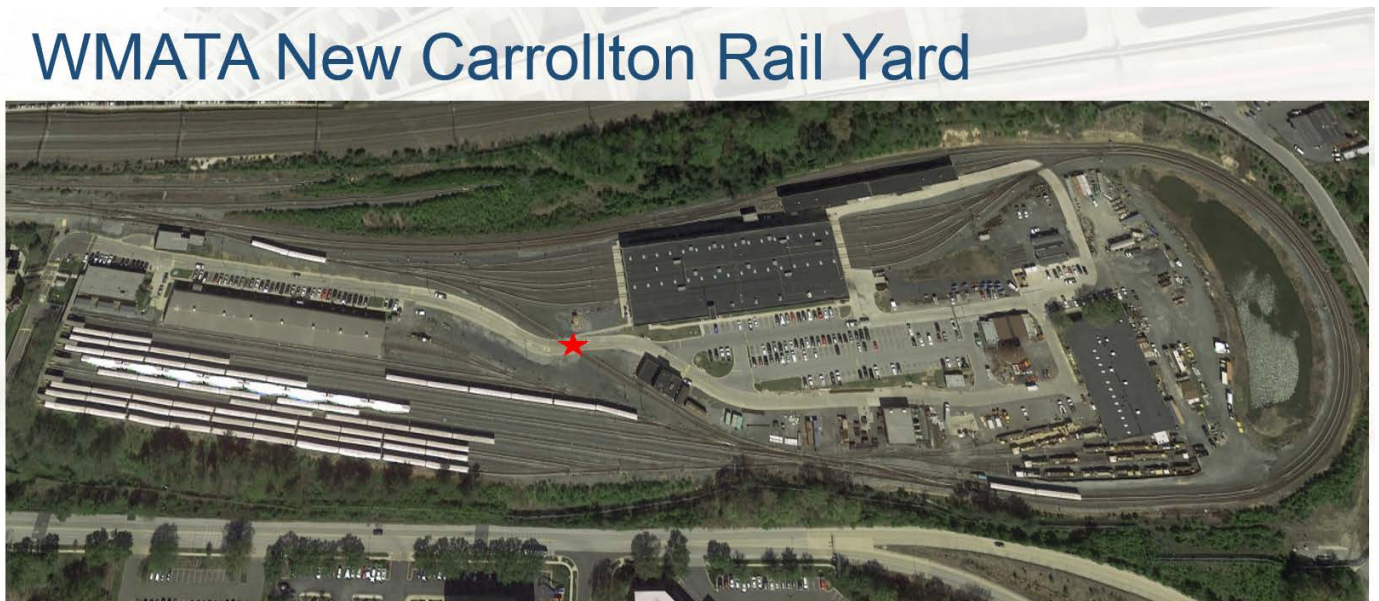
Photo 1 – The first grade crossing entering the yard.

On Wednesday, October 23, 2019, at 05:35 hrs., the Rail Operations Control Center (ROCC) notified SAFE of Flatcar (F) 505 making contact with WMATA's Non-revenue vehicle (WNRV) 22516 at New Carrollton Yard Roadway Crossing within the New Carrollton Yard, which is the first grade crossing entering the yard. See photo 1. The event was captured by the yard Closed Circuit Television (CCTV) video at 05:30 hrs.
