## Inspection Form

Washington Metrorail Safety Commission

<b>Inspection Date</b>	YYYY	MM	DD	<b>Report Number</b>	20200123-WMATA-LBW-1		
	2020	01	23				
<b>Rail Agency Name</b>	Washington Metropolitan Area Transit Authority			<b>Rail Agency Department</b>	CMNT	<b>Sub-Department</b>	S&I
<b>Rail Agency Department Contact Information</b>	<b>Name</b>		<b>Email</b>		<b>Office Phone</b>		<b>Mobile Phone</b>
	[REDACTED]		[REDACTED]		[REDACTED]		[REDACTED]
	[REDACTED]		[REDACTED]		[REDACTED]		[REDACTED]
<b>Inspection Location</b>	Brentwood Yard S&I Facility

<b>Inspection Activity #</b>	1	<b>Inspection Subject</b>	Service & Inspection – Brentwood Yard				<b>Activity Code</b>	VM	GEN	OBS	
<b>Job Briefing Employee Name/Title</b>	Ryan Fortune Superintendent S&I		<b>Accompanied Inspector?</b>	NA	<b>Out Brief Conducted</b>	Yes	<b>Time</b>	0800	<b>Outside Shift</b>	NO	
<b>Related Reports</b>	N/A		<b>Related CAPS / Findings</b>								
<b>Related Rules, SOPs, Standards, or Other</b>	<b>Ref</b>		<b>Rule or SOP</b>		<b>Standard</b>		<b>Other / Title</b>		<b>Checklist Reference</b>		
<b>Inspection Location</b>	Main Track	Yard	Station	OCC	RTA Facility	WMSC Office	<b>Track Type</b>	At-grade	Tunnel	Ele

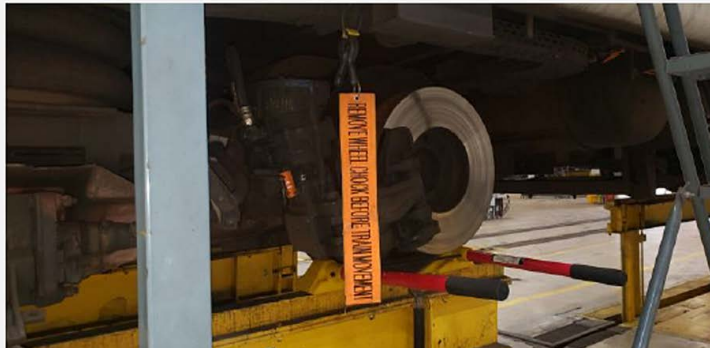
Cars 6108-9 were located at station two on the 13-north track. At the time of the inspection this vehicle was undergoing a coupler replacement, and the WMSC inspector did not enter either cars.

Three axels were chocked with warning flags located at two of the three chocked locations. Track 13 was blue flagged outside of the shop door.

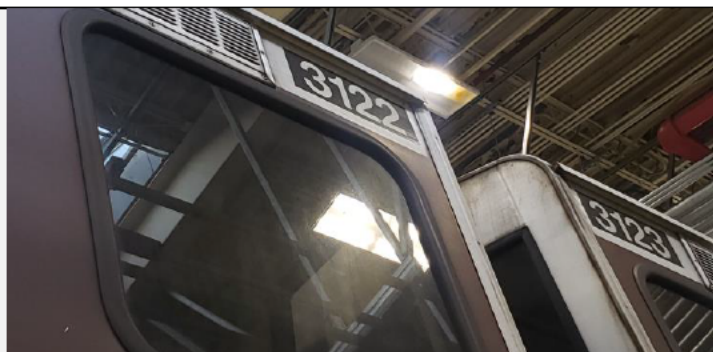
Cars 3122-3 were located at station one on the 9-north track. At the time of inspection there was no active work being performed. On rail car 3123, the bulkhead door was inspected and an issue with the door seal was found and discussed with the WMATA escort. One axel was chalked with a warning flag present and track nine was blue flagged.

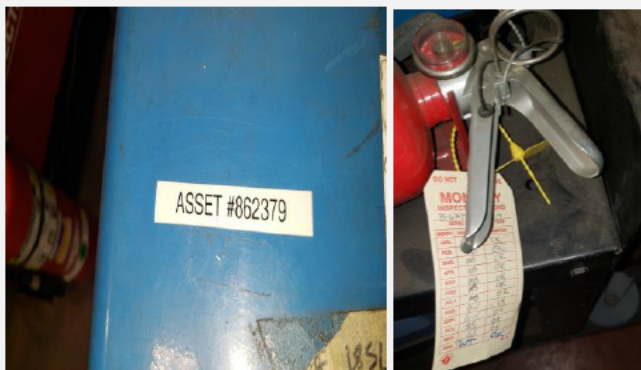
During the inspection of the Hot Works area, all equipment and fire extinguishers were inspected. During this inspection, one defect was identified. Asset #862379 was observed ready to use with an extinguisher due for inspection. This was immediately discussed with Brent Wade the employee responsible for tool calibration and during the exit briefing with management.

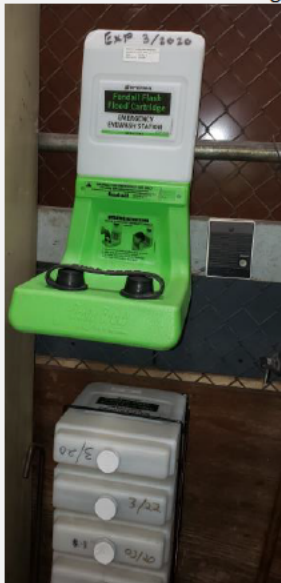
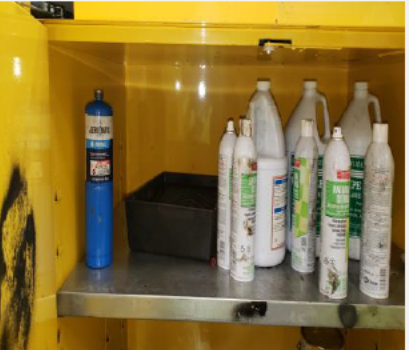
During the inspection of the eye wash stations, all stations inspected were found to be complying with expiration dates. During the inspection of the hazard material storage, combustibles and flammables items were stored in the same cabinet. Although there are separate cabinets for each, they were improperly stored together. This was

<p>immediately brought to the attention of the WMSC inspector escort and discussed in the exit briefing.</p> <div style="display: flex; justify-content: space-around;">
