Inspection Form

Washington Metrorail Safety Commission

Inspection Date	YYYY	MM	DD	Report Number	20202801-WMATA-JMW		
	2020	28	01				
Rail Agency Name	Washington Metropolitan Area Transit Authority			Rail Agency Department	WMATA	Sub- Department	TRST
Rail Agency Department Contact Information	Name		Email	Office Phone		Mobile Phone	
	[REDACTED]		[REDACTED]	[REDACTED]		[REDACTED]	
Inspection Location	A Line track #1 between CM A1 395+00+/- to CM A1 444+00+/-.

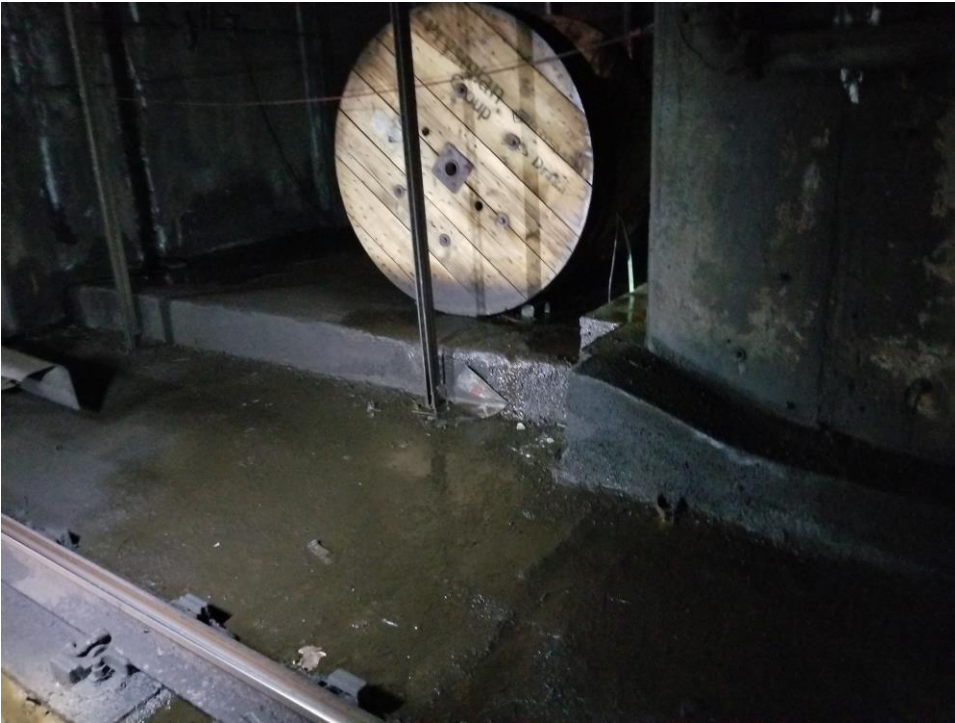
<p>WMSC personnel under the protection of a WMATA RWIC, continued a series of track inspections in regards to arcing insulators, CAP FTA 17-1-12 and CAP FTA 17-1-17. The inspection performed on January 28th, 2020, took place on the A Line track #1 between CM A1 395+00+/- to CM A1 444+00+/-.</p> <p>Notable Observations:</p> <ol style="list-style-type: none"> 1. ST04 and PM 55 were operating in a safe manner and followed applicable rules for movement of RMM's (class 2 vehicles) on mainline. 2. Metrorail's RWIC working between inspection location utilized the old shunt strap which didn't require the use of "hot sticking" gloves. The new shunt straps utilizes better clamping and requires "hot sticking" gloves to attach to the rail for safety. 3. Various water intrusion area's located throughout this inspection location CM A1 396+60+/- to CM A1 403+00+/-, CM A1 407+15+/- to 418+70+/-, These leaks are all on top of the rail. 4. CM A1 401+30+/- Missing Insulator 5. CM A1 441+15+/- Leak on top of curve closure rail 	Recommended Finding? YES	Remedial Action Required? NO

Recommended Reinspection? NO	
	Remedial Action	After inspection there were a few noticeable leaks on and around the switch area. Roadway workers must be mindful of the proper handling of shunts and related ppe associated with its job functions.	
Effective Practices
