Inspection Form

Washington Metrorail Safety Commission

Inspection Date	YYYY	MM	DD	Report Number	20201802-WMATA-JMW		
	2020	02	18				
Rail Agency Name	Washington Metropolitan Area Transit Authority			Rail Agency Department	WMATA	Sub- Department	TRST
Rail Agency Department Contact Information	Name		Email		Office Phone		Mobile Phone
	██████████ ██████████		██████████ ██████████		██████████		██████████ ██████████
Inspection Location	A Line track #1 between CM A1 71+50+/- to CM A1 128+00+/-.

Inspection Activity #	1	Inspection Subject	Insulator/Tunnel Leak Inspection				Activity Code		TRK	OBS	WI
Job Briefing Employee Name/Title	WMATA RWIC/Compliance Group		Accompanied Inspector?	YES	Out Brief Conducted	YES	Time	2200-0400	Outside Shift	YES	
Related Reports	N/A		Related CAPS / Findings		FTA 17-1-12 (Track Bed Cleaning) FTA 17-1-17 (Insulator Cleaning/Installation)						
Related Rules, SOPs, Standards, or Other	Ref		Rule or SOP		Standard		Other / Title		Checklist Reference		
	RWPM		SR 3.116 RVO/Equipment Malfunction								
	TRST 1000		OPS 1								
Inspection Location	Main Track	Yard	Station	OCC	RTA Facility	WMSC Office	Track Type	At-grade	Tunnel	Elevated	N/A
	X								X		
Line(s)	A	Tra

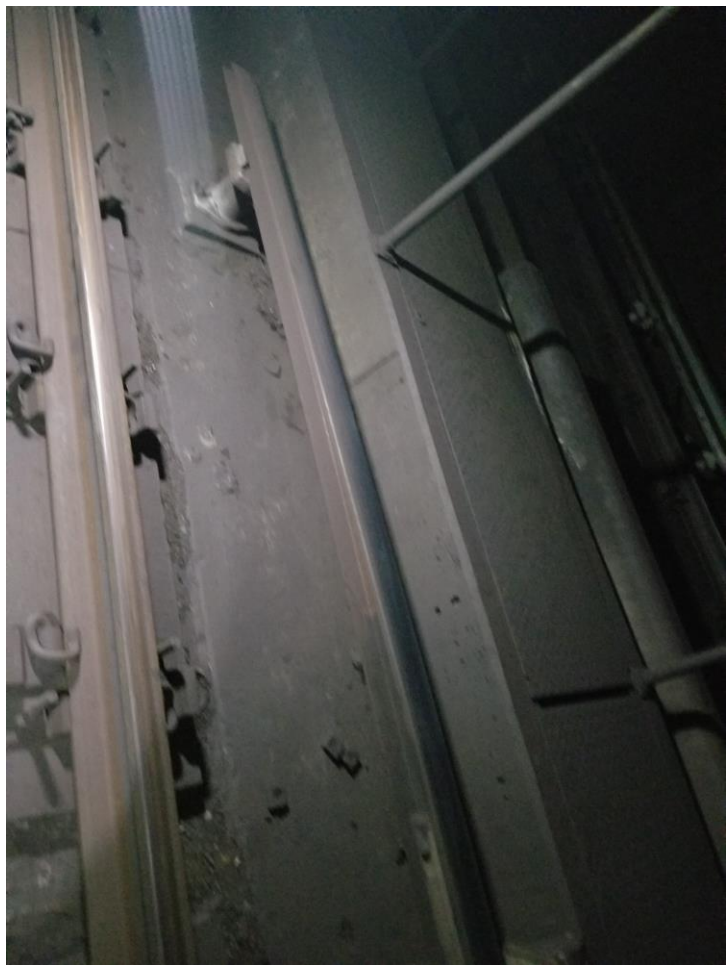
Description	<p>WMSC personnel under the protection of a WMATA RWIC, continued a series of track inspections in regards to arcing insulators, CAP FTA 17-1-12 and CAP FTA 17-1-17. The inspection performed on February 19th, 2020, took place on the A Line track #1 between CM A1 71+50+/- to CM A1 128+00+/-.</p> <p>Notable Observations:</p> <ol style="list-style-type: none"> 1. Clogged Invert from CM A1 80+00+/- to CM A1 84+00+/- 2. Missing coverboards CM 72+40+/- to CM 73+50+/- 3. Missing coverboards on end approach CM 73+00+/- 73+50+/- 4. Missing coverboards at CM 73+60+/- to CM 74+00+/- 	Number of Defects	3
		Recommended Finding?	YES
		Remedial Action Required?	NO
		Recommended Reinspection?	NO
Remedial Action	Metrorail's TRST department must ensure that coverboards are being reported if missing and in need of replacement.		
Effective Practices
