Inspection Form

Washington Metrorail Safety Commission

Inspection Date	YYYY	MM	DD	Report Number	20200903-WMATA-JMW		
	2020	03	09				
Rail Agency Name	Washington Metropolitan Area Transit Authority			Rail Agency Department	WMATA	Sub- Department	TRST
Rail Agency Department Contact Information	Name		Email		Office Phone		Mobile Phone
	██████████ ██████████		██████████ ██████████		██████████		██████████ ██████████
Inspection Location	A Line track #2 between CM A1 204+50 to CM A1 134+00.

Inspection Activity #	1	Inspection Subject	Insulator/Tunnel Leak Inspection				Activity Code		TRK	OBS	WI
Job Briefing Employee Name/Title	WMATA RWIC/Compliance Group		Accompanied Inspector?	YES	Out Brief Conducted	YES	Time	2200-0300	Outside Shift	YES	
Related Reports	N/A		Related CAPS / Findings		FTA 17-1-12 (Track Bed Cleaning) FTA 17-1-17 (Insulator Cleaning/Installation)						
Related Rules, SOPs, Standards, or Other	Ref	Rule or SOP		Standard		Other / Title		Checklist Reference			
	RWPM	SOP 28 28.2									
	TRST 1000	OPS 1									
Inspection Location	Main Track	Yard	Station	OCC	RTA Facility	WMSC Office	Track Type	At-grade	Tunnel	Elevated	N/A
	X								X		
Line(s)	A	Track Number	2	Chain Marker and

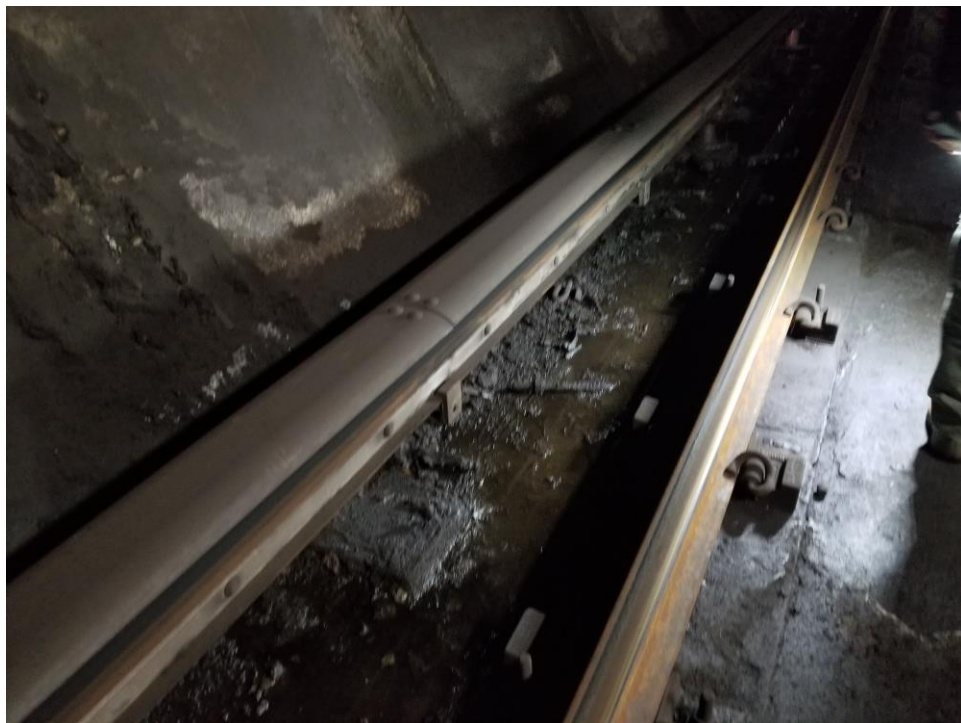
<p>1-17. The inspection performed on March 9th, 2020, took place on the A Line track #2 between CM A1 204+50 to CM A1 134+00.</p> <p>Notable Observations:</p> <ol style="list-style-type: none"> 1. Possible RMM's exceeding 15 mph within the passenger platform limits. 2. Noticeable water, mud and debris under contact rail and surrounding insulators, CM A2 192+40+/- to CM A2 192+70+/-. 3. Debris and mud under contact rail and insulators. CM 192+00+/- 4. Sever deterioration of the safety walk. CM 189+80+/- 5. Water, debris and some wall/structural damage near vent shaft. CM 172+40+/- 6. Cracks in the floating slab at Cleveland Park in walls and near insulators. 7. CM A2 158+30 to CM A2 156+00+/- deterioration of the safety walk and water intrusion on the head of the rail. 	<p>Remedial Action Required?</p>	<p>YES</p>
		<p>Recommended Reinspection?</p>	<p>YES</p>
Remedial Action	<p>Metrorail should take measures for cleaning mud and debris from areas that were previously identified as having bad leaks. The mud, debris and water are contributing factors to insulator fires. Also, Metrorail should utilize methods such as curtain grouting or plugging locations with leaks that make direct contact with the head of the rail. In tunnel locations with temperature fluctuations, water intrusion assists with the corrosion of rail. Furthermore, safety walks in two locations appear to be deteriorating, and severely cracked in a couple of locations. The safety walk is a key safety feature for roadway workers to stay clear of trains or other rail vehicles.</p>
