Washington Metrorail Safety Commission

Inspection Date	YYYY MM DD		Report Number	20200818-WMATA-LBW-1					
inspection date	2020	08	18	Report Number	ZUZUUOIO-VVIVIATA-LBVV-I				
Rail Agency Name	Washington Metropolitan Area Transit Authority			Rail Agency Department	Operations Sub-Department Sta		Stations		
	1	Name		Email	Office Phone		Mobile Phone		
Rail Agency Department									
Contact Information									
Inspection Location	Cheverly (D11)

Inspection Activity #	1 Inspection Statio			Station	n Assessment – Cheverly (D11)				Activity Code		RTRA		GEN	RR	
Job Briefing Employee Name/Title	NA				Accompanied Inspector?		NA	Out Brief Conducted	NA	Time	N/	A	Outside Shift	NA	
Related Reports	N/A Related CAF Findings						•	1	NA						
Related Rules,	Ref Rule o			Rule or	SOP		Standard	ndard		Other / Title		Checklist Reference			
SOPs, Standards,															
or Other															
Inspection Location	Ma Tra		Yard	Stati	ion C	СС	RTA Facility	WMSC Office	Track Type	At-grad	e Tu	nnel	Eleva	ated	N/A
Location				X				X		X					
Line(s)	Delta Track			Chain Marker F			rom			То					
Line(s)	Number				and/or Station(s)										
Vehicles	Head Car Number Number of Cars Equipment														
De

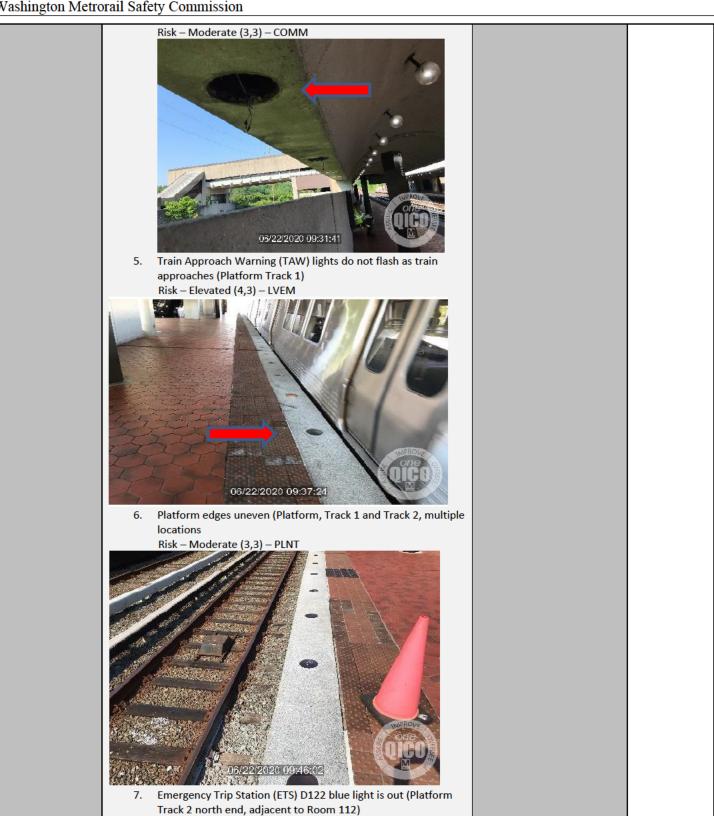
Multiple public address system speakers missing (Platform canopy Track 1 and Track 2) Remedial Action Required? No

Form WMSC-IR-1 Version date: 10/5/18 Risk – Elevated (4,3) – LVEM
