Inspection Form

Washington Metrorail Safety Commission

Inspection Date	YYYY	MM	DD	Report Number	20200819-WMATA-LBW-1		
	2020	08	19				
Rail Agency Name	Washington Metropolitan Area Transit Authority			Rail Agency Department	Operations	Sub-Department	Stations
Rail Agency Department Contact Information	Name		Email		Office Phone		Mobile Phone
	[REDACTED]		[REDACTED]		[REDACTED]		[REDACTED]
	[REDACTED]		[REDACTED]		[REDACTED]		[REDACTED]
	[REDACTED]		[REDACTED]		[REDACTED]		[REDACTED]
Inspection Location	Morgan Boulevard (G04)

Inspection Activity #	1	Inspection Subject	Station Assessment – Morgan Boulevard (G04)				Activity Code		RTRA	GEN	RR
Job Briefing Employee Name/Title	NA		Accompanied Inspector?	NA	Out Brief Conducted	NA	Time	NA	Outside Shift	NA	
Related Reports	N/A		Related CAPS / Findings		NA						
Related Rules, SOPs, Standards, or Other	Ref		Rule or SOP		Standard		Other / Title		Checklist Reference		
Inspection Location	Main Track	Yard	Station	OCC	RTA Facility	WMSC Office	Track Type	At-grade	Tunnel	Elevated	N/A
			X			X			X		
Line(s)	Golf	Track Number		Chain Marker and/or Station(s)		From		To			
Vehicles	Head Car Number		Number of Cars		Equipment						
Description	The WMSC

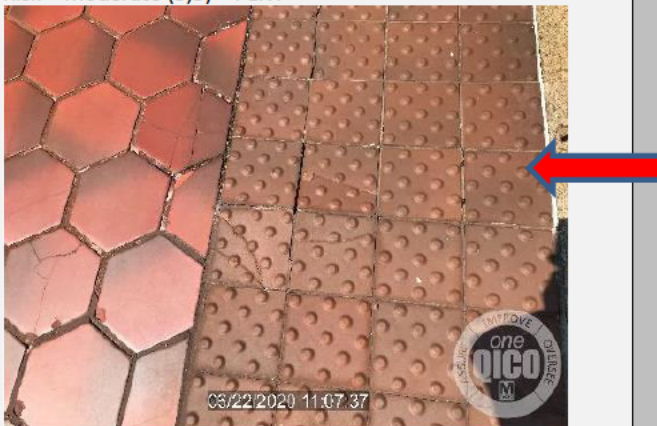
Risk – Moderate (3,3) – PLNT

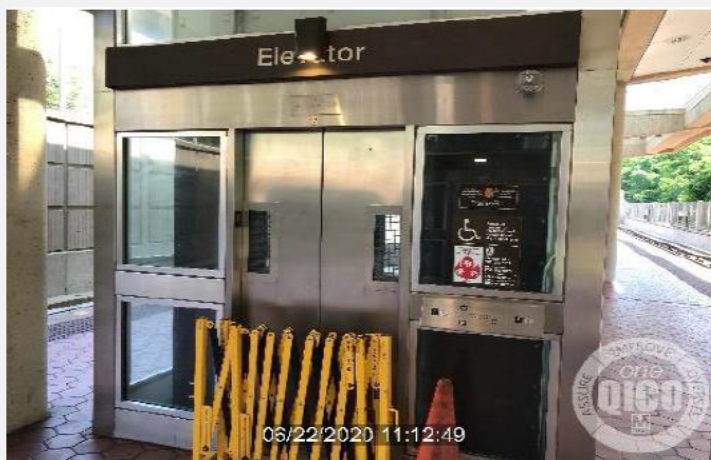
- 5. Elevator out of service (G04X02)
Risk – Elevated (4,3) – ELES

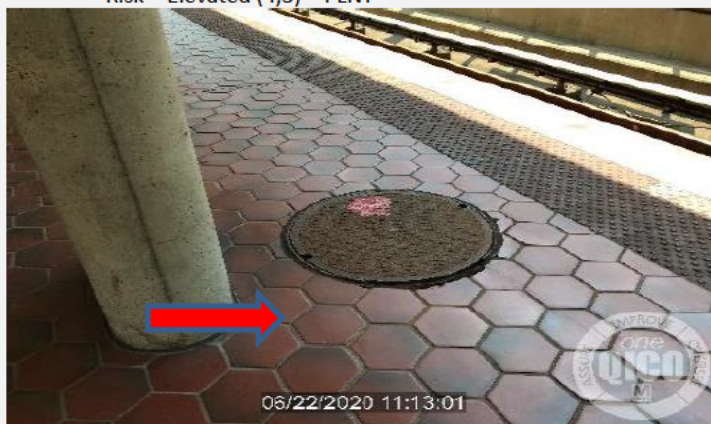
- 6. Manhole cover loose and uneven
(Platform, Track 1 adjacent to elevator G04X02)
Risk – Elevated (4,3) – PLNT

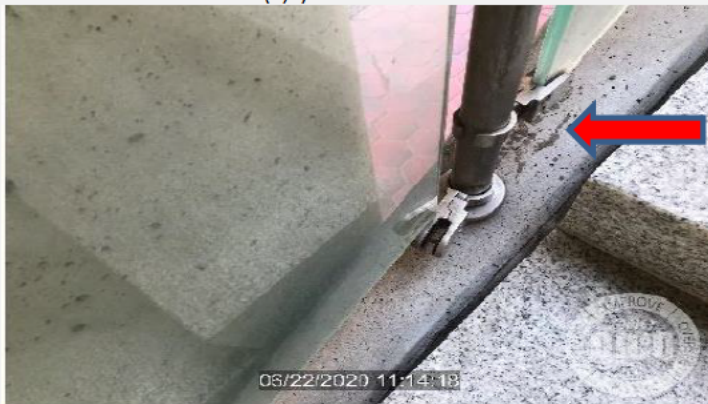
- 7. Glass panel loose and improperly mounted
(Platform, Track 1 adjacent to elevator G04X02)
Risk – Moderate (4,2) – PLNT

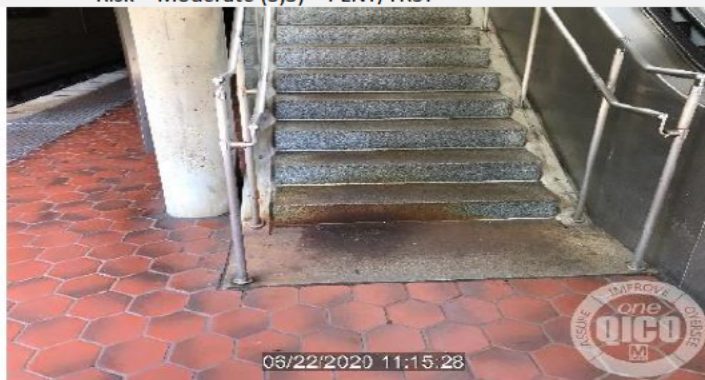
- 8. Stain/evidence of water leak on stairs
(Platform, Track 1 adjacent to elevator G04X01)
Risk – Moderate (3,3) – PLNT/TRST

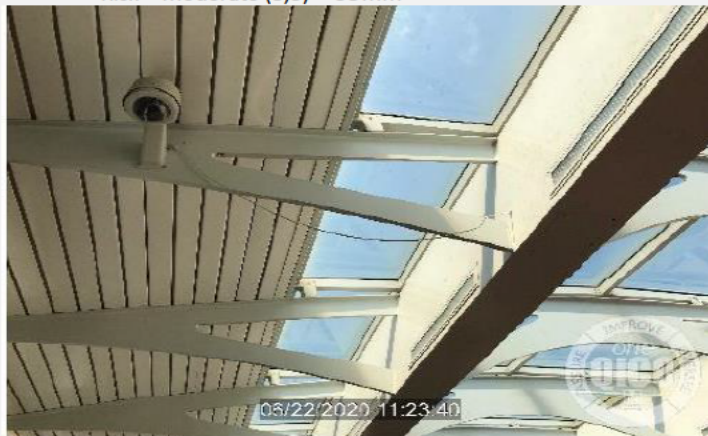
- 9. CCTV camera cable loose/unmounted
Mezzanine above elevator G04X01
Risk – Moderate (3,3) – COMM

The Inspector recommends reinspection of Morgan Boulevard (G04) to reassess the discrepancies identified in this report and open work orders.
