## Inspection Form

Washington Metrorail Safety Commission

<b>Inspection Date</b>	YYYY	MM	DD	<b>Report Number</b>	20200901-WMATA-LBW-1		
	2020	09	01				
<b>Rail Agency Name</b>	Washington Metropolitan Area Transit Authority			<b>Rail Agency Department</b>	Operations	<b>Sub-Department</b>	Stations
<b>Rail Agency Department Contact Information</b>	<b>Name</b>		<b>Email</b>		<b>Office Phone</b>		<b>Mobile Phone</b>
	[REDACTED]		[REDACTED]		[REDACTED]		[REDACTED]
	[REDACTED]		[REDACTED]		[REDACTED]		[REDACTED]
	[REDACTED]		[REDACTED]		[REDACTED]		[REDACTED]
<b>Inspection Location</b>	Greensboro (N03)

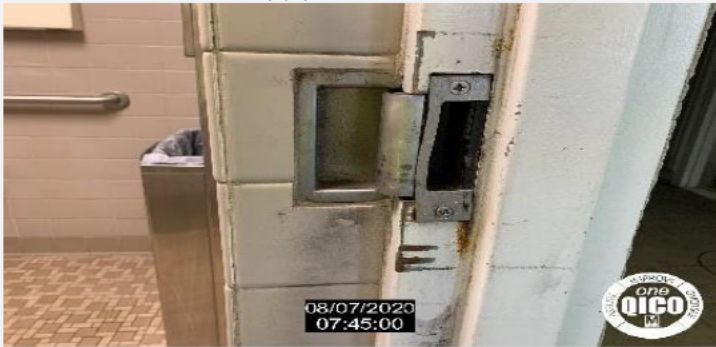
<p>identify documented and outstanding items. A risk rating was assigned for all discrepancies identified during field assessments.</p> <p>Due to COVID-19 and social distancing, this inspection was completed without entering Greensboro (N03) and without interacting with any Metrorail personnel.</p> <p>Discrepancies Identified for further review and follow up:</p> <ol style="list-style-type: none"> <li>1. Door strike plate damaged, magnetic lock inoperative – Mezzanine level on left Risk – Moderate (4,3) – PLNT</li> </ol>	<table border="1" style="width: 100%; border-collapse: collapse;"> <tr> <td style="width: 70%;"><b>Remedial Action Required?</b></td> <td style="width: 30%; text-align: center;">No</td> </tr> </table>	<b>Remedial Action Required?</b>	No
<b>Remedial Action Required?</b>	No

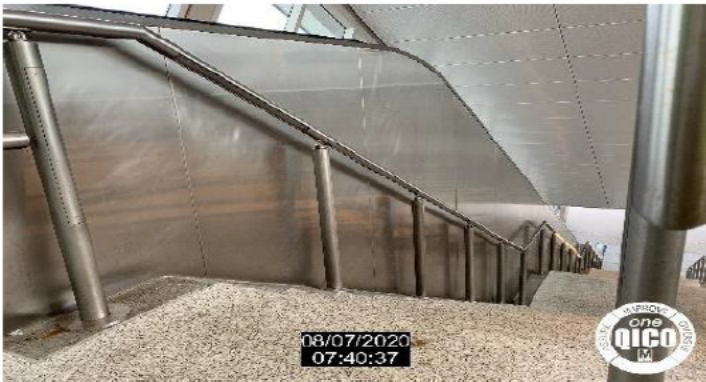
<p style="text-align: center;">08/07/2020 07:45:00</p>			
<ol style="list-style-type: none"> <li>2. Stairway handrail lights out multiple locations – pedestrian bridge and stairwell Risk – Low (1,3) – LVEM</li> </ol>

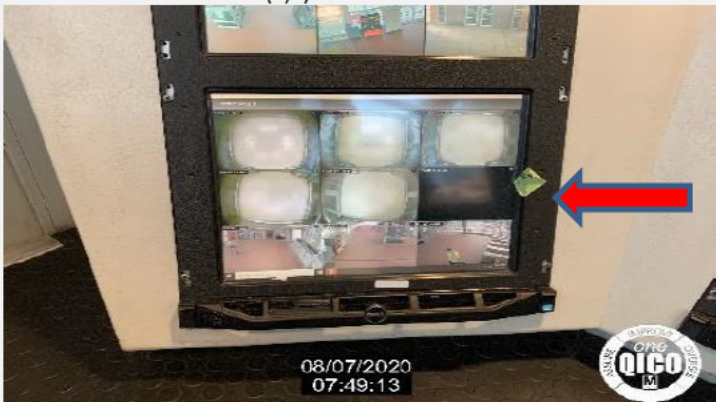
<p style="text-align: center;">08/07/2020 07:40:37</p>			
<ol style="list-style-type: none"> <li>3. CCTV camera out of service – camera ELX-031 Risk – Moderate (4,2) – COMM</li> </ol>

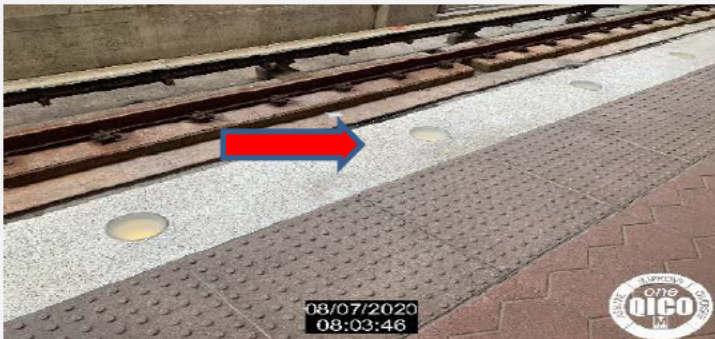
<p>4. Train Approach Warning (TAW) lights flashing without vehicle in approach or present Risk – Moderate (3,3) – LVEM</p>
