Inspection Form

Washington Metrorail Safety Commission

Inspection Date	YYYY	MM	DD	Report Number	20200903-WMATA-LBW-2		
	2020	09	03				
Rail Agency Name	Washington Metropolitan Area Transit Authority			Rail Agency Department	Track	Sub-Department	RWP
Rail Agency Department Contact Information	Name		Email		Office Phone		Mobile Phone
	[REDACTED]		[REDACTED]		[REDACTED]		[REDACTED]
	[REDACTED]		[REDACTED]		[REDACTED]		[REDACTED]
	[REDACTED]		[REDACTED]		[REDACTED]		[REDACTED]
Inspection Location	Alexandria Yard – (C99)

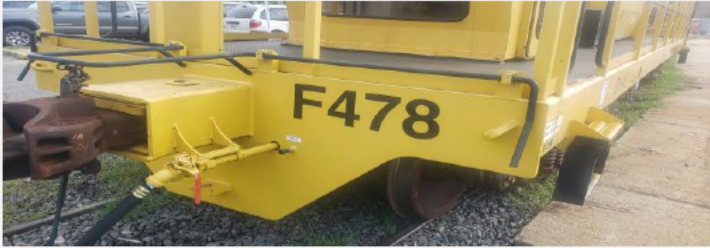
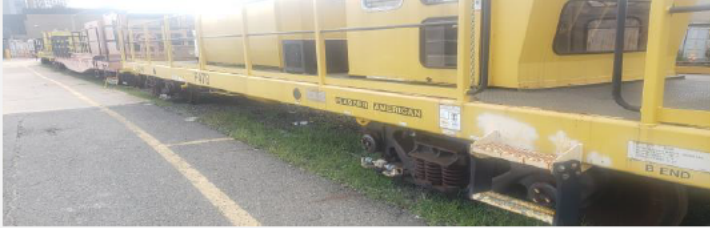
<p>briefing was conducted with Metrorail personnel. The scope of the Alexandria Yard – (C99) inspection was vehicle securement and RWP personal protective equipment (PPE). During this inspection, the inspector was monitoring the radio channel for Alexandria Yard – (C99), and personnel were observed in the performance of their duties. There is currently an open corrective action for PPE (C-0041). The WMSC inspector monitored three (3) working groups of Metrorail employees and contractors, and vehicles not in use or unattended were observed for correct securement.</p> <p>1. Of the Class II vehicles inspected, one (1) vehicle, Plasser - F478, was stored without wheel stops or chocks not following Operating rule (OR) 3.126 9(b).</p> <p><i>When storing Class II Rail Vehicles, operators shall:</i></p> <ul style="list-style-type: none"> a. Set parking brakes on all locomotives, prime movers, cars, and any other wheeled units in the consist; b. Apply wheel stops or chocks to both sides of one wheel, on one axle, of each truck in the consist; and c. Perform a "walk-around" inspection to ensure brakes are properly applied, chocks or stops are in place, and no equipment is fouling any other tracks.

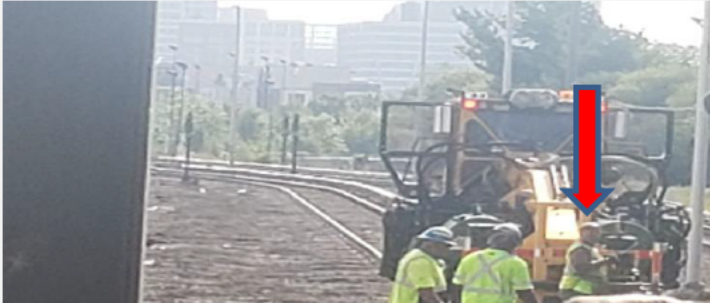
<p>2. A track and structure (TRST) employee was observed in the work limits without a hard hat in violation of 5.11 (PPE standards for on track safety).</p>

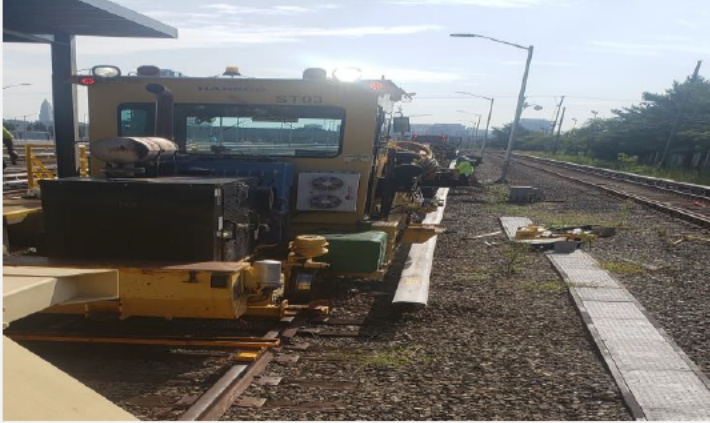
<p>4. The equipment operator of TC-07 on track 25 was observed exiting the vehicle and using the third rail coverboard as a step to exit the vehicle not adhering to Metrorail safety rule (SR). <i>SR - 4.171 Employees shall not walk, stand, step, or sit on running rails, frogs, switches, switch points, third rail cover boards, PVC conduit, guard rails, rail braces, interlocking apparatus, or other wayside equipment.</i></p>		
Remedial Action	N/A
