Inspection Form

Washington Metrorail Safety Commission

Inspection Date	YYYY	MM	DD	Report Number	20200915-WMATA-LBW-1		
	2020	09	15				
Rail Agency Name	Washington Metropolitan Area Transit Authority			Rail Agency Department	Operations	Sub-Department	Stations
Rail Agency Department Contact Information	Name		Email		Office Phone		Mobile Phone
	[REDACTED]		[REDACTED]		[REDACTED]		[REDACTED]
	[REDACTED]		[REDACTED]		[REDACTED]		[REDACTED]
	[REDACTED]		[REDACTED]		[REDACTED]		[REDACTED]
Inspection Location	Virginia Square (K03)

Inspection Activity #	1	Inspection Subject	Station Assessment – Virginia Square (K03)				Activity Code		RTRA	GEN	RR
Job Briefing Employee Name/Title	NA		Accompanied Inspector?	NA	Out Brief Conducted	NA	Time	NA	Outside Shift	NA	
Related Reports	N/A		Related CAPS / Findings		NA						
Related Rules, SOPs, Standards, or Other	Ref		Rule or SOP		Standard		Other / Title		Checklist Reference		
Inspection Location	Main Track	Yard	Station	OCC	RTA Facility	WMSC Office	Track Type	At-grade	Tunnel	Elevated	N/A
			X			X			X		
Line(s)	Kilo	Track Number		Chain Marker and/or Station(s)	From			To			
Vehicles	Head Car Number		Number of Cars		Equipment						
Description	The WMSC In

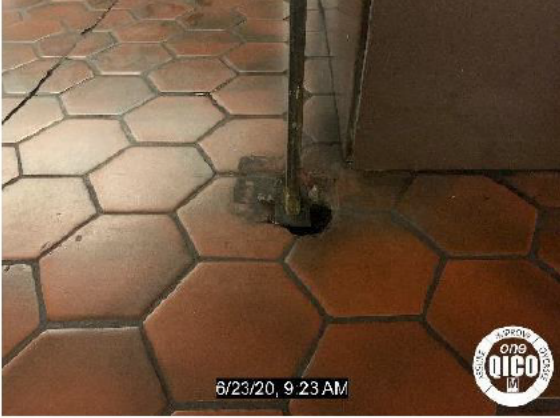
<p>identify documented and outstanding items. A risk rating was assigned for all discrepancies identified during field assessments. Due to COVID-19 and social distancing, this inspection was completed without entering Virginia Square (K03) and without interacting with any Metrorail personnel.</p> <p>Discrepancies Identified for further review and follow up:</p> <ol style="list-style-type: none"> Handrail base not secure – adjacent to escalator K03X04 Risk – Moderate (4,2) – PLNT

<p>The Inspector recommends reinspection of Virginia Square (K03) to reassess the discrepancies identified in this report and open work orders.</p>	<p>Remedial Action Required?</p>	<p>No</p>
		<p>Recommended Reinspection?</p>	<p>Yes</p>
Remedial Action	N/A

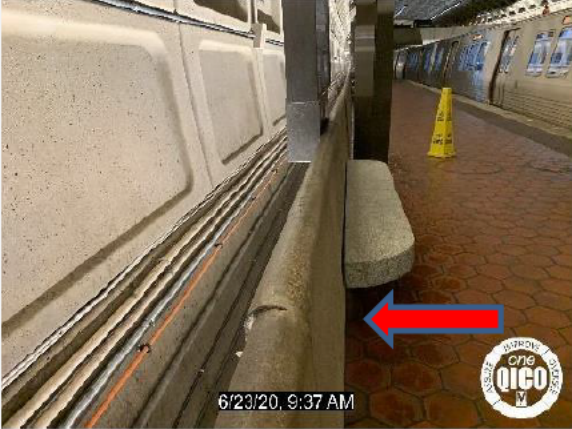
<ol style="list-style-type: none"> Parapet walls separating Platform, track 1 near the center Risk – Moderate (4,2) – TRST
