## Inspection Form

Washington Metrorail Safety Commission

| <b>Inspection Date</b> | YYYY | MM | DD | <b>Report Number</b> | 20210204-WMATA-LBW-2 | | |

| <b>Inspection Activity #</b> | 1 | <b>Inspection Subject</b> | Storing Class I Vehicles – Greenbelt Yard | | | <b>Activity Code</b> | RTRA | GEN | OBS | | |

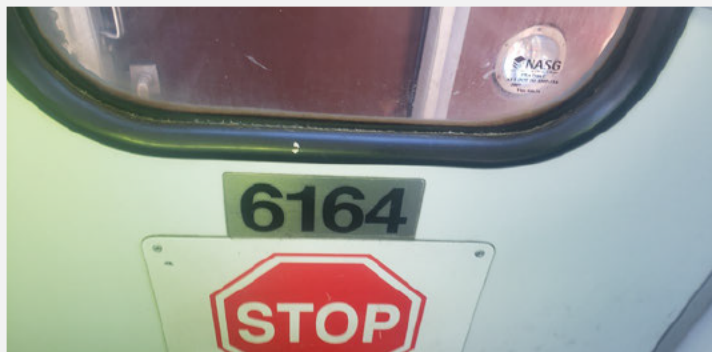
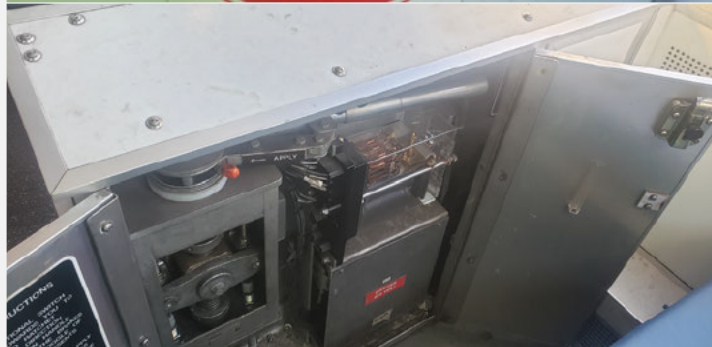
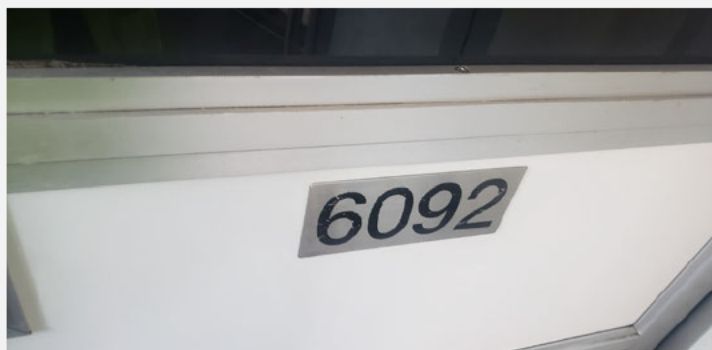
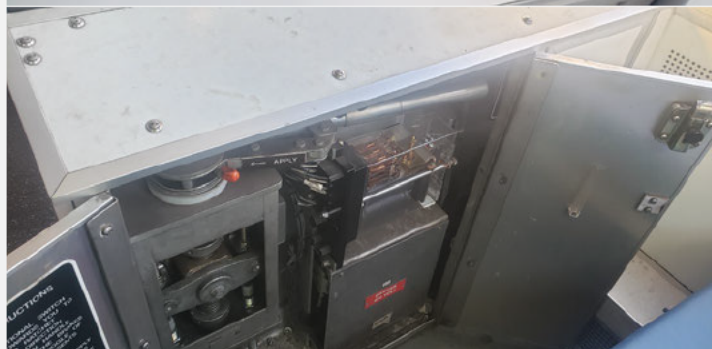
| | <p>train car #2064 located on storage track #14 in Greenbelt Yard, was found to be in contact with the bump post. The scope of this inspection was the storage of 2000, 3000 and 6000 series rail cars. All 6000 series rail vehicles have been removed from revenue service since November 2021 and should be properly stored and secured. When storing a Class I rail vehicle, the WMATA Metrorail Safety Rules and Procedures Handbook (MSRPH) rule 3.126 states: (a) Secure cars being stored a minimum distance of two (2) feet apart at all storage locations, yards and/or tail tracks; (b) Set handbrakes on at least two cars; (c) Set a sufficient additional number of handbrakes for the grade on which the cars are being stored; (d) Ensure that the cars being stored are not fouling other tracks; and (e) If the consist is to be stored for more than 15 days, the consists shall be chocked and blue flagged.</p> <p>The Federal Transit Administration (FTA) previously conducted an investigation into rail vehicle securement practices at the Washington Metropolitan Area Transit Authority (WMATA) Metrorail system. That investigation resulted in both findings and required actions. The findings and required actions were intended to prevent unintended train movement.</p> <p><i>FTA Finding 1: WMATA does not provide redundant protection when securing unattended rail vehicles.</i></p> <p>Prior to beginning the inspection, the WMSC inspector conducted a briefing with the Greenbelt Yard interlocking operator and received a yard map identifying all stored vehicle locations within the rail yard. During this inspection eighteen of the twenty-eight 6000 series rail vehicles were inspected. The inspector also inspected 1000 series, 3000 series, 4000 series and 5000 series vehicles in long term storage. All vehicles inspected were located on storage tracks 3 and 4. The Greenbelt Operations Superintendent and the Managing Director of Rail were not available at the conclusion of the inspection for an exit briefing.</p> <p>On Track 3 (6092/6093-6095/6094) was stored with only one handbrake applied on car 6092. MSRPH rule 3.126 (a) requires at least 1 handbrake applied on at least two cars and (e) If the consist is to be stored for more than 15 days, the consists shall be chocked and blue flagged as required. The following Class I vehicles were stored with only one handbrake and no wheel chocks or blue flagging on track 3:<br/>(6164/6165 - 6187/6186 - 6173/6172 – 6012/6013). Handbrake on 6092. (6061/6060) Handbrake on 6061</p> <p>On Track 4 (6082/6083) and (6056/6057) was stored with no handbrake applied. The WMSC inspector did not board the remaining vehicles on track 4 due to paper signage posted restricting boarding. Of the five consist in long term storage<br/>(3008/3009) was chocked but no blue flagging was observed<br/>(3020/3021) was not chocked and no blue flagging was observed<br/>(5000/5001) was chocked but no blue flagging was observed<br/>(1000/1001) was chocked but no blue flagging was observed<br/>(4000/4001) was chocked but no blue flagging was observed</p> <p>During this inspection, the WMSC inspector observed Class I vehicles in long term storage without wheel chocks or blue flagging protection.</p> | <b>Recommended Finding?</b> | |

This is a violation of the requirement as written in the rule. This requirement needs to be emphasized to all responsible personnel for compliance, at all applicable Metrorail yards, to prevent repeat observations of the same noncompliant condition, noted here.
