Inspection Form

Inspection Date	YYYY	MM	DD	Report Number	20210207-WMATA-LBW-1		
	2021	02	04				
Rail Agency Name	Washington Metropolitan Area Transit Authority			Rail Agency Department	Operations	Sub-Department	Vehicles
Rail Agency Department Contact Information	Name		Email		Office Phone		Mobile Phone
	[REDACTED]		[REDACTED]		[REDACTED]		[REDACTED]
Inspection Location	Greenbelt Yard – Storage Tracks

Inspection Activity #	1	Inspection Subject	Storing Class II Vehicles – Greenbelt Yard				Activity Code	RTRA	GEN	OBS	
Job Briefing Employee Name/Title	Greenbelt Interlocking Operator		Accompanied Inspector?	NA	Out Brief Conducted	NA	Time	1345	Outside Shift	Yes	
Related Reports	N/A		Related CAPS / Findings		FTA-VSC-16-001 (Closed)						
Related Rules, SOPs, Standards, or Other	Ref		Rule or SOP		Standard		Other / Title		Checklist Reference		
			OR-3.126								
Inspection Location	Main Track	Yard	Station	OCC	RTA Facility	WMSC Office	Track Type	At-grade	Tunnel	Elevated	N/A
		X									
Line(s)	E-99	Track Number	2	Chain Marker and/or Station(s)			From		To		
				NA			NA		NA		
Vehicles	Head Car Number		Number of Cars		Equipment						
			9								
Description	The WMSC Inspector conducted a cl

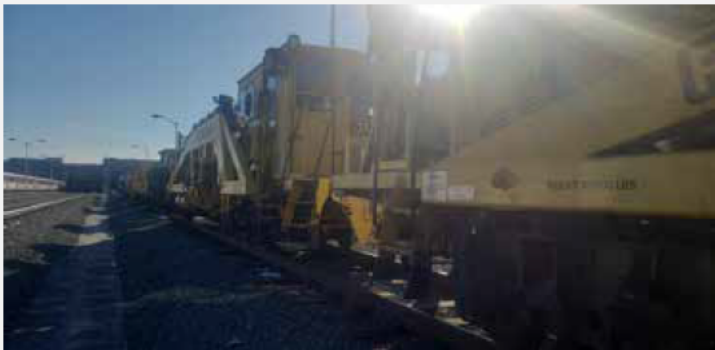
<p>found to be in contact with the bump post. The scope of this inspection was the storage of Class II Rail Vehicles. When storing a Class II rail vehicle, the WMATA Metrorail Safety Rules and Procedures Handbook (MSRPH) rule 3.126 states:</p> <p>When storing Class II Rail Vehicles, operators shall: MSRPH 3.126</p> <ol style="list-style-type: none"> a. Set parking brakes on all locomotives, prime movers, cars, and any other wheeled units in the consist. b. Apply wheel stops or chocks to both sides of one wheel, on one axle of each truck in the consist: and c. Perform a "walk-around" inspection to ensure brakes are properly applied, chocks or stops are in place, and no equipment is fouling any other tracks. <p>Prior to beginning the inspection, the WMSC inspector conducted a briefing with the Greenbelt Yard interlocking operator and received a yard map identifying all stored vehicle locations within the rail yard. During this inspection nine (9) Class II rail vehicles were inspected. All vehicles inspected were located on Greenbelt Storage Tracks 2. The inspector completed a walk-around inspection of the following vehicles to inspect for wheel stops or chocks to both sides of one wheel.</p> <ol style="list-style-type: none"> 1. PM49 2. L002 3. BR02 4. PM28 5. ST01 6. F482 7. BR03 8. T004 9. T005 <p>During this inspection, all Class II vehicles inspected were found to be following MSRPH 3.126. The vehicles were properly chocked and not fouling any other tracks. An exit briefing was not conducted at the conclusion of the inspection.</p> <div style="text-align: center; margin-top: 10px;">
