Inspection Form

Washington Metrorail Safety Commission

Inspection Date	YYYY	MM	DD	Report Number	20210325-WMATA-LBW-1		
	2021	03	25				
Rail Agency Name	Washington Metropolitan Area Transit Authority			Rail Agency Department	ATC	Sub-Department	Operations
Rail Agency Department Contact Information	Name		Email		Office Phone		Mobile Phone
	[REDACTED]		[REDACTED]		[REDACTED]		[REDACTED]
Inspection Location	BRAVO Line - Union Station (B03), NOMA Gallaudet (B35) and Rhode Island Ave (B04)

Inspection Activity #	1	Inspection Subject	Train speed command verification				Activity Code	RTRA	RI	OBS	
Job Briefing Employee Name/Title	N/A		Accompanied Inspector?	No	Out Brief Conducted	No	Time	1200	Outside Shift	Yes	
Related Reports	N/A		Related CAPS / Findings								
Related Rules, SOPs, Standards, or Other	Ref		Rule or SOP		Standard		Other / Title		Checklist Reference		
Inspection Location	Main Track	Yard	Station	OCC	RTA Facility	WMSC Office	Track Type	At-grade	Tunnel	Elevated	N/A
	X							X	X	X	
Line(s)	BRAVO	Track Number	1 & 2	Chain Marker and/or Station(s)	From			To			
					NA			NA			
Vehicles	Head Car Number		Number of Cars		Equipment

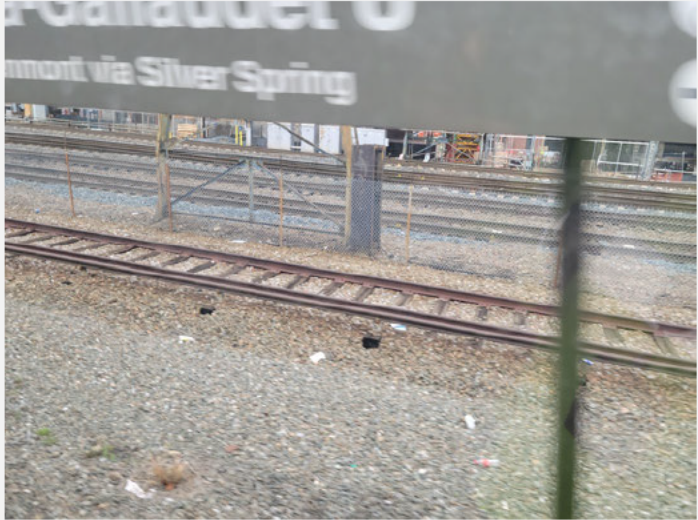
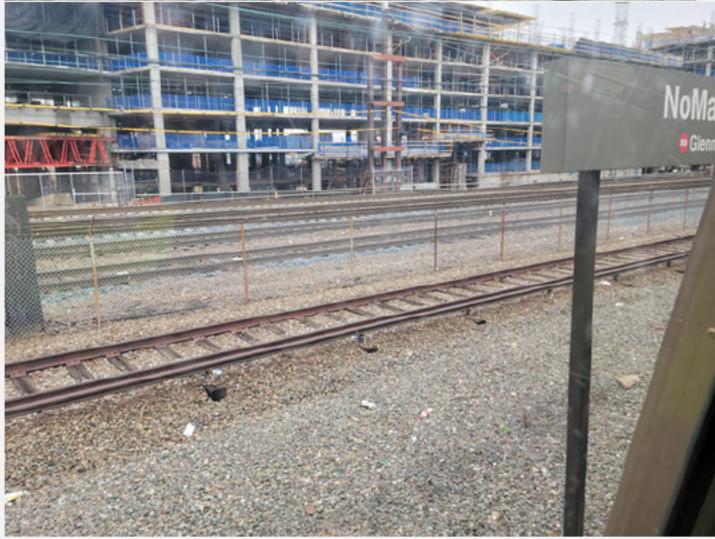
Description	<p>The WMSC Inspector conducted a riding inspection on the BRAVO line between Union Station (B03), NOMA Gallaudet (B35) and Rhode Island Ave (B04). This inspection resulted from a SAFE I-3 notification (A collision involving a rail vehicle on the mainline, yard or shop that does not result in a fatality, serious injury or substantial property damage. Not involving another rail vehicle) received Thursday, February 11, 2021. The WMSC received notification that at approximately 14:35 hours: Train #106 reported making contact with a CSX fence as it proceeded through Brentwood Yard (B99) territory on track #1. This incident led to the WMSC identifying the lack of an intrusion detection warning system between Union Station and Rhode Island Avenue in the common corridor shared with Amtrak/CSX.</p>	Number of Defects	0

Remedial Action Required?	No
	<p><i>A common corridor is a shared transportation Roadway such as where Metrorail runs in the median strip of an interstate highway or adjacent to or between railroad tracks.</i></p> <p><i>An Intrusion Detection and Warning System consists of breakable cables which are attached to the chain link fences which separate the Metrorail Tracks, Railroad Tracks, or Vehicle Traffic Road, along the Metrorail Roadway. The IDW system will indicate the location of an intrusion of WMATA Equipment, Railroad Equipment, or Road Vehicles which impact</i></p>	Recommended Reinspection?	No

or penetrate the fence and intrude into the Roadway of the other. In addition, the IDW will initiate zero Speed commands in the affected area to stop trains in the immediate vicinity.

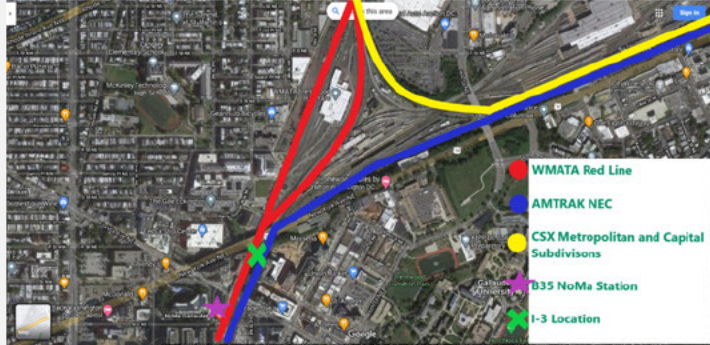
The WMSC inspector was verifying the implantation of reduced train speed commands on track 1 between B03 and B04. During the inspection train speeds were verified on both tracks 1 and 2. The inspector notified the Rail Operations Control Center (ROCC) via telephone prior to performing the riding inspection. The inspector contacted each train operator (T/O) after the train stopped and opened the train doors to service the station. Due to social distancing, the WMSC inspector did not enter the operator’s cab area and verified all readouts through the T/O door.

<p>At B1 129+00 increases to 28mph Increases to 50 entering Rhode Island Ave Station</p> <p>The WMSC inspector verified that WMATA Automatic Train Control (ATC) turned the speed couplers thereby reducing the speed commands to no greater than 35mph on the BRAVO line track 1 between Union Station (B03) and Rhode Island Ave (B04)</p>		
Remedial Action	N/A
