## Inspection Form

Washington Metrorail Safety Commission

<b>Inspection Date</b>	YYYY	MM	DD	<b>Report Number</b>	20210423-WMATA-LBW-1		
	2021	04	23				
<b>Rail Agency Name</b>	Washington Metropolitan Area Transit Authority			<b>Rail Agency Department</b>	Operations	<b>Sub-Department</b>	Vehicles
<b>Rail Agency Department Contact Information</b>	<b>Name</b>		<b>Email</b>		<b>Office Phone</b>		<b>Mobile Phone</b>
	[REDACTED]		[REDACTED]		[REDACTED]		[REDACTED]
<b>Inspection Location</b>	Alexandria Yard – Tracks 23 and Track 24

<b>Inspection Activity #</b>	1	<b>Inspection Subject</b>	Storing Class I Vehicles – Alexandria Yard			<b>Activity Code</b>	RTRA	GEN	OBS		
<b>Job Briefing Employee Name/Title</b>	Alexandria Interlocking Operator		<b>Accompanied Inspector?</b>	NA	<b>Out Brief Conducted</b>	NA	<b>Time</b>	1120	<b>Outside Shift</b>	Yes	
<b>Related Reports</b>	20210204-WMATA-LBW-2		<b>Related CAPS / Findings</b>		FTA-VSC-16-001 (Closed)						
<b>Related Rules, SOPs, Standards, or Other</b>	Ref		Rule or SOP		Standard		Other / Title		Checklist Reference		
			OR-3.126								
<b>Inspection Location</b>	Main Track	Yard	Station	OCC	RTA Facility	WMSC Office	<b>Track Type</b>	At-grade	T

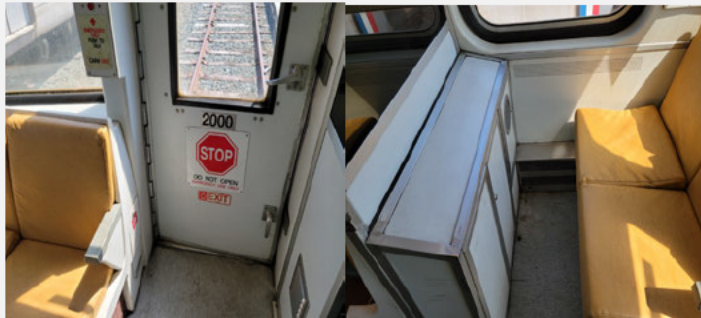
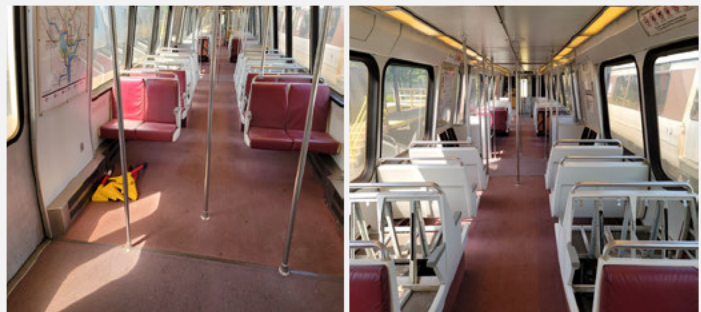
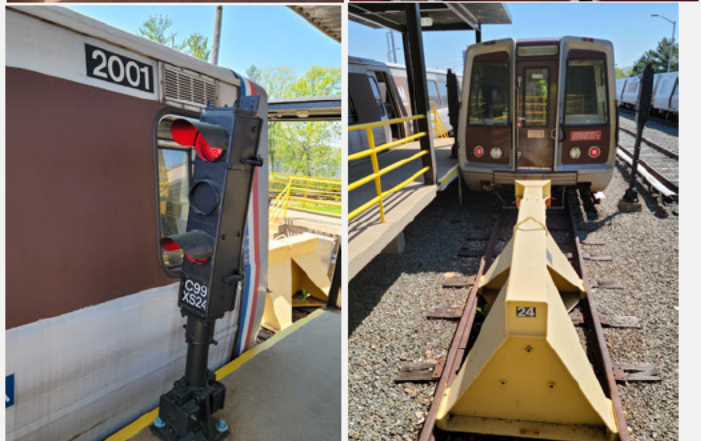
<p>were observed in the Greenbelt Yard without handbrakes, wheel chocks or blue flagging protection which violates Operating Rule 3.126. Rail vehicles are required to be properly stored to prevent unintended train movement. Metrorail was previously issued findings that resulted in a corrective action, (FTA-VSC-16-001 - Closed), by the Federal Transit Administration (FTA) for rail vehicle securement practices at the Washington Metropolitan Area Transit Authority (WMATA) Metrorail system.</p> <p><b>(MSRPH) rule 3.126 states:</b> (a) Secure cars being stored a minimum distance of two (2) feet apart at all storage locations, yards and/or tail tracks; (b) Set handbrakes on at least two cars; (c) Set a sufficient additional number of handbrakes for the grade on which the cars are being stored; (d) Ensure that the cars being stored are not fouling other tracks; and (e) If the consist is to be stored for more than 15 days, the consists shall be chocked and blue flagged.</p> <p>The WMSC inspector conducted a briefing with the Alexandria Yard interlocking operator and a second briefing with the WMATA employee that assisted with verifying the status of the handbrakes.</p> <p>The WMSC inspector conducted a visual inspection of the class I vehicles that were stored in Alexandria Yard on tracks 23 and 24. Before contacting the Alexandria Yard interlocking operator, a two-car consist on track 24 and four-car consist stored on track 23 were inspected.</p> <p>The inspector boarded car 2001 on track 24. All handbrake compartments were closed indicating that the holding brakes were not applied. Wheel chocks were located inside of rail car 2000 adjacent to the number 2 door, but no chocks were installed on the exterior of the consist. The inspector inspected rail car 2062 located on storage track 23. The handbrake compartment doors were open, but the handbrake did not appear to be applied. The left front seat well of rail car 2062 was observed open. This is an indication that the friction brakes might be cut out.</p> <p>The inspector went to the Interlocking operator office to inquire about the status the stored vehicles on track 23 and 24 and was informed that handbrakes were applied. The vehicle on track 24 was identified as last being utilized as a de-icing train. The vehicle was identified as not moving in over a week after having the de-icing equipment removed.</p> <p>The inspector returned to track 24 with a Rail Transportation (RTRA) employee. The rail vehicle on track 24 was keyed up to identify if a handbrake was applied. The RTRA employee was able to receive a "brakes off" which is an indication that no handbrakes were applied to the consist. The vehicle on track 23 had open seat wells which is a possible indication of friction brakes being cut out. When 2062 was keyed up, the train console did not have the "Brakes On" indicator illuminated. This indicates that at least one friction brake was cut out on this consist. Rail vehicle 2062 was also able to get the "brakes off" light to illuminate. This indicates that NO handbrakes were applied on the consist on track 23. The handbrake compartments of 2062 were left open, but the holding brakes were not applied. The open handbrake compartment door gave the appearance that the handbrakes were applied.</p>	<p><b>Recommended Finding?</b></p> <hr/> <p><b>Remedial Action Required?</b></p> <hr/> <p><b>Recommended Reinspection?</b></p>	<p></p> <p>Yes</p> <p></p> <p>Yes</p>

During this inspection of Alexandria Yard, the WMSC inspector observed Class I vehicles stored without handbrakes, wheel chocks or blue flagging protection. **This is a violation of the requirement as written in the rule. This requirement needs to be emphasized to all responsible personnel for compliance, at all applicable Metrorail yards, to prevent repeat observations of the same noncompliant condition, noted here.**
