**WMSC Commissioner Brief: W-0100 – Improper Roadway Worker Protection – U Street Station – February 5, 2021**

**FINAL REPORT OF INVESTIGATION A&I E21050**

<b>Date of Event:</b>	2/5/2021
<b>Type of Event:</b>	Improper Roadway Worker Protection
<b>Incident Time:</b>	02:00 hours.
<b>Location:</b>	U Street-Cardozo Station, Track 1, and Track 2
<b>Time and How received by SAFE:</b>	10:22 hours. SAFE On-call Phone
<b>WMSC Notification Time:</b>	12:13 hours.
<b>Rail Vehicle:</b>	None
<b>Injuries:</b>	None
<b>Damage:</b>	None
<b>SMS I/A Incident Number:</b>	20210205#91704

U Street-Cardozo Station  
Improper Roadway Worker Protection  
February 5, 2021

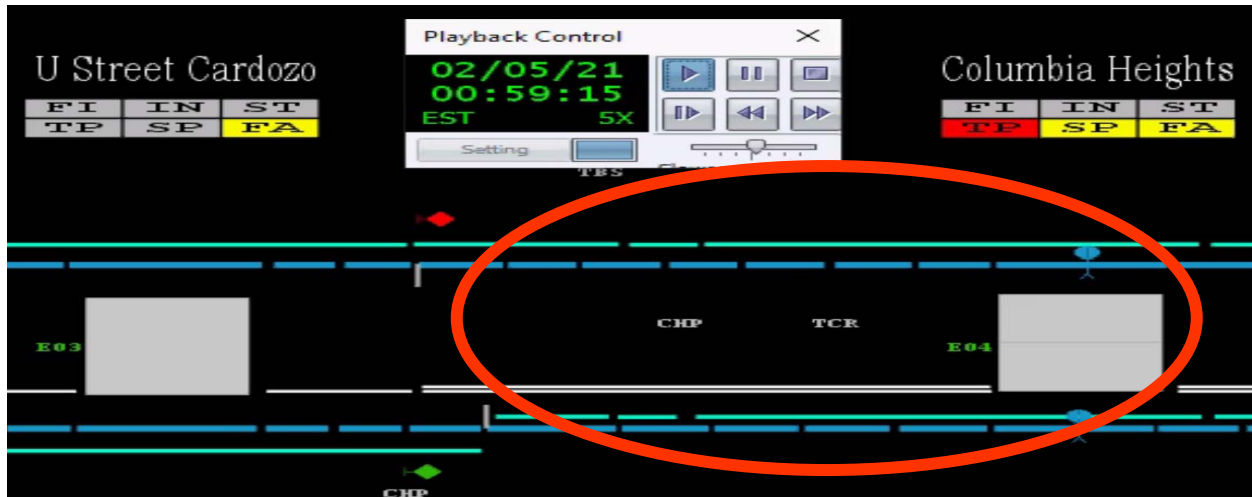
Diagram 1 - Based on the AIMS, at 00:59:15 hours, prohibit exits, block calls, cancellation of automatic signals, blue block, and human form status were in place before the RWIC entered the roadway to hot stick and confirm that third rail power was de-energized between U Street-Cardozo Station and Columbia Heights Station, Track 1 and Track 2.

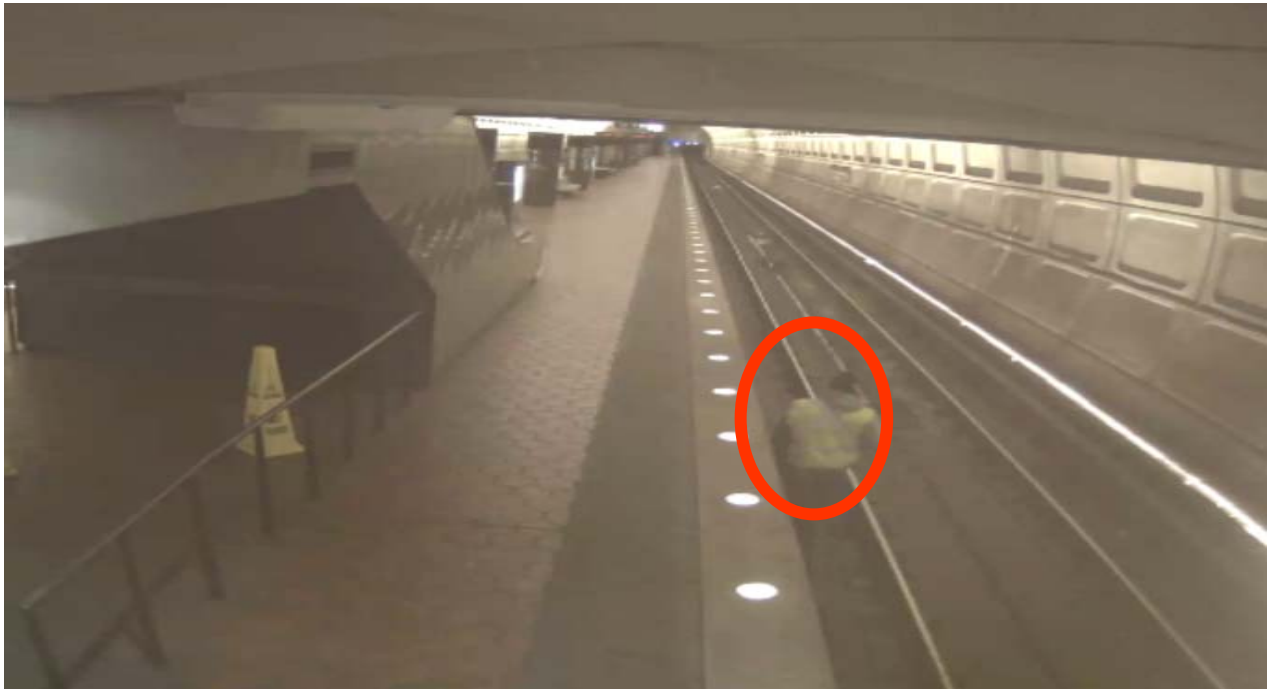
*Figure 1 - Based on the CCTV, at 02:00:21 hours, a piggybacking work crew member representing TRST entered the U Street-Cardozo Station roadway to perform cleaning efforts and was not wearing a hardhat while on WMATA's roadway.*

- Based on CCTV footage, a piggyback work crew member was identified on CCTV not wearing a hardhat while on WMATA's roadway. This action was not in compliance with MSRPH 5.11, "Personal Protective Equipment Standard for On-Track Safety."

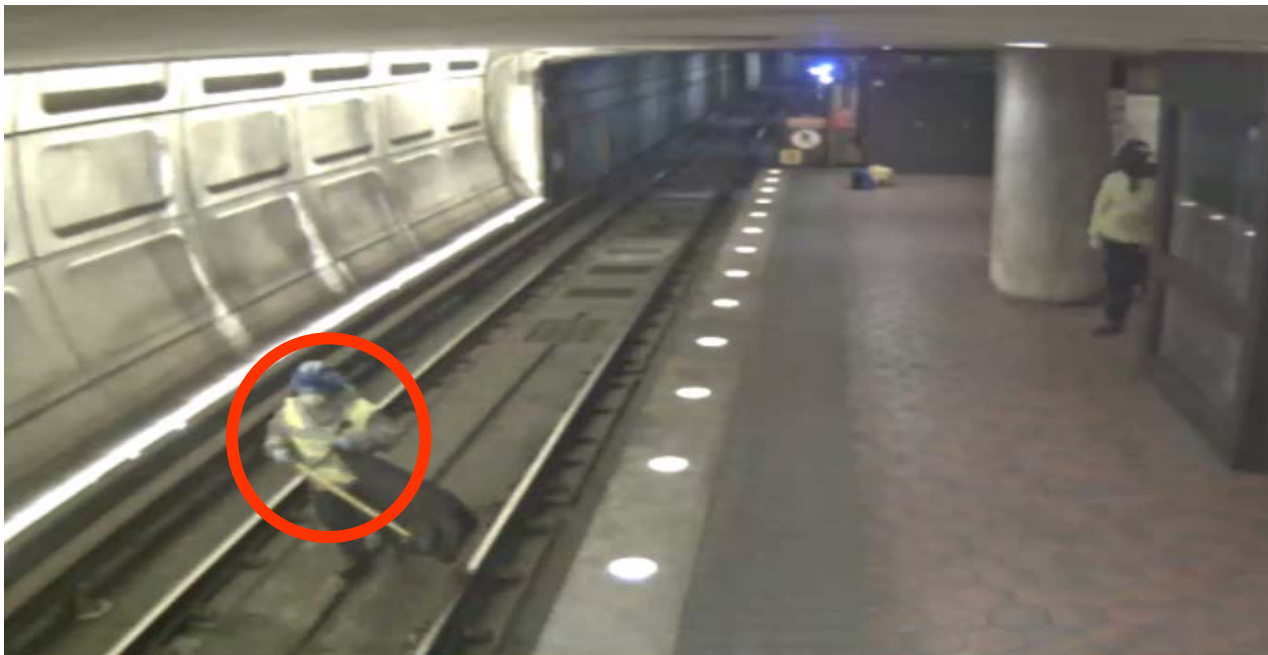
*Figure 2 - Based on the CCTV, at 02:00:40 hours, a piggybacking work crew entered the roadway without participating in the RSJB before requesting permission from the RWIC to enter their working limits.*

- The RWIC allowed the piggyback work crew to enter the roadway within the working limits of the RWIC without having the piggyback work crew participate in their RJSB. This action was not in compliance with MSRPH, 5.15, Piggybacking Responsibilities.

- Based on CCTV footage, the piggyback work crew entered the U Street-Cardozo Station roadway to perform cleaning efforts before the Crew Leader requested permission from the RWIC to enter the working limits. This action was not in compliance with MSRPH Section 5.15 - Piggybacking.

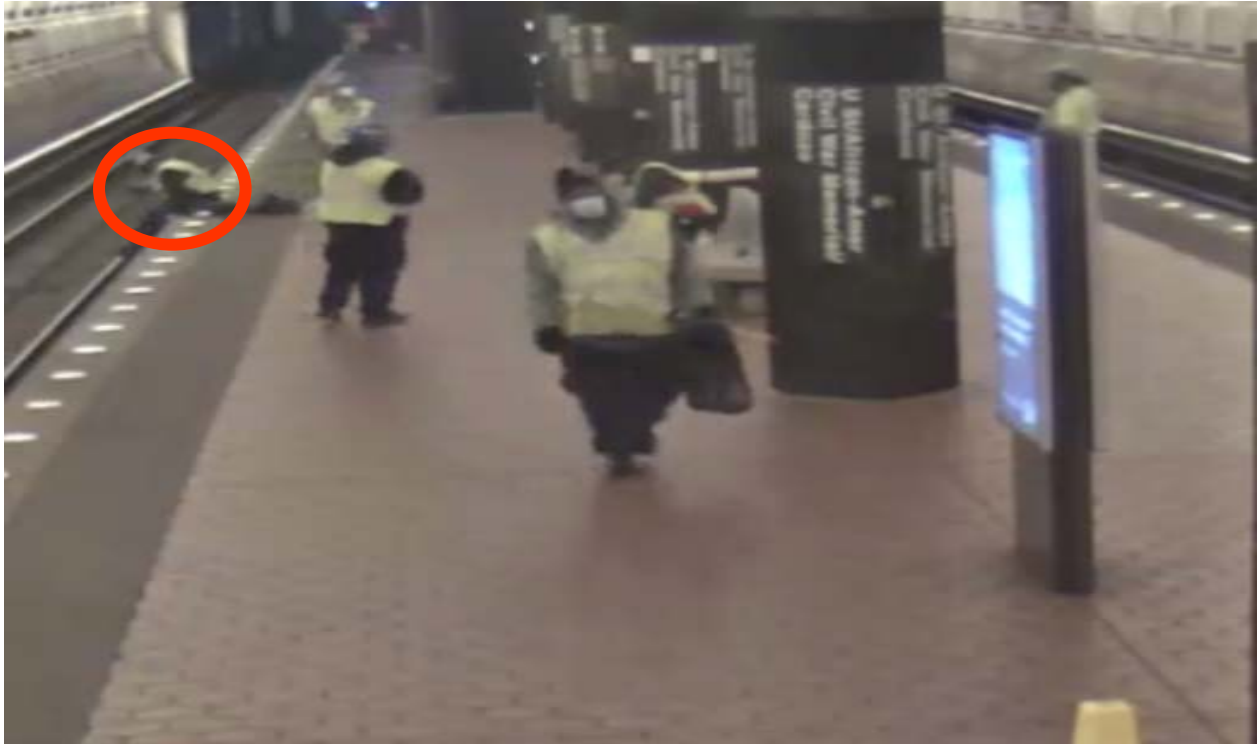
Figure 3 - Based on the CCTV, at 02:05:29 hours, a member from the piggybacking work crew jumped from the station platforms without using an appropriate means of descent.

- Based on CCTV footage, a piggyback work crew member was identified on CCTV jumping from the station platforms without using an appropriate means of descent. This action was not in compliance with MSRPH, 4.186. Employees shall not jump from vehicles, station platforms, or elevated structures, but shall use an appropriate means of descent.

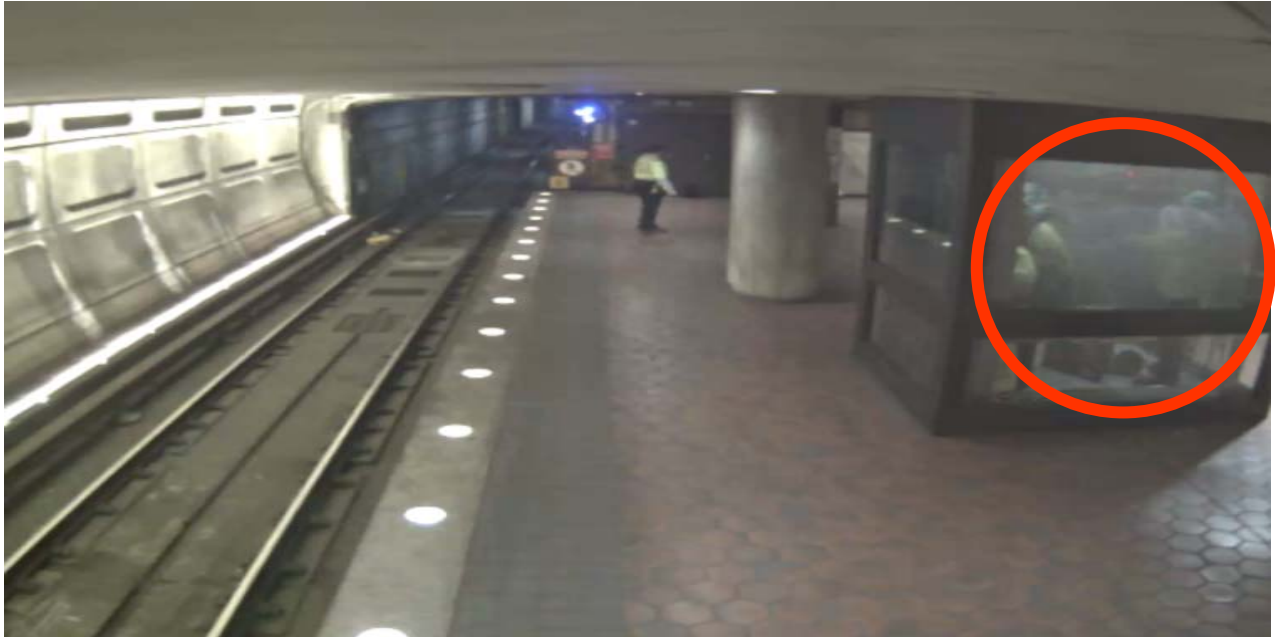
Figure 4 - Based on the CCTV, at 02:41:23 hours, the piggybacking work crew cleared the roadway and departed U Street-Cardozo Station.
