**WMSC Commissioner Brief: W-0110 – Improper Roadway Worker Protection – Naylor Road/Southern Ave stations
– April 28, 2021**

FINAL REPORT OF INVESTIGATION A&I

Southern Avenue Station – Improper Roadway Worker Protection

April 28, 2021

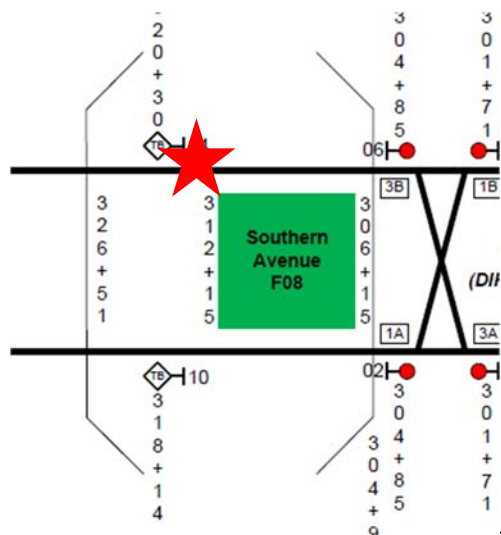
Field Sketch/Schematics

Southern Avenue Station, Track 2

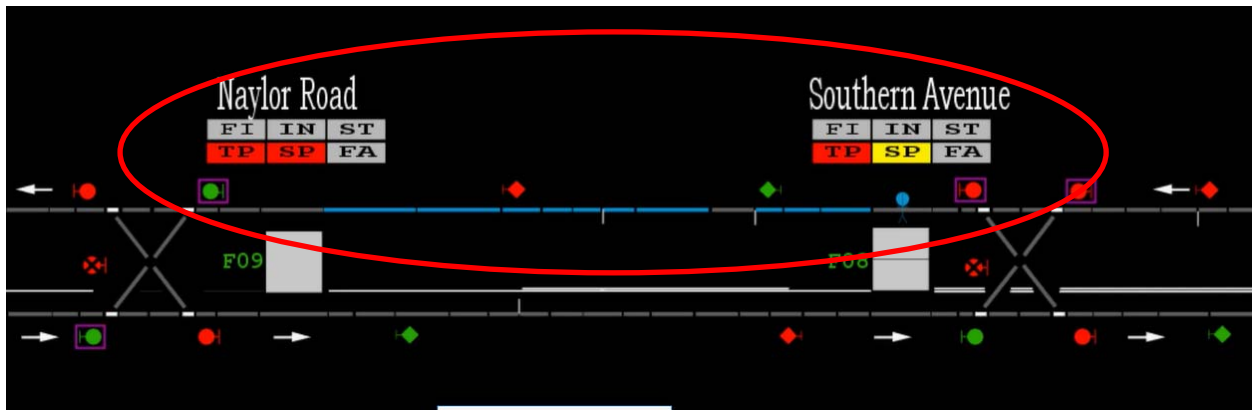
Diagram 1: FT protection provided at Southern Avenue Station.

10:20:10 hours	<u>Radio RTC</u> : Acknowledged and reminded RWIC to remain vigilant. (audio distorted). [Radio]
10:33:39 hours	<u>RWIC</u> : Requested FT from F2-344+00 to F2-323+00

10:34:19 hours	<u>Radio RTC</u> : Granted FT to RWIC and instructed RWIC to notify when FT was relinquished. [Radio]
10:34:33 hours	<u>RWIC</u> : Acknowledged FT was granted. [Radio]

10:34:55 hours	<u>RWIC</u> : Contacted AMF1 to acknowledge FT was granted. [Radio]
10:36:54 hours	<u>RWIC</u> : Relinquished FT and back under AMF protection. [Radio]

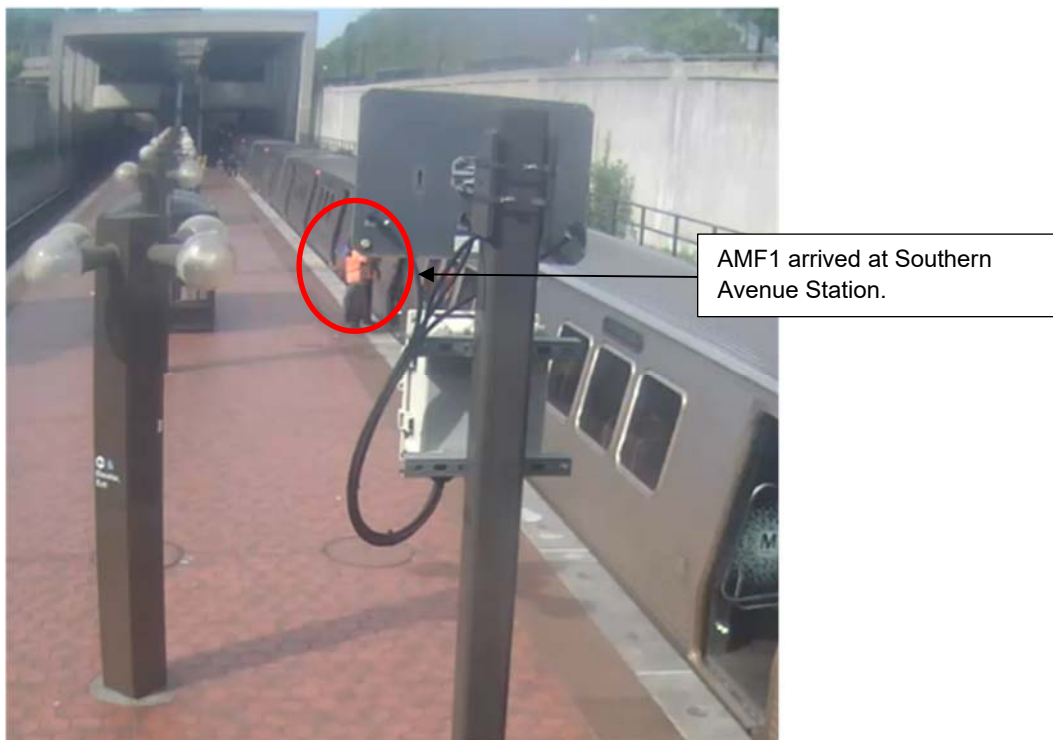
Figure 1: This image shows when AMF1 arrived at Southern Avenue Station at approximately 09:51 hours.

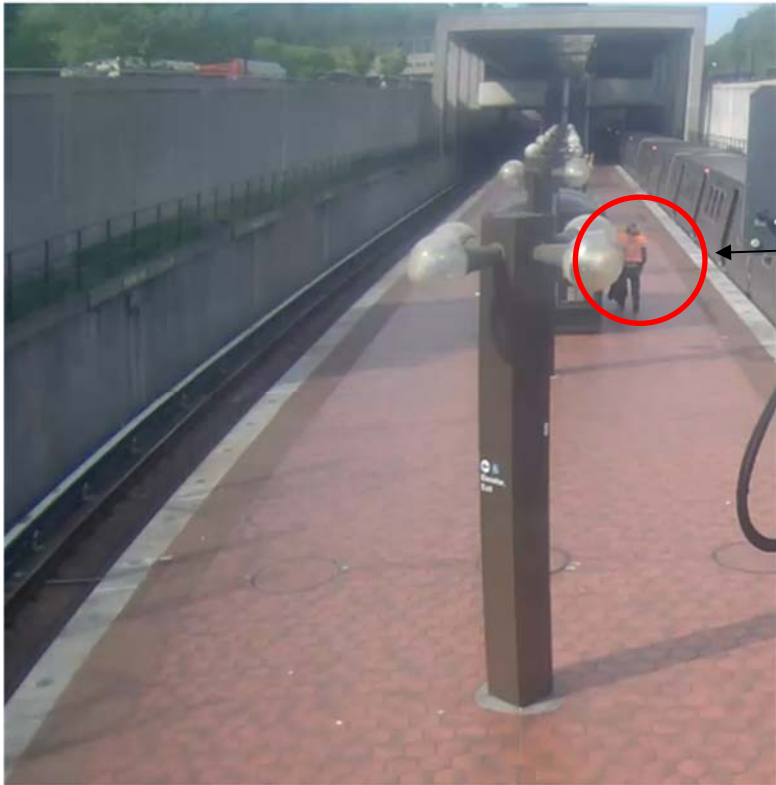
Figure 2: This image shows AMF1 walking into the shelter at approximately 09:52 hours.

At approximately 10:20 hours, the RWIC notified the Radio RTC that the crew was safely on the platform at Naylor Road Station and wanted to proceed to Southern Avenue Station, Track 2, under AMF protection. The Radio RTC granted the RWIC permission to proceed with the track inspection to Southern Avenue Station and advised to stay vigilant. The RWIC failed to radio AMF1 to confirm they were in place for AMF duties. Prior to the RWIC's arrival at Naylor Road Station, Closed-Circuit Television (CCTV) footage showed that AMF1 arrived at Southern Avenue Station and entered a shelter on the platform. AMF1 remained in the shelter until the inspection

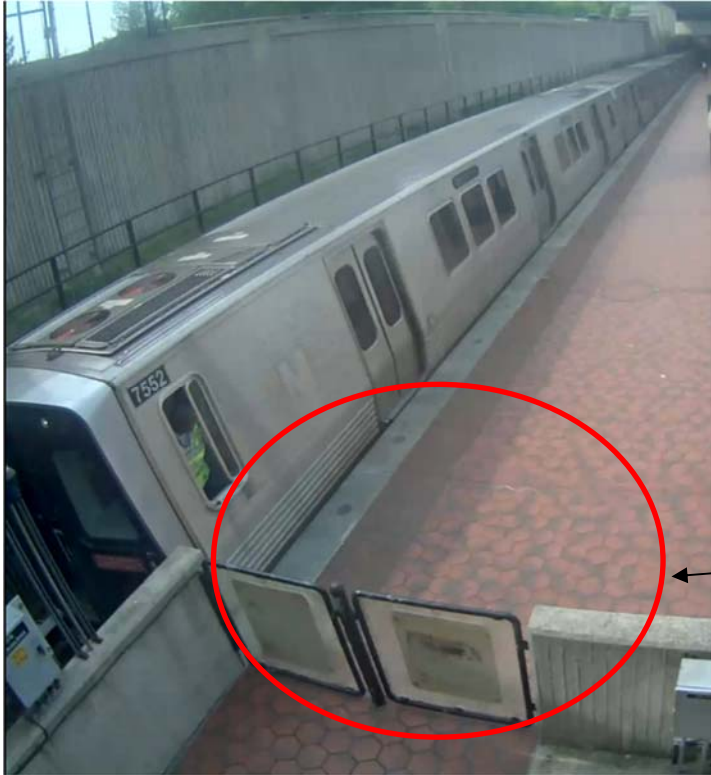
Figure 3: This image shows the train that passed at approximately 10:25 hours during the time the AMF was assigned AMF duties.

Crew arrived on the platform. At approximately 10:25 hours, Train ID # 510 arrived at Southern Avenue Station, boarded passengers, and proceeded without receiving any instructions from AMF1.

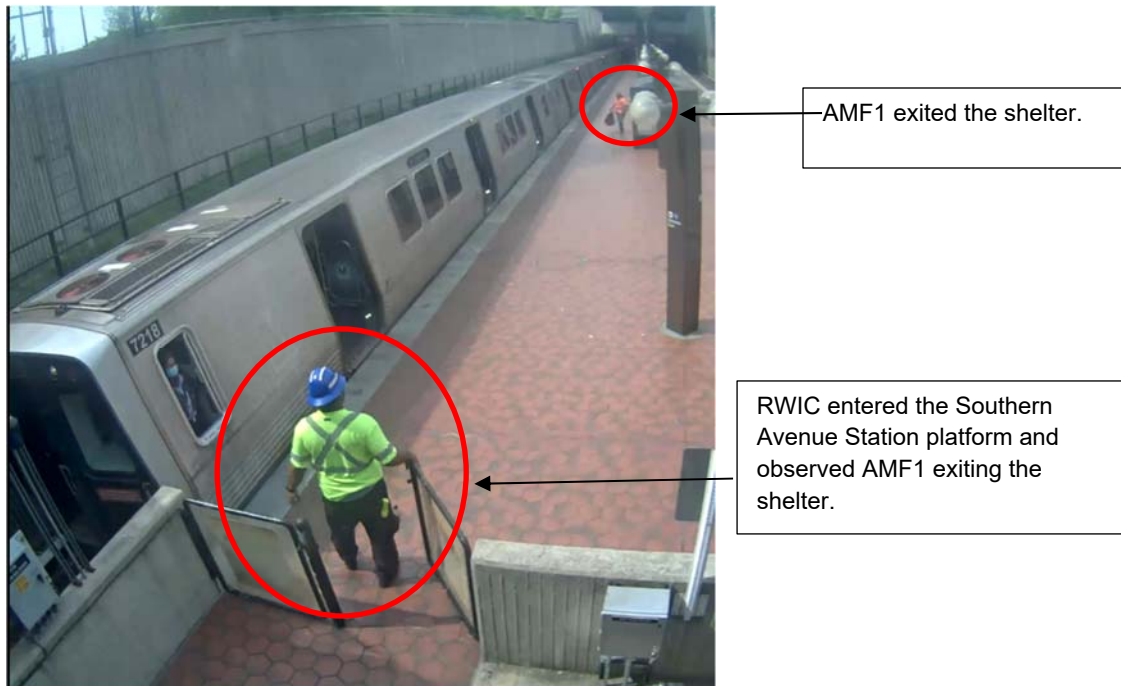
Figure 4: This image shows the RWIC entered the station platform after completing the track inspection at approximately 10:45 hours and noticing AMF1 exiting the shelter and not positioned at the 8-car marker.
