WMSC Commissioner Brief: W-0126 – Evacuation for Life-Safety Reasons – Metro Center Station – July 4, 2021

Washington Metro Area Transit Authority
Department of Safety and Environmental
Management (SAFE)
FINAL REPORT OF INVESTIGATION A&I E21277

Metro Center Station
Evacuation for Life Safety Reasons
July 4, 2021

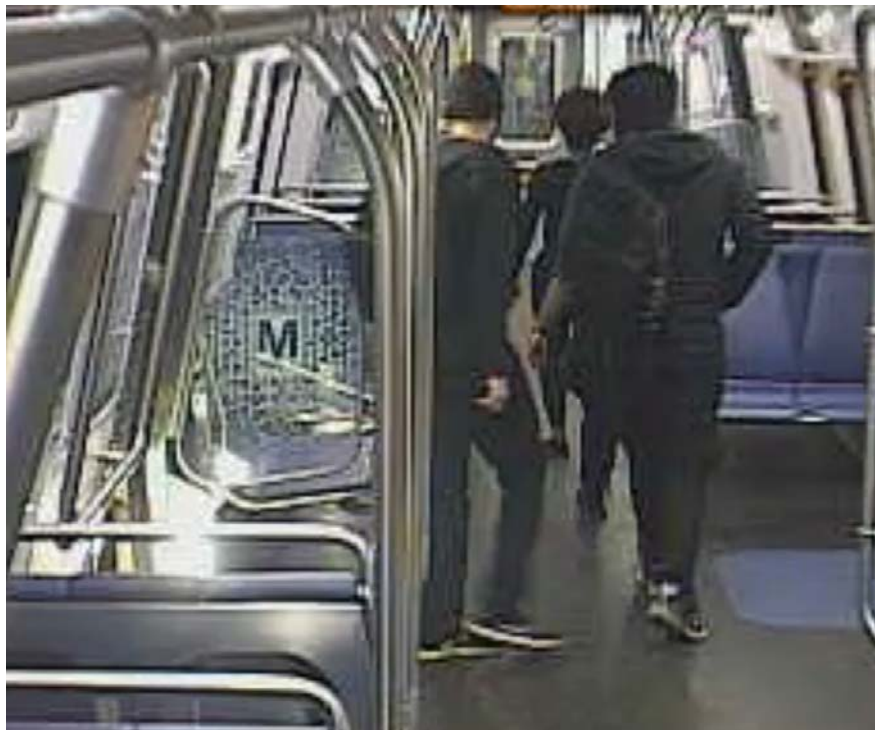
Figure 1 - Based on the railcar video, four customers dressed in all black boarded the middle of the railcar on Train ID 113, Car 7339.

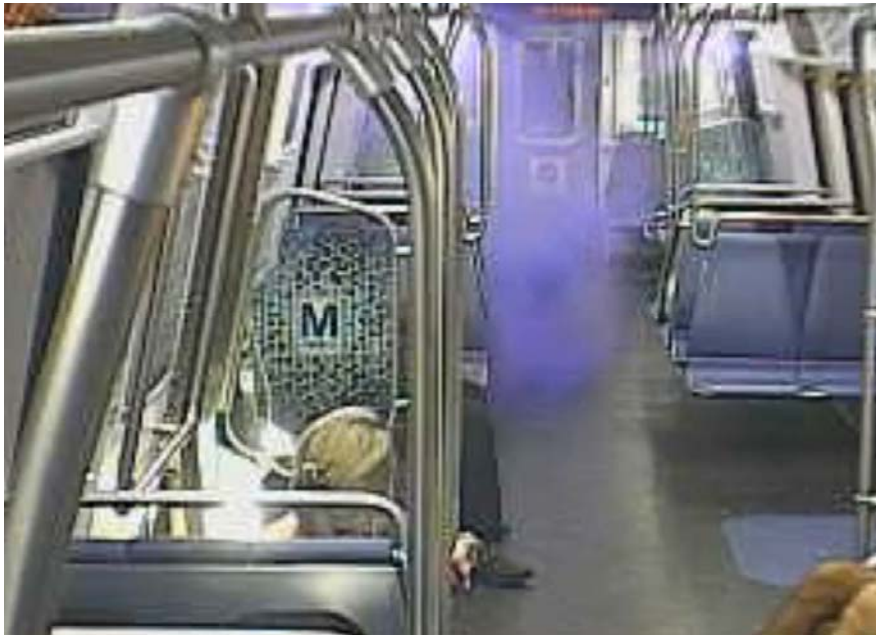
Figure 2 - Based on the railcar video, someone in the group of four customers dressed in all black ignited a purple-colored smoke bomb, a type of firework, then they all departed Car 7339.

- Based on the railcar video, someone in the group of four customers dressed in all black had lit a purple-colored smoke bomb, a type of firework, then they all departed Car 7339.

The probable cause of the Evacuation for Life Safety Reasons event on Train ID 113 at Metro Center Station was intentional action (vandalism) by a group of individuals igniting a purple-colored smoke bomb, a type of firework, on Car 7339 that resulted in smoke emitting from Car 7339.

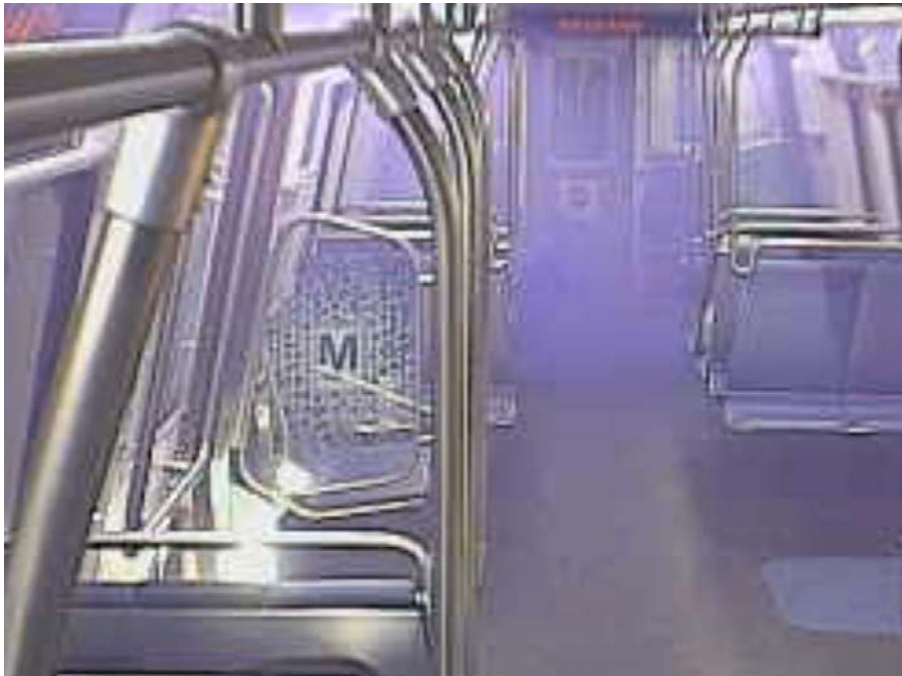
Figure 3 - Based on the railcar video, Train ID 113 was offloaded at Metro Center Station, Track 1.
