WMSC Commissioner Brief: W-0131 – Improper Roadway Worker Protection – Fort Totten Station – August 12, 2021

FINAL REPORT OF INVESTIGATION A&I E21362

Fort Totten Station – Improper Roadway Worker Protection

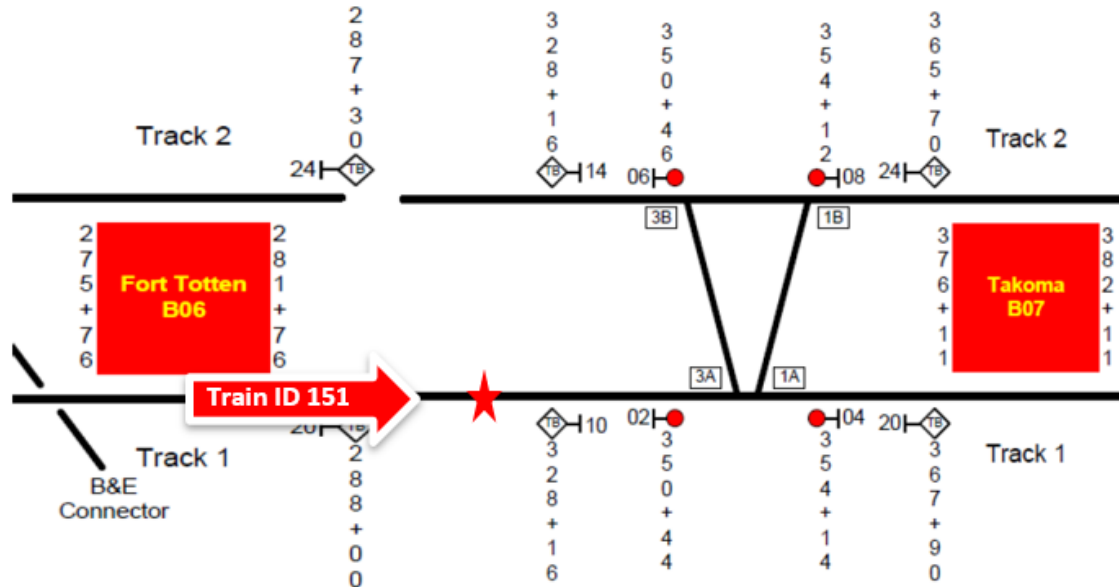
Field Sketch/Schematics

Fort Totten Station, Track 1 (Location of Train ID 151 at the time FT was granted).

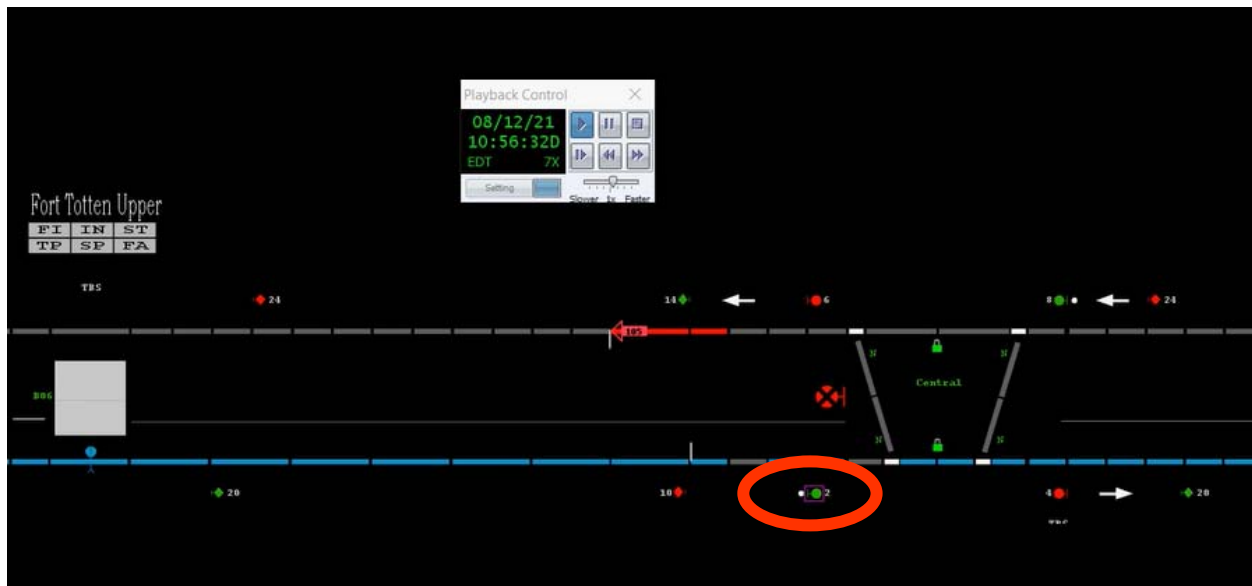
Image 1 – AIMS display after ROCC granted permission for Mobile Work Crew to enter the roadway.

At approximately 10:49 hours, the Mobile Work Crew arrived at Chain Maker (CM) B1 350+00 (between Takoma Park and Fort Totten Stations), the RWIC contacted ROCC and requested FT protection to inspect between CM B1 350+00 and 339+00, a hot spot area identified in the Track Access Guide. ROCC instructed the Mobile Work Crew to standby and stand clear for train movement. At approximately 10:56 hours, the Radio RTC granted permission to the TRST personnel to continue their inspection under FT protection. The AMF located at Fort Totten Station transmitted that they were holding trains at Fort Totten Station, track 1.

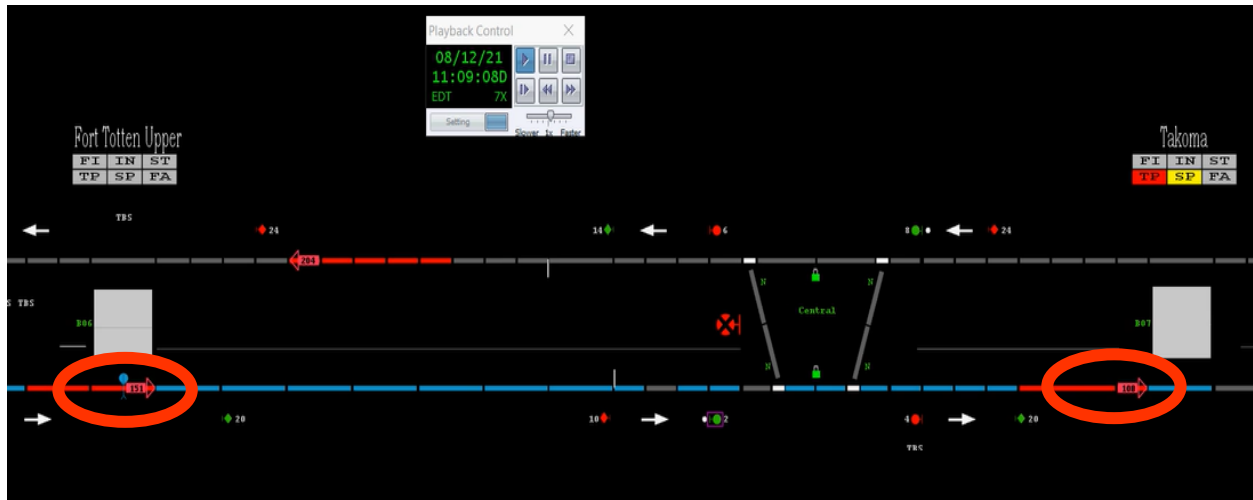
Image 2 – AIMS display depicting Train ID 108 passing the Mobile Work Crew and Train ID 151 on the platform at Fort Totten Station.

At approximately 11:01 hours, the RWIC requested FT again between CM B1 325+00 to 305+00. The Radio RTC instructed the Mobile Work Crew to standby and stand clear for train movement. The AMF located at Fort Totten Station acknowledged that the Mobile Work Crew was under AMF protection. The Radio RTC instructed the RWIC to notify ROCC when the train had passed their location. At approximately 11:09 hours, the RWIC notified the Radio RTC that the train had passed their location.

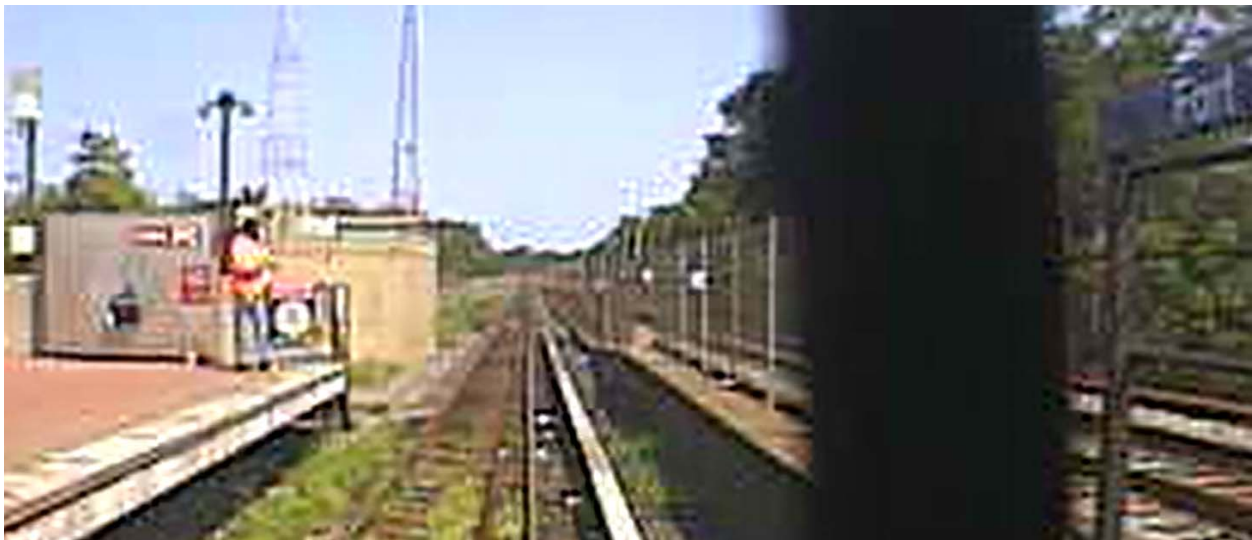
Image 3 - Train ID 151 arriving at approximately 11:09 hours, on the platform at Fort Totten Station with the AMF in place.

At approximately 11:09 hours, Train ID 151 arrived at Fort Totten Station, track 1 where the Train Operator encountered the AMF.

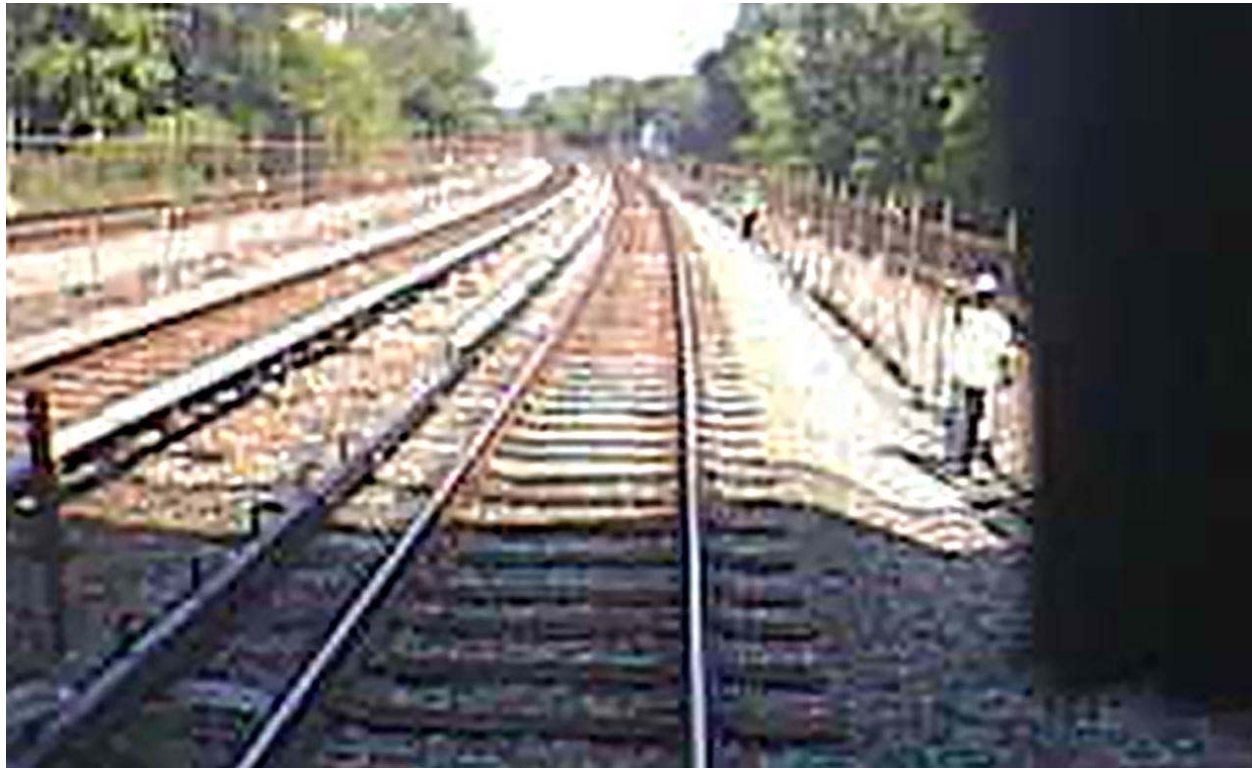
Image 5 – Train ID 151 passing roadway workers who are in a place of safety

Seconds after FT was granted, multiple transmissions were made by various department personnel causing the inability of the Student Radio RTC to quickly renege the granted foul time, and to allow the RWIC to notify the AMF located at Fort Totten Station to hold the trains. Once there was a break in transmissions, the Student Radio RTC attempted to contact the RWIC to clear the roadway and the AMF attempted to ascertain the status of the FT of the Mobile Work Crew. The Student Radio RTC informed the RWIC to standby and stand clear for train movement in their area after granting foul time.
