WMSC Commissioner Brief: W-0171 – Improper Roadway Worker Protection – Rosslyn Station – February 15, 2022

Washington Metro Area Transit Authority
Department of Safety – Office of Investigations (OSI)
FINAL REPORT OF INVESTIGATION A&I E22104

Rosslyn Station – Improper RWP

February 15, 2022

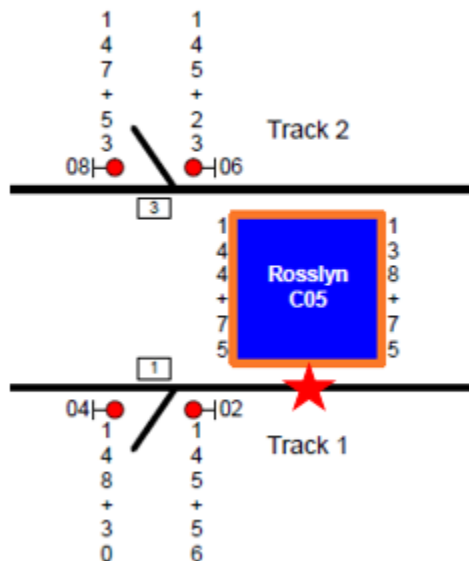
Field Sketch/Schematics

**Locations are approximate. Not to scale.*

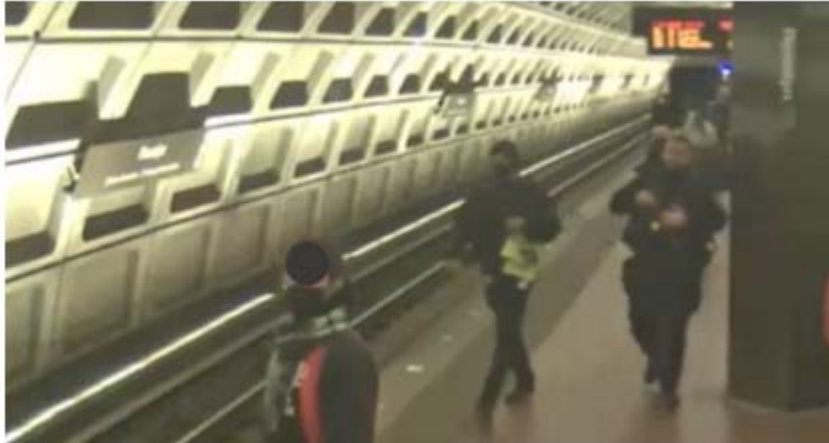
Image 1 – RTRA Rail Supervisor arriving at Rosslyn Station platform with MTPD.

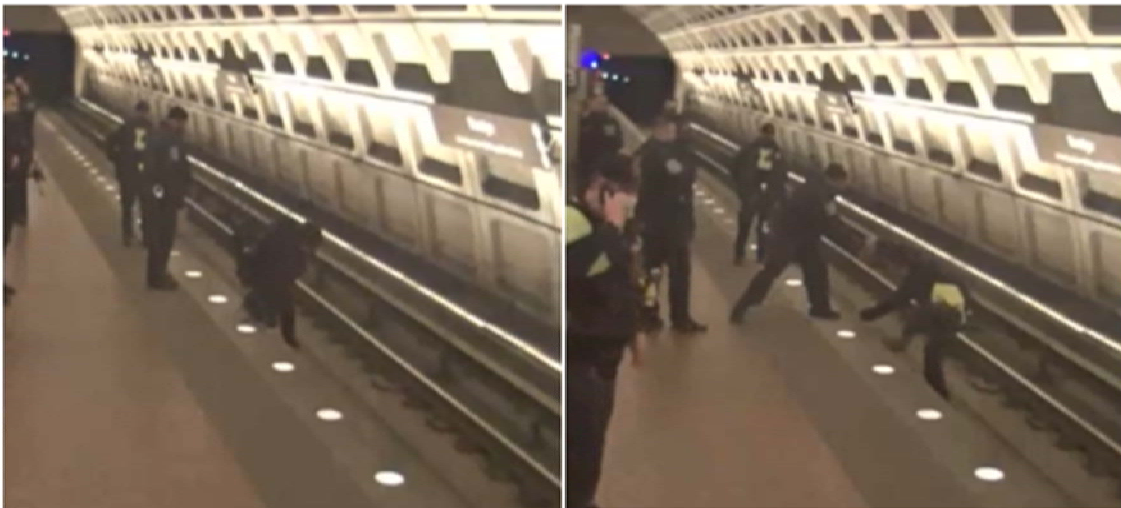
At approximately 17:31 hours, after the third train passed, the RTC granted foul time, permitting the Rail Supervisor to enter the roadway and retrieve the item. The Rail Supervisor entered the roadway in the middle of the platform with their safety vest attached to their backpack. At approximately 17:32 hours, the Rail Supervisor relinquished their foul time.

Image 2 - RTRA Rail Supervisor entering the roadway under foul time, and the Rail Supervisor returning to the platform.

The Rail Supervisor had sufficient time (approximately 6 minutes) to prepare to enter the roadway with the required personal protective equipment; as they arrived at the platform at 17:24 hours, and the third train passed their location at approximately 17:30 hours before ROCC granted foul time.

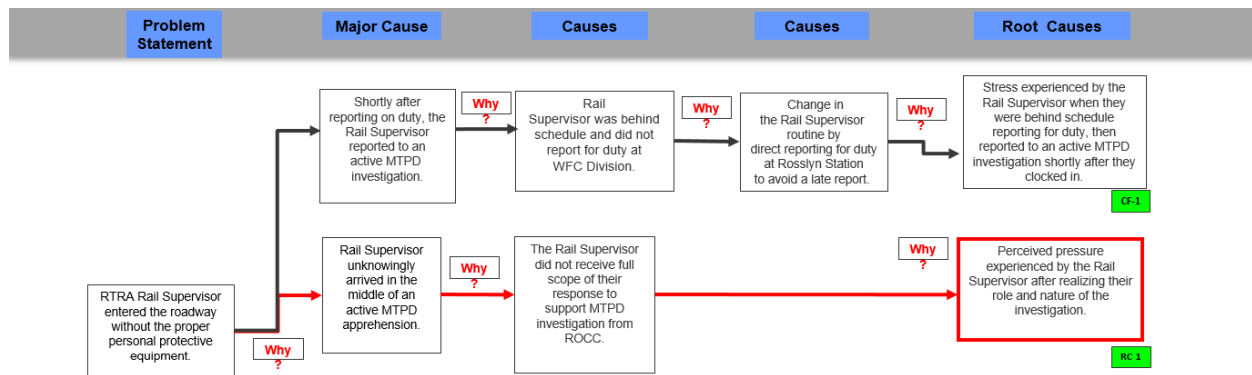
Appendix C - Root Cause Analysis

The probable cause of the Improper RWP event on February 15, 2022, was the Rail Supervisor did not consider the full scope of their response to support an MTPD investigation from ROCC. A potential contributing factor to the incident was the pressure sustained by the Rail Supervisor when they arrived in the middle of an active MTPD apprehension on the platform at Rosslyn Station.

Additionally, the stress experienced by the Rail Supervisor also contributed when they were behind schedule reporting for duty, then reported to an active MTPD investigation shortly after starting their shift.

Corrective Action Code	Description	Responsible Party	Due Date
98512_SAFE CAPS_RTRA_001	RTRA to distribute a Supervisor Notification relating to the Importance of Safety Vest.	RTRA	Completed
98512_SAFE CAPS_RTRA_002	Develop a policy/procedures specific to Rail Supervisors that detail instructions for Rail Supervisors reporting for daily duty.	RTRA	09/30/2022
98512_SAFE CAPS_RTRA_003	Develop a policy/procedures specific to Rail Supervisors authorized to use their personal vehicles to direct report and clock in for duty at various locations.	RTRA	09/30/2022
98512_SAFE CAPS_RSSC_001	Update to MSRPH regarding use of personal cellular phones to conduct WMATA matters.	RSSC	09/30/2022
98512_SAFE CAPS_MTPD_001	Develop additional Roll Call Meeting notes specific to roadway access violations and reporting.	MTPD	Completed
