**WMSC Commissioner Brief: W-0182 – Improper Roadway Worker Protection – Metro Center Station – May 3, 2022**

Washington Metro Area Transit Authority  
Department of Safety and Environmental  
Management (SAFE)  
**FINAL REPORT OF INVESTIGATION A&I E22270**

# Medical Center Station – Improper Roadway Worker Protection (RWP)

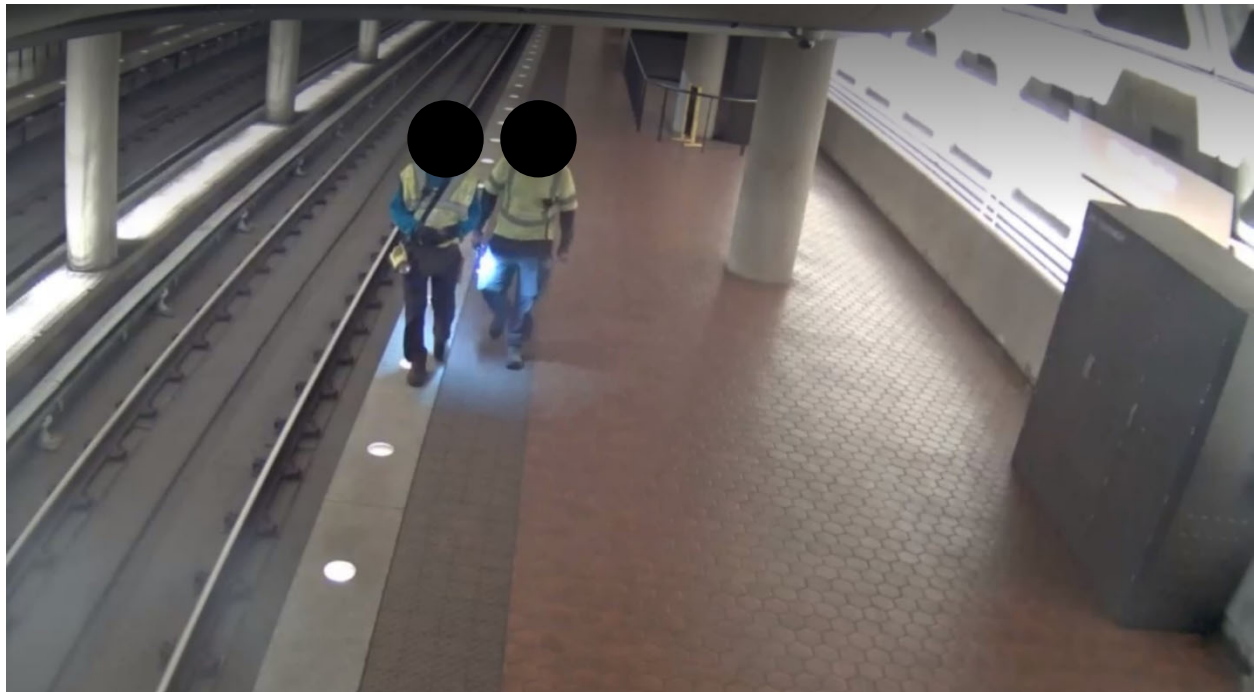
Figure 5 – TRST personnel conducting a track inspection via the Metro Center Station platform, Track 1, at approximately 09:40:01 hours.

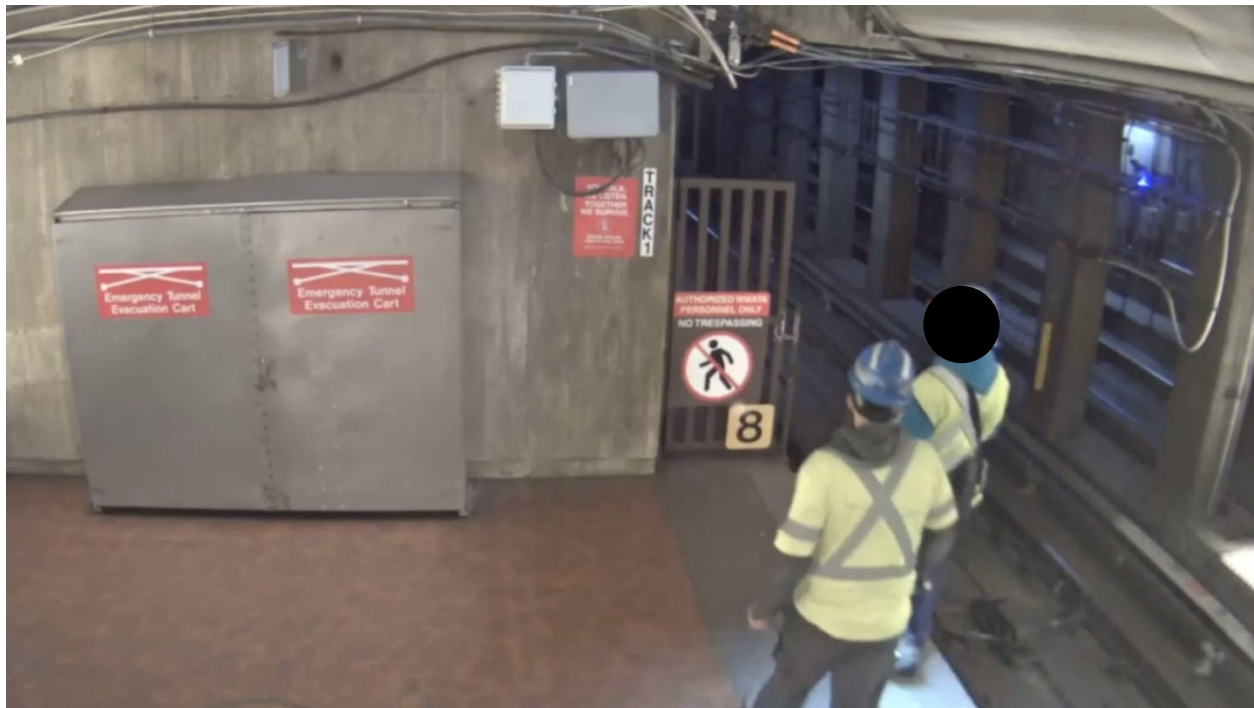
Figure 6 – TRST personnel approaching the 8-Car Marker at Metro Center Station, Track 1, at approximately 09:40:08 hours.

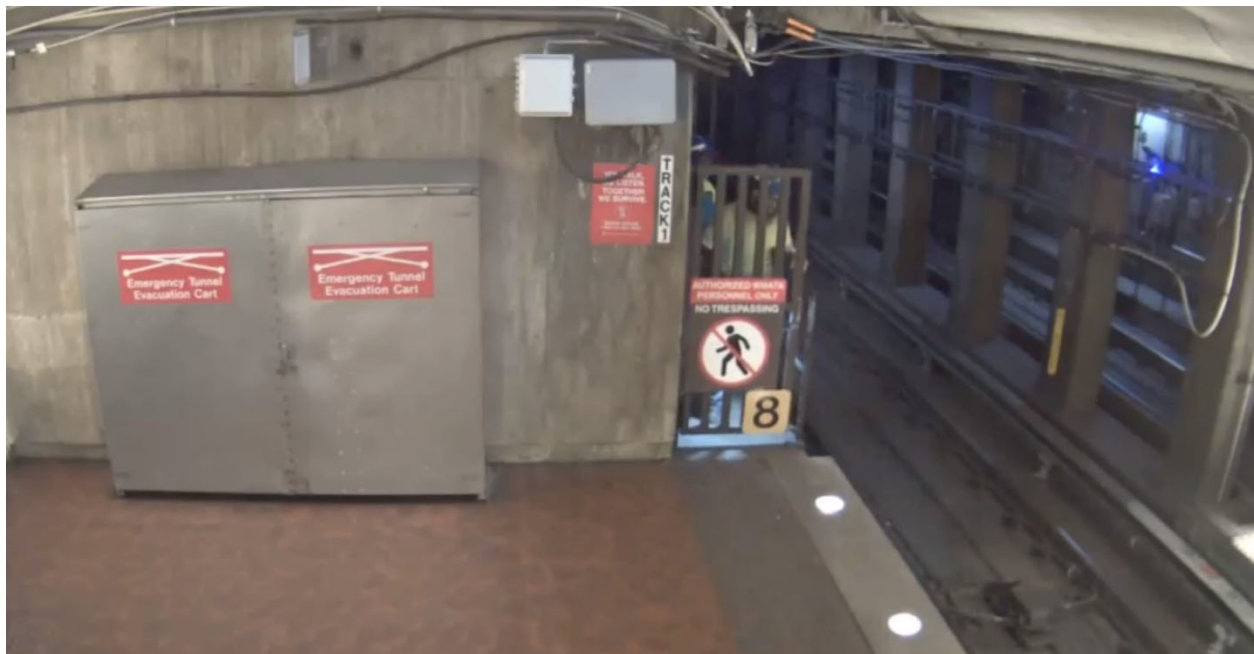
Figure 7 – TRST personnel leaving the platform and entering the roadway beyond the end at Metro Center Station, Track 1, at approximately 09:40:18 hours.

- The RWIC did not request permission from ROCC to continue their inspection from Metro Center Station and entered the roadway without permission from ROCC.

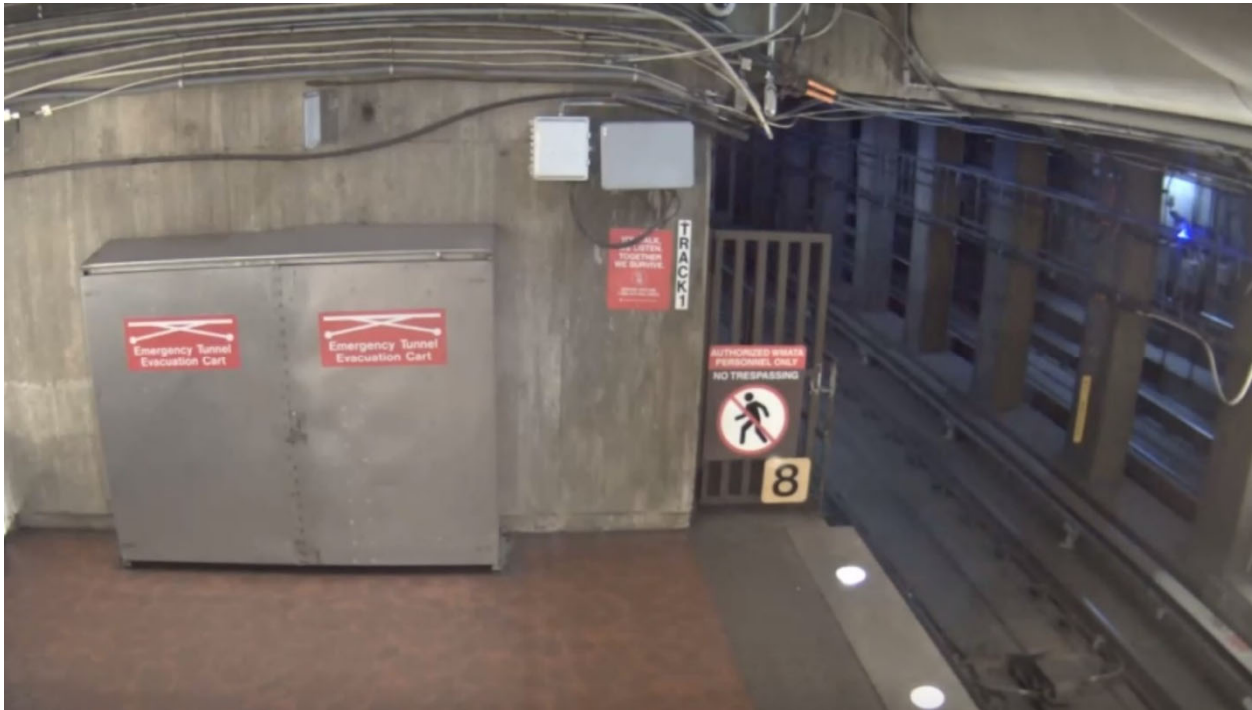
Figure 8 – TRST personnel out of camera view at approximately 09:40:24 hours.

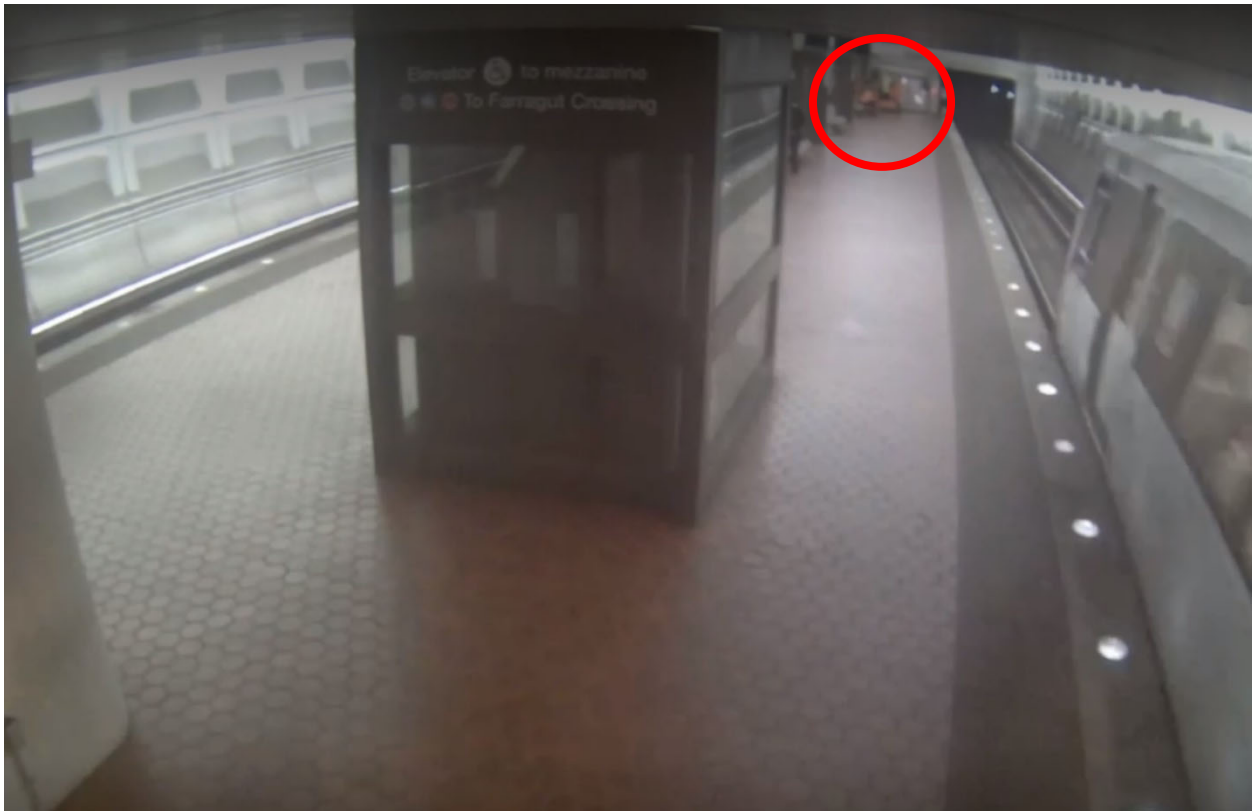
Figure 9 – Train ID 108 approaching 8-Car Marker at Farragut North Station, Track 1 at approximately 09:44:29 hours. AMF is not set up.

- The AMF did not brief the Train Operator of Train ID 108 of personnel conducting a track inspection on the roadway because they were not instructed to begin flagging operations.

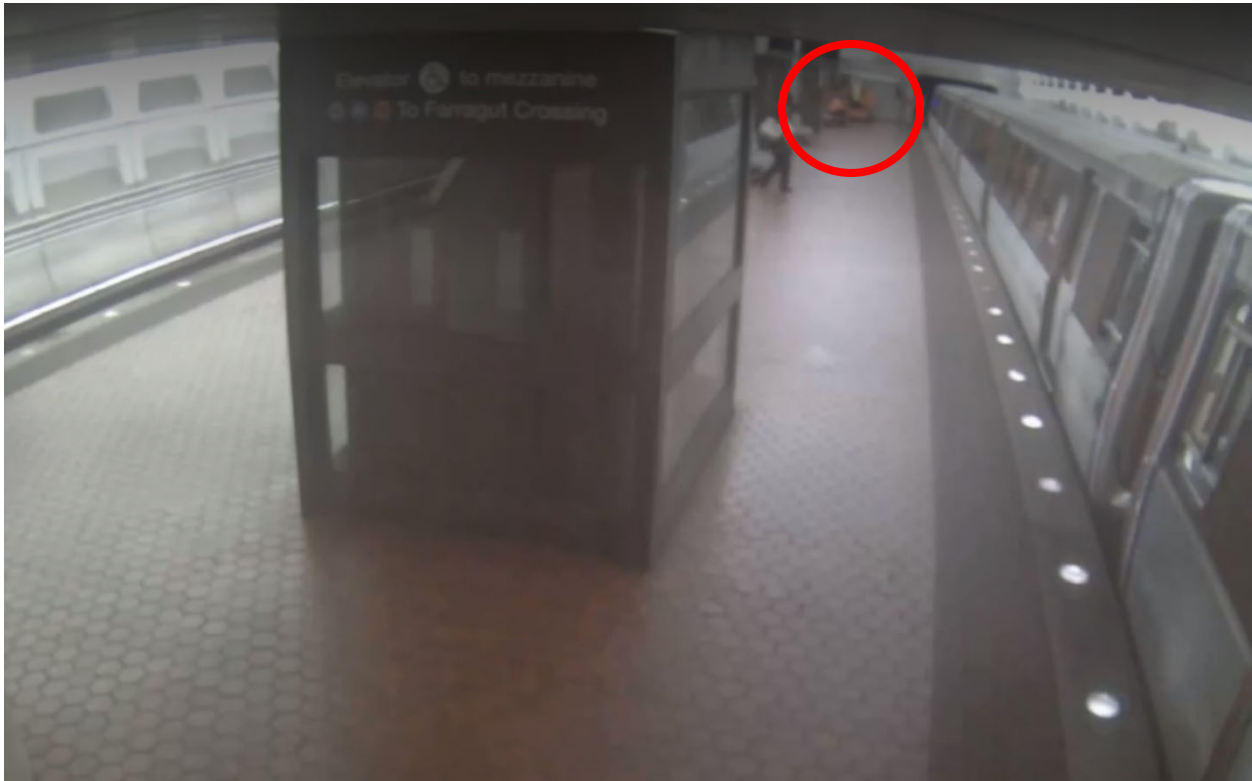
Figure 10 – Train ID 108 stops at the 8-Car Marker at Farragut North Station, Track 1 at approximately 09:44:41 hours. AMF is not set up and did not brief the Train Operator.

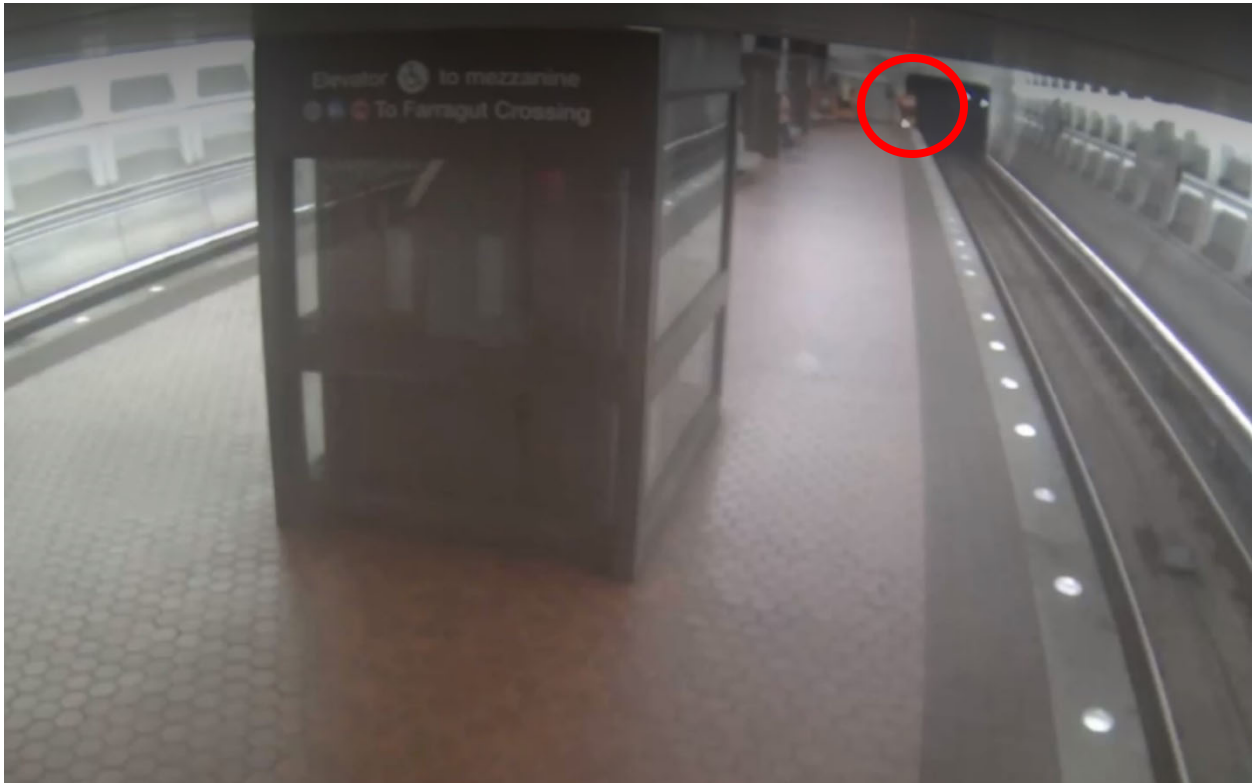
Figure 11 – AMF turns on lantern and start AMF duties at the 8-Car Marker at Farragut North Station, Track 1 at approximately 09:48:45 hours.
