### Inspection Form

Washington Metrorail Safety Commission

<b>Inspection Date</b>	YYYY/MM/DD 2022/06/06	<b>Report Number</b>	20220606-WMATA-LBW-01
<b>Rail Agency Name</b>	Washington Metropolitan Area Transit Authority	<b>Rail Agency Department</b>	Name
<b>Rail Agency Department</b>	CMNT	<b>Contact Information</b>	
<b>Inspection Location</b>	Alexandria Rail Yard 3201 Eisenhower Ave. Alexandria, VA

<b>Inspection Activity #</b>	1	<b>Inspection Subject</b>	Storage of 7000 Series rail cars with back-to-back measurement exceedances			<b>Activity Code</b>					
<b>Job Briefing Employee Name/Title</b>	NA	<b>Accompanied Inspector?</b>	No			<b>Out Brief Conducted</b>	No	<b>Time</b>	10:00 AM	<b>Outside Shift</b>	Yes
<b>Related Reports</b>	SERVICE BULLETIN SBF-114 Rev. 01 SERVICE BULLETIN SBF 110 Rev. 02		<b>Related CAPS / Findings</b>			December 29, 2021, WMSC order keeping 7000 Series railcars out of passenger					
<b>Related Rules, SOPs, Standards, or Other</b>	<b>Ref</b>		<b>Rule or SOP</b>			<b>Standard</b>		<b>Other / Title</b>		<b>Checklist Reference</b>	
										MSI 140026	
<b>Inspection Location</b>	Main Track	Yard	Station	OCC	RTA Facility	WMSC Office	<b>Track Type</b>	At-grade	Tu

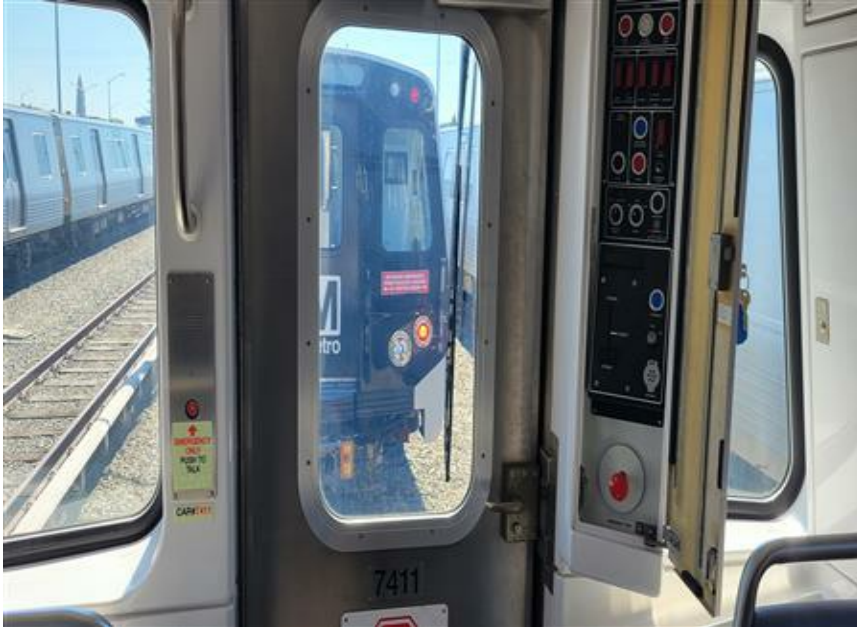
20220606\_102742.jpg

NA		NA		
<b>Vehicles</b>	<b>Head Car Number</b>		<b>Number of Cars</b>			<b>Equipment</b>	NA				
	NA		7410-7411 7063-7062 7490-7491 7238-7239 7994-7995 7156-7157								
<b>Description</b>	<p>The WMSC inspector conducted an unannounced inspection of the Alexandria Yard storage tracks. 7000 Series rail vehicles that failed back-2-back wheel inspections were checked for compliance with Safety Bulletin SBF 110 (Procedure for removing and releasing 7K cars from service due to back-to-back failures), Safety Bulletin SBF-114 (7K rail car storage) and operating rule 3.126 (storage of class I rail vehicles). All 7K cars identified with back-to-back measurements that do not comply with MSI 140026 are stored with out of service tags on the Master Controller of each 7K A-car and Hostler Panel on the B-car, window decals placed on the windshield of the Operator's Cab of each 7K A-car and Hostler Panel on the B-car and red flags and lanterns at the front and back of the failed married pair. An exit briefing was not conducted with the S&amp;I Superintendent, but all defects identified during the inspection were brought forth during the 7K daily vehicle call. Six married pairs of 7000 series rail cars were inspected of which two married pairs were not in compliance with SBF-110. 1. Rail car 7411 (B-Car) was observed without the critical failure decal in the window. 2. Rail car 7411 (B-Car) was observed without the out of service tag (R76-90-0001) on the Hostler Panel 3. Rail car 7063 (B-Car) was observed without the critical failure decal in the window. A paper sign was placed in lieu of the required decal 4. Rail car 7063 (B-Car) was observed without the out of service tag (R76-90-0001) on the Hostler Panel 5. Rail car 7062 (A-Car) was observed without the critical failure decal in the window. 6. Rail car 7062 (A-Car) was observed without the out of service tag (R76-90-0001) on the Hostler Panel</p>						<b>Number of Defects</b>

<b>Recommended Finding?</b>		No		
							<b>Remedial Action Required?</b>		Yes		
							<b>Recommended Reinspection?</b>		Yes		
<b>Remedial Action</b>	Defects identified were verbally relayed to WMATA during the daily 7K vehicle meeting
