The Washington Metrorail Safety Commission

Safety Audit of the Washington Metropolitan Area Transit Authority Audit of Structures Program

Final Report:
July 25, 2023

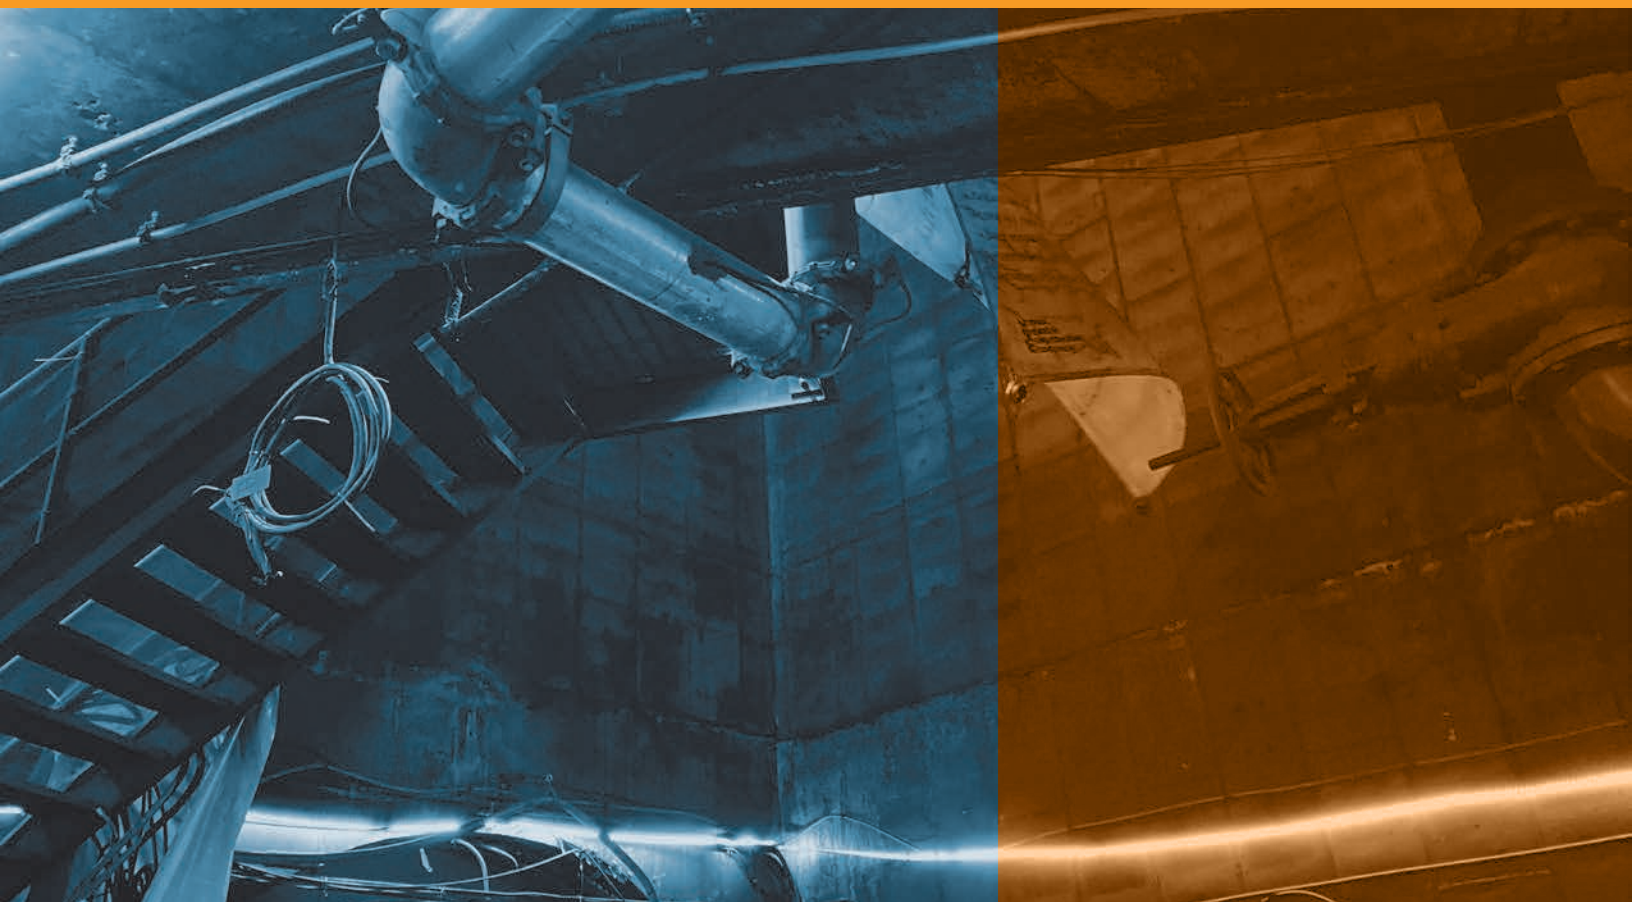
Metrorail was carrying out important structural rehabilitation work on the Yellow Line to improve the integrity of the Metrorail system. The WMSC observed this work on the Yellow Line bridge and tunnel between L'Enfant Plaza Station and Pentagon Station.
