WMSC Commissioner Brief: W-0236 – Collision at Crystal City Station – March 9, 2023

Washington Metropolitan Area Transit Authority
Department of Safety (SAFE)
Office of Safety Investigations (OSI)
FINAL REPORT OF INVESTIGATION A&I E23163

Crystal City Station – Collision

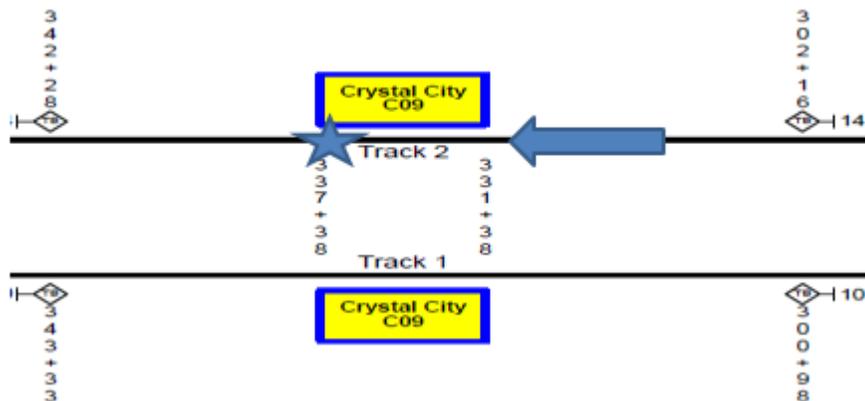
Field Sketch/Schematics

**Locations are approximate. Not to scale.*

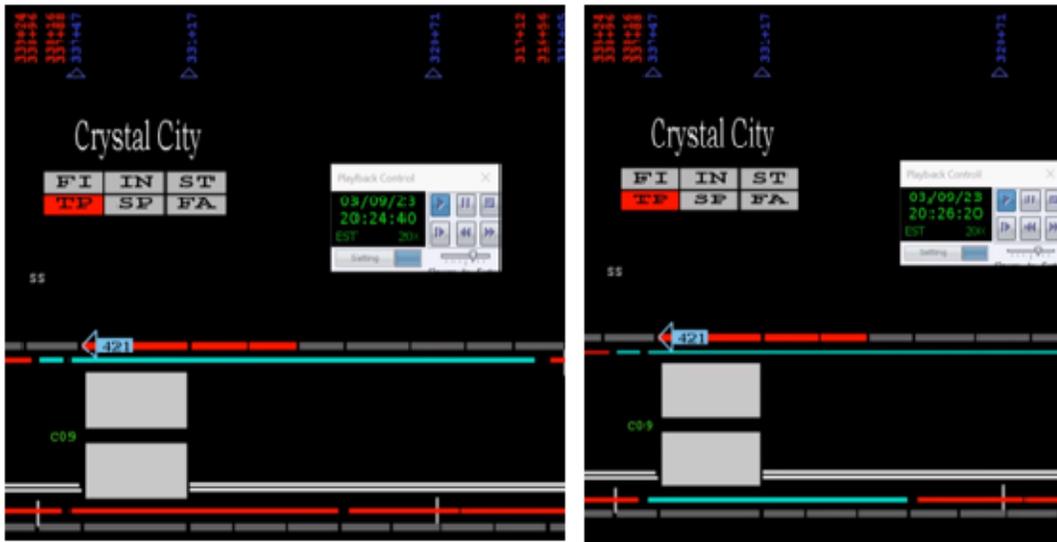
Figure 1 - Third rail power de-energized at Crystal City Station on track 2 at 20:24 hours and on track 1 at 20:26 hours.

At 20:24 hours, third rail power was de-energized at Crystal City Station on track 2. At 20:26 hours, third rail power was de-energized at Crystal City Station on track 1.

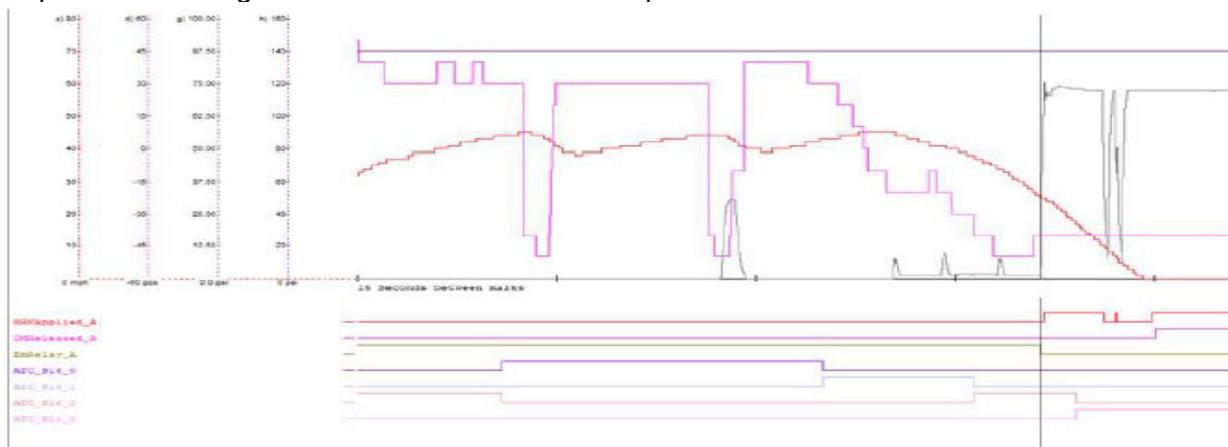
Time	Marker ID	MP Position	Speed	Distance Traveled	
20:23:04	F1	P3	44mph		
20:23:28	F2	P3	43mph	1489ft	
20:23:39	F3	B4	38mph	712ft	
20:23:41		B5	35mph	80ft	
20:23:44		B4	27mph	137ft	EMR Deenergized
20:23:47	F4	B4	17mph	97ft	
20:23:52		B4	0	48ft

Figure 2 - Graphical representation of train behavior during the event. Note that the F1, F2, and F3 markers are outside the platform limits.

“CENV has reviewed the VMS data and determined that the cars involved in the incident responded as designed. Please see the VMS snapshot and incident timeline below.
