WMSC Commissioner Brief: W-0242 Serious Injury – New Carrollton Rail Yard – April 23, 2023

FINAL REPORT OF INVESTIGATION A&I E23286

Date of Event:	April 24, 2023
Type of Event:	A-2 Serious Injury
Incident Time:	13:35 hours
Location:	New Carrollton Rail Yard (D99)
Time and How received by SAFE:	13:35 hours SAFE/Mission Assurance Coordinator (MAC)
WMSC Notification Time:	13:35 hours
Responding Safety Officers:	WMATA: OSO and OSI personnel WMSC: None Other: None
Rail Vehicle:	None
Injuries:	Laceration to the right leg
Damage:	None
Emergency Responders:	Metro Transit Police Department (MTPD), Prince George's County Fire Department/EMS (PGCFD)
SMS I/A Incident Number:	20230424#107936

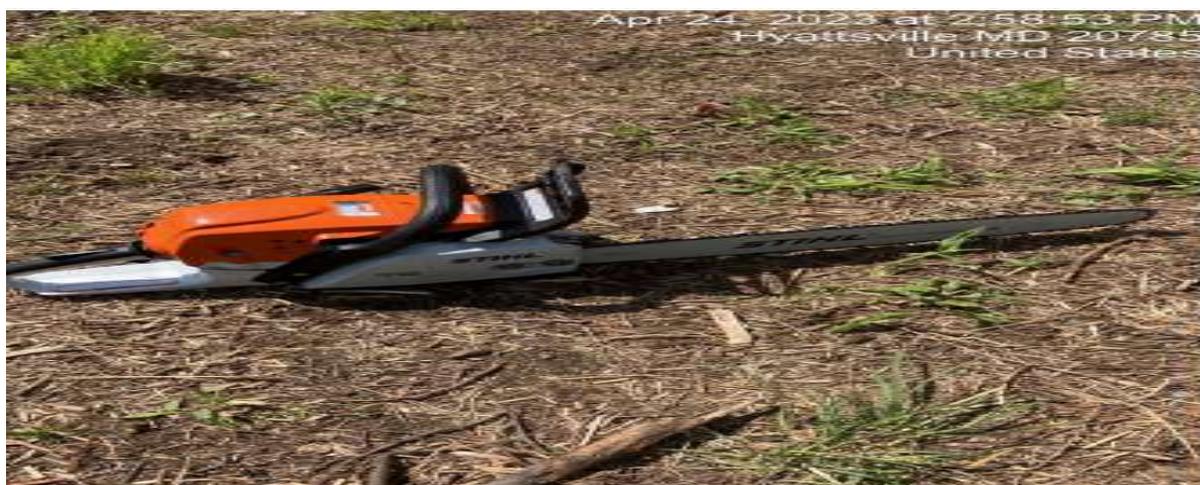
Figure 2 STHL Farm Boss Chainsaw

At 13:35 hours, the contractor was working the hillside adjacent to Tail Track 1 and was removing heavy vegetation with a Stihl Farm Boss chainsaw when they sustained a deep laceration to their right leg after losing their footing on the hillside.

In addition to other precautionary statements related to boots, gloves, and vibration fatigue, the instruction manual for the Stihl Farm Boss Chainsaw recommends, "To reduce the risk of cut injuries, wear the type of overalls, long pants or chaps that contain pads of cut-retardant material..."

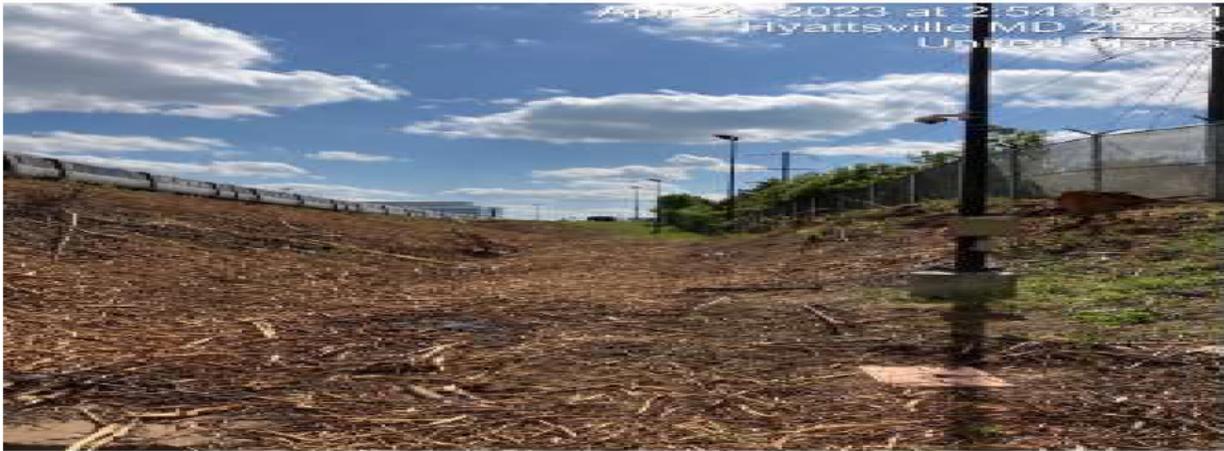
Figure 3 Tail Track 1- New Carrollton Rail Yard

On April 24, 2023, at the time of the incident, NOAA recorded the temperature as 61°F, with clear skies. The ground conditions were observed as wet and uneven (hill and debris from landscaping work). The weather did not contribute to this incident specifically; however, the uneven ground

and ground moisture contributed to this event. (Weather source: NOAA) – Location: New Carrollton, MD.

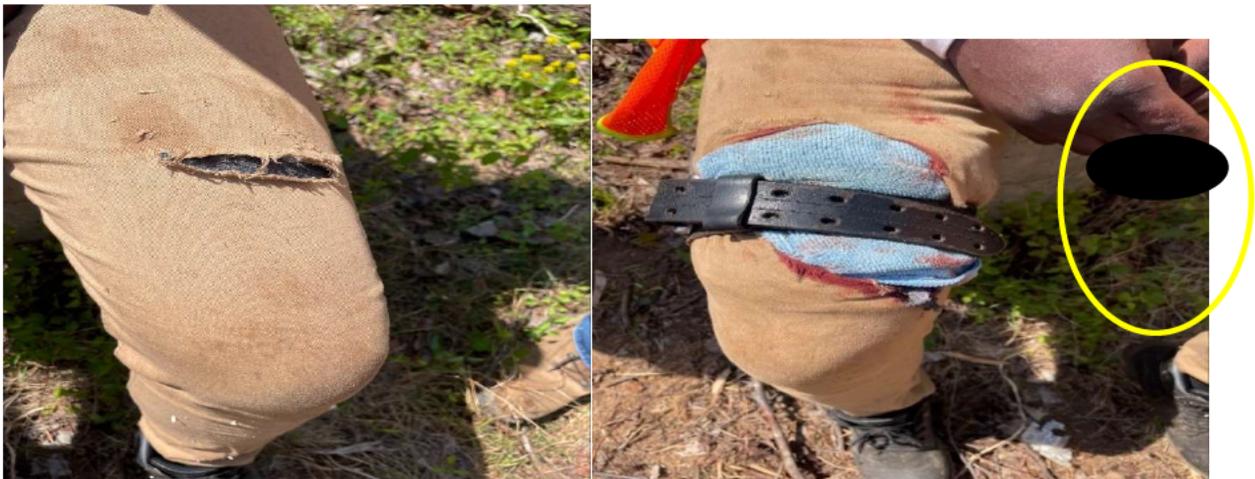
Figure 4 Contractor's injury

During this incident, the injured contractor was not utilizing chainsaw chaps which were available and recommended by the RWIC. The utilization of chainsaw chaps would have prevented or lessened the severity of this injury. The wounded contractor stated that it was their error in not utilizing chainsaw chaps, and they were in haste to complete their assignment when this injury occurred.

The contractor was treated and released the same day, receiving fifteen (15) staples to their right leg.

The probable cause for this incident was the failure to utilize prescribed proper personal protective equipment (PPE); specifically, chainsaw chaps, which would have prevented or lessened the injury. Contributing Factors to the event included rushing, as stated by the contractor, uneven ground conditions, and inadequate oversight.

Corrective Action Code	Description	Responsible Party	Estimated Completion Date
107936_SAFECAPS_TRST_001	Develop a lesson-learned document that discusses the use of proper PPE when utilizing motorized equipment (chainsaws) and other equipment that could cause injury.	TRST SRC	Completed

Corrective Action Code	Description	Responsible Party	Estimated Completion Date
107936_SAFECAPS_TRST_002	TRST will ensure that Industrial Commercial Cleaning Group (ICCG) conducts a safety stand-down/lesson learned sessions for the work crews focusing on proper procedures for utilizing the proper Personal Protection Equipment (PPE) when operating handheld cutting instruments.	TRST SRC	Completed
