WMSC Commissioner Brief: W-0243 Serious Injury – Potomac Yard Station – April 17, 2023

FINAL REPORT OF INVESTIGATION A&I E23264

Potomac Yard Station – Serious Injury

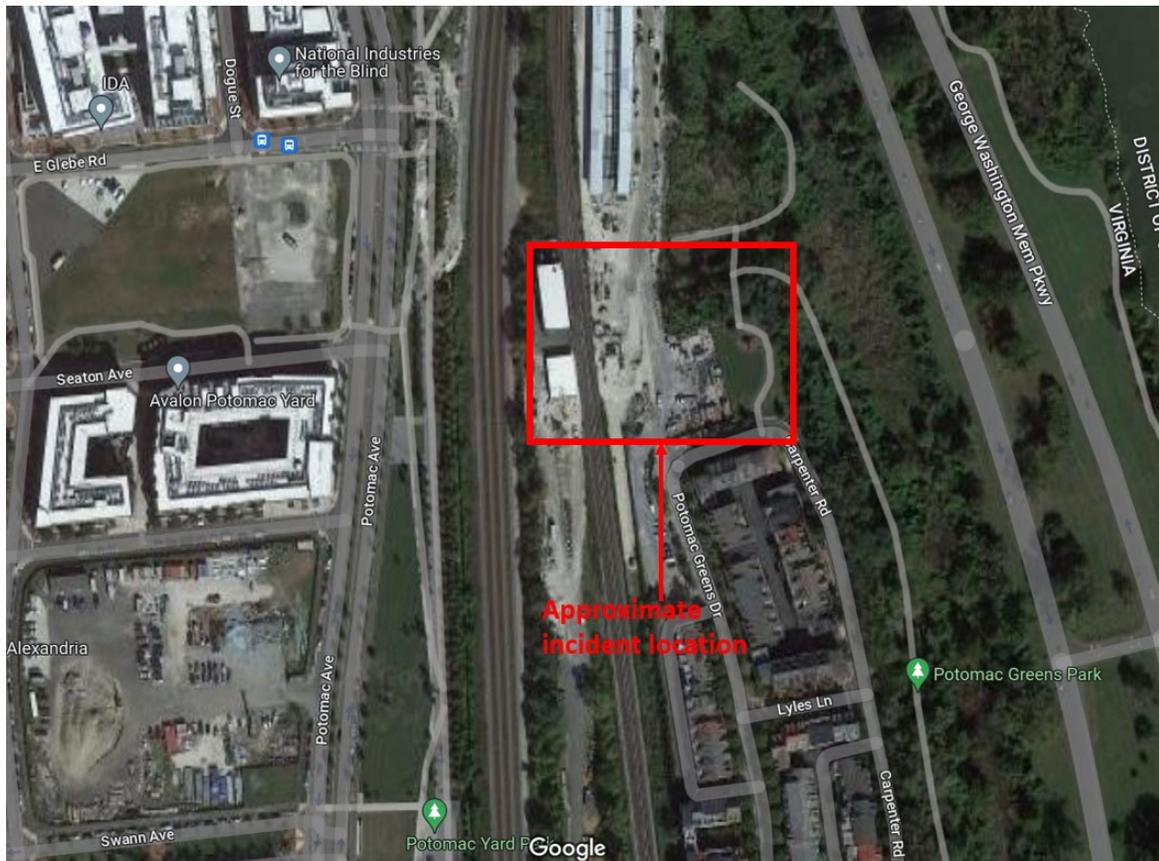
Field Sketch/Schematics

The above depiction is not to scale.

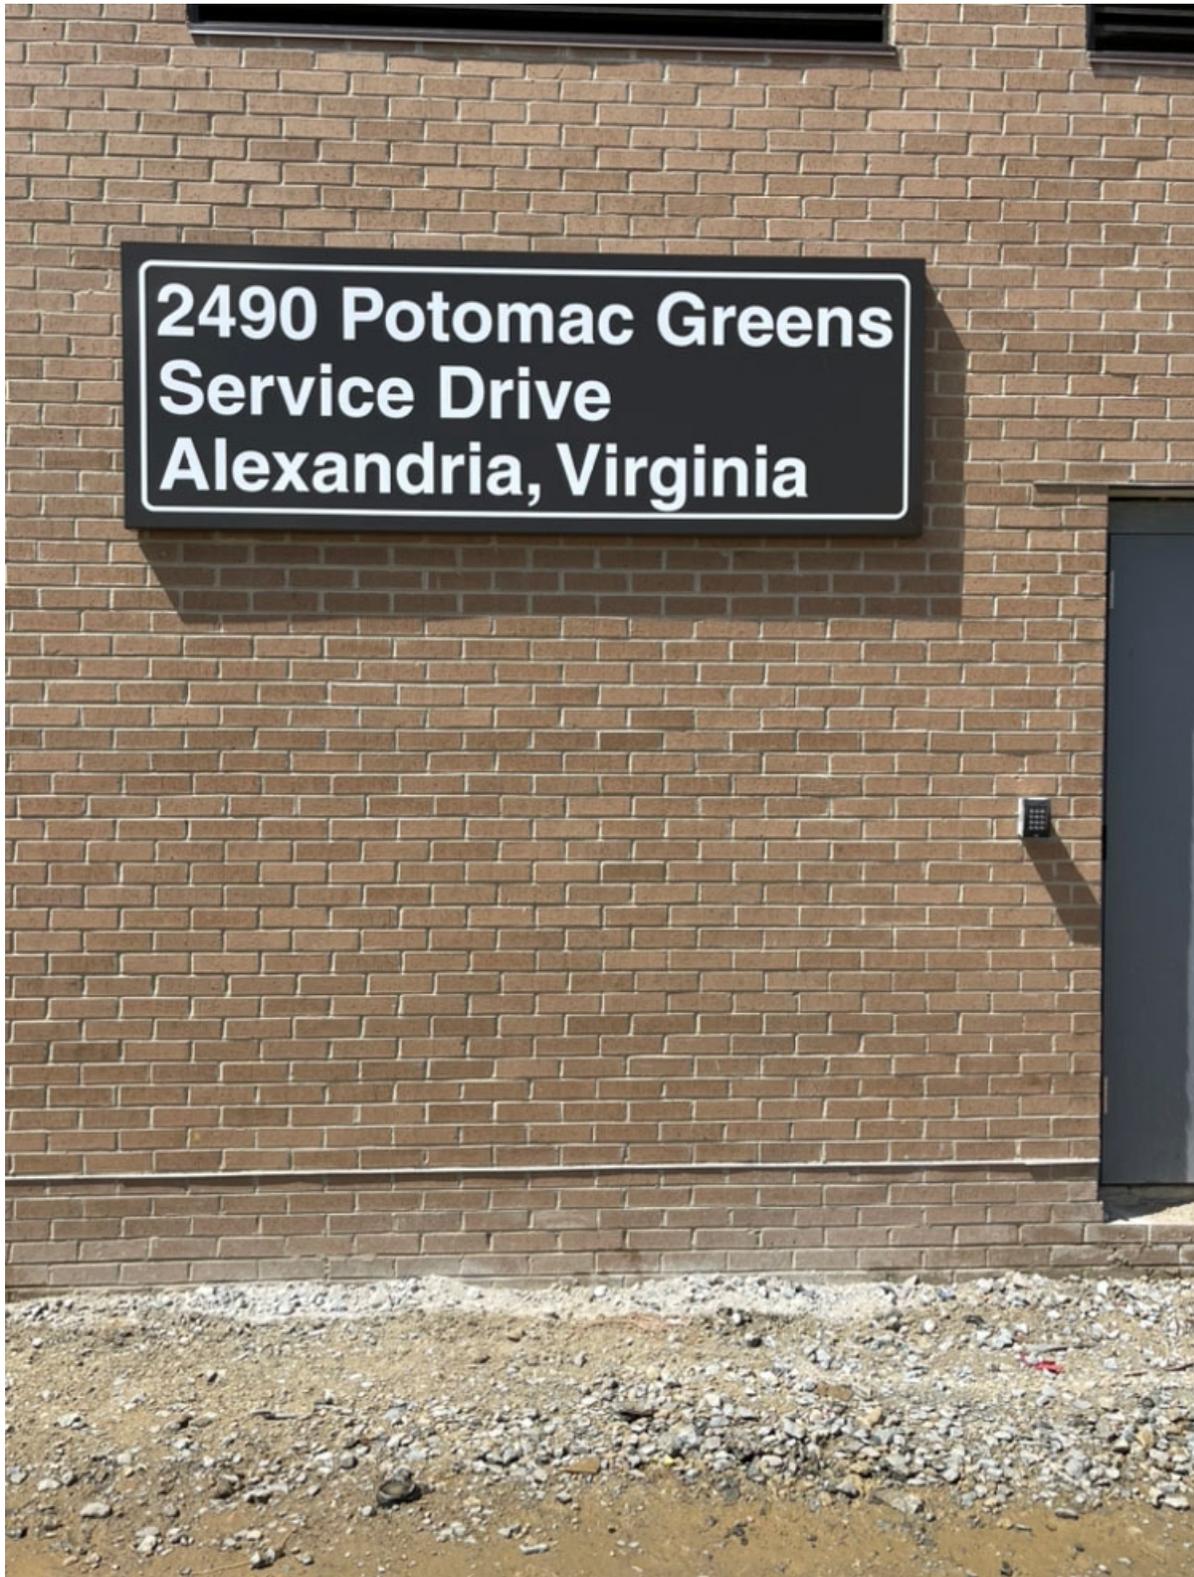
Image 1 – Front view of the installed signage at the incident site.

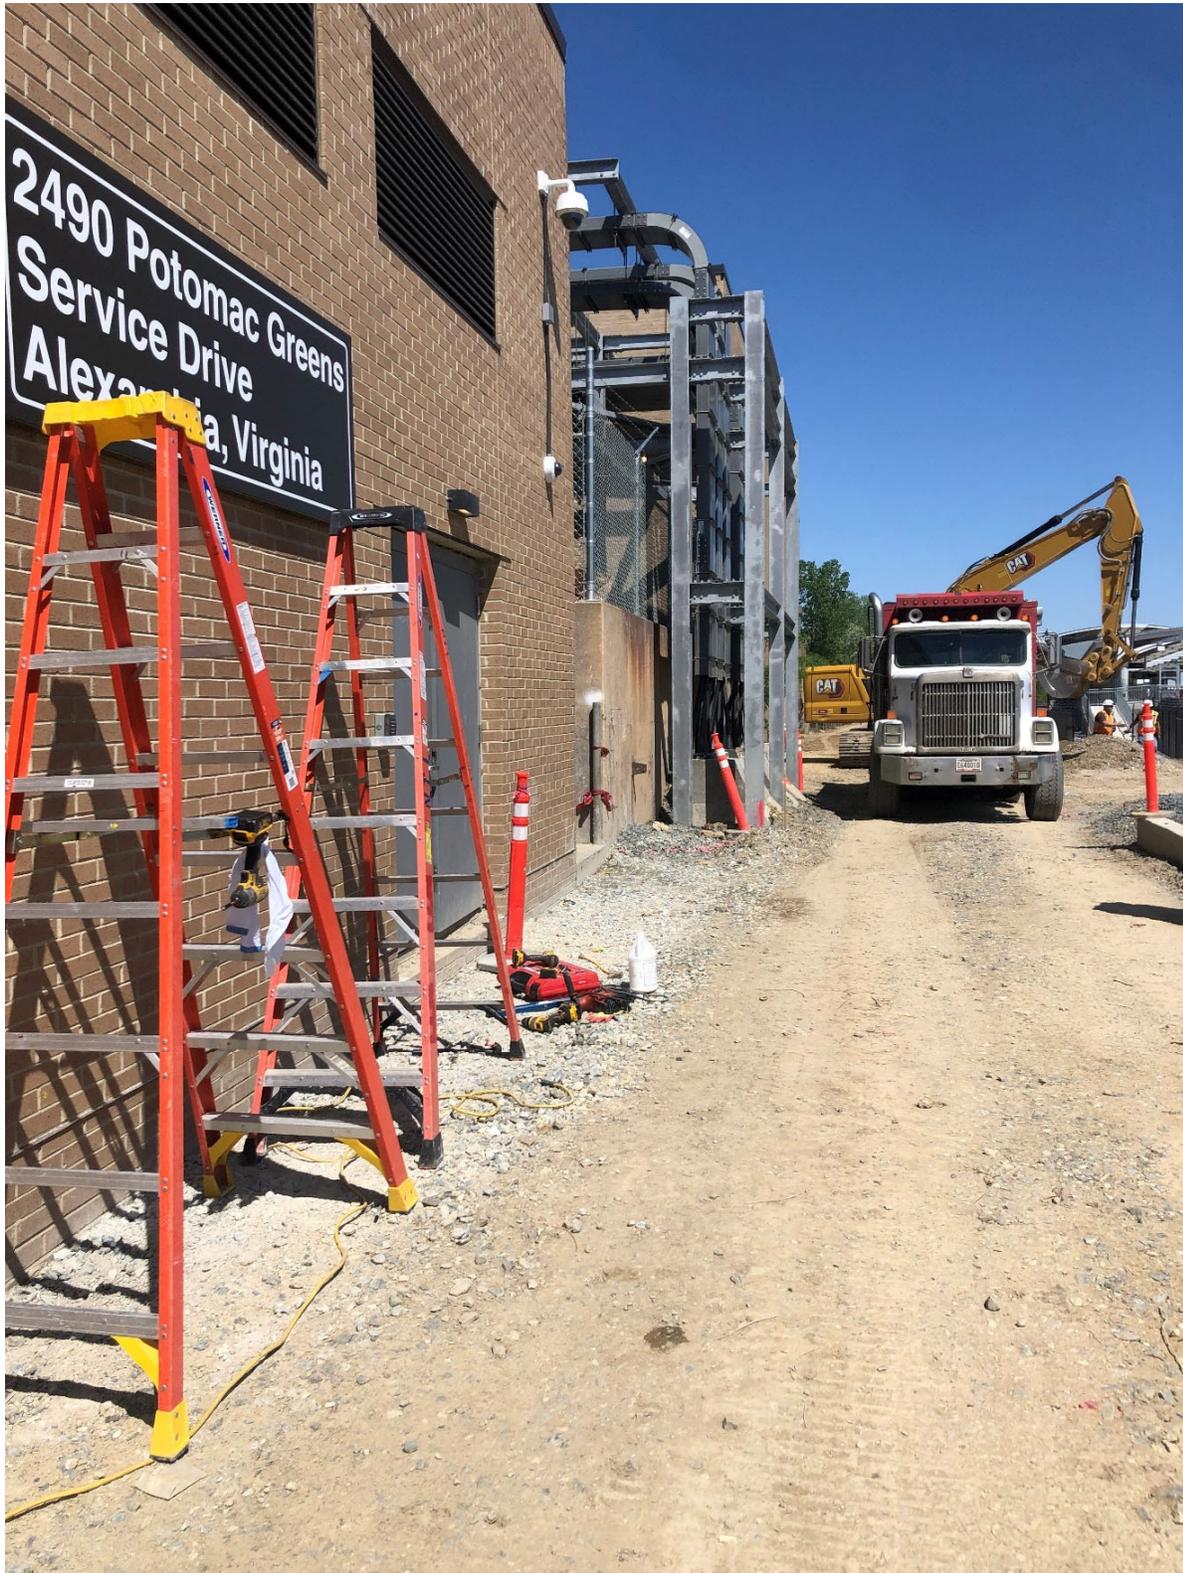
Image 2 – View of the Gelberg Signs Employee’s work location setup within the construction zone at the Potomac Yard Station. Note cords and uneven ground beneath the ladders’ footing.

The probable cause of the serious injury was a failure to follow the approved Job Hazard Analysis. The Gelberg Signs Foreman did not ensure the contractors installing the signage at Potomac Yard were adhering to the approved job hazard analysis (JHA) for the work assignment. Contributing Factors to the incident were uneven ground and a failure to add stability as a mitigation measure.

- Gelberg Signs employees were installing address signage under tasking of Potomac Yard Contractors group.
- Two 8-foot A-frame ladders were used for the installation.
- The ground beneath the ladders was dirt with stones and generally uneven.
- There were only three employees present for the installation.
- The employee's injuries were initially reported as minor but upgraded after they received treatment off the work site.

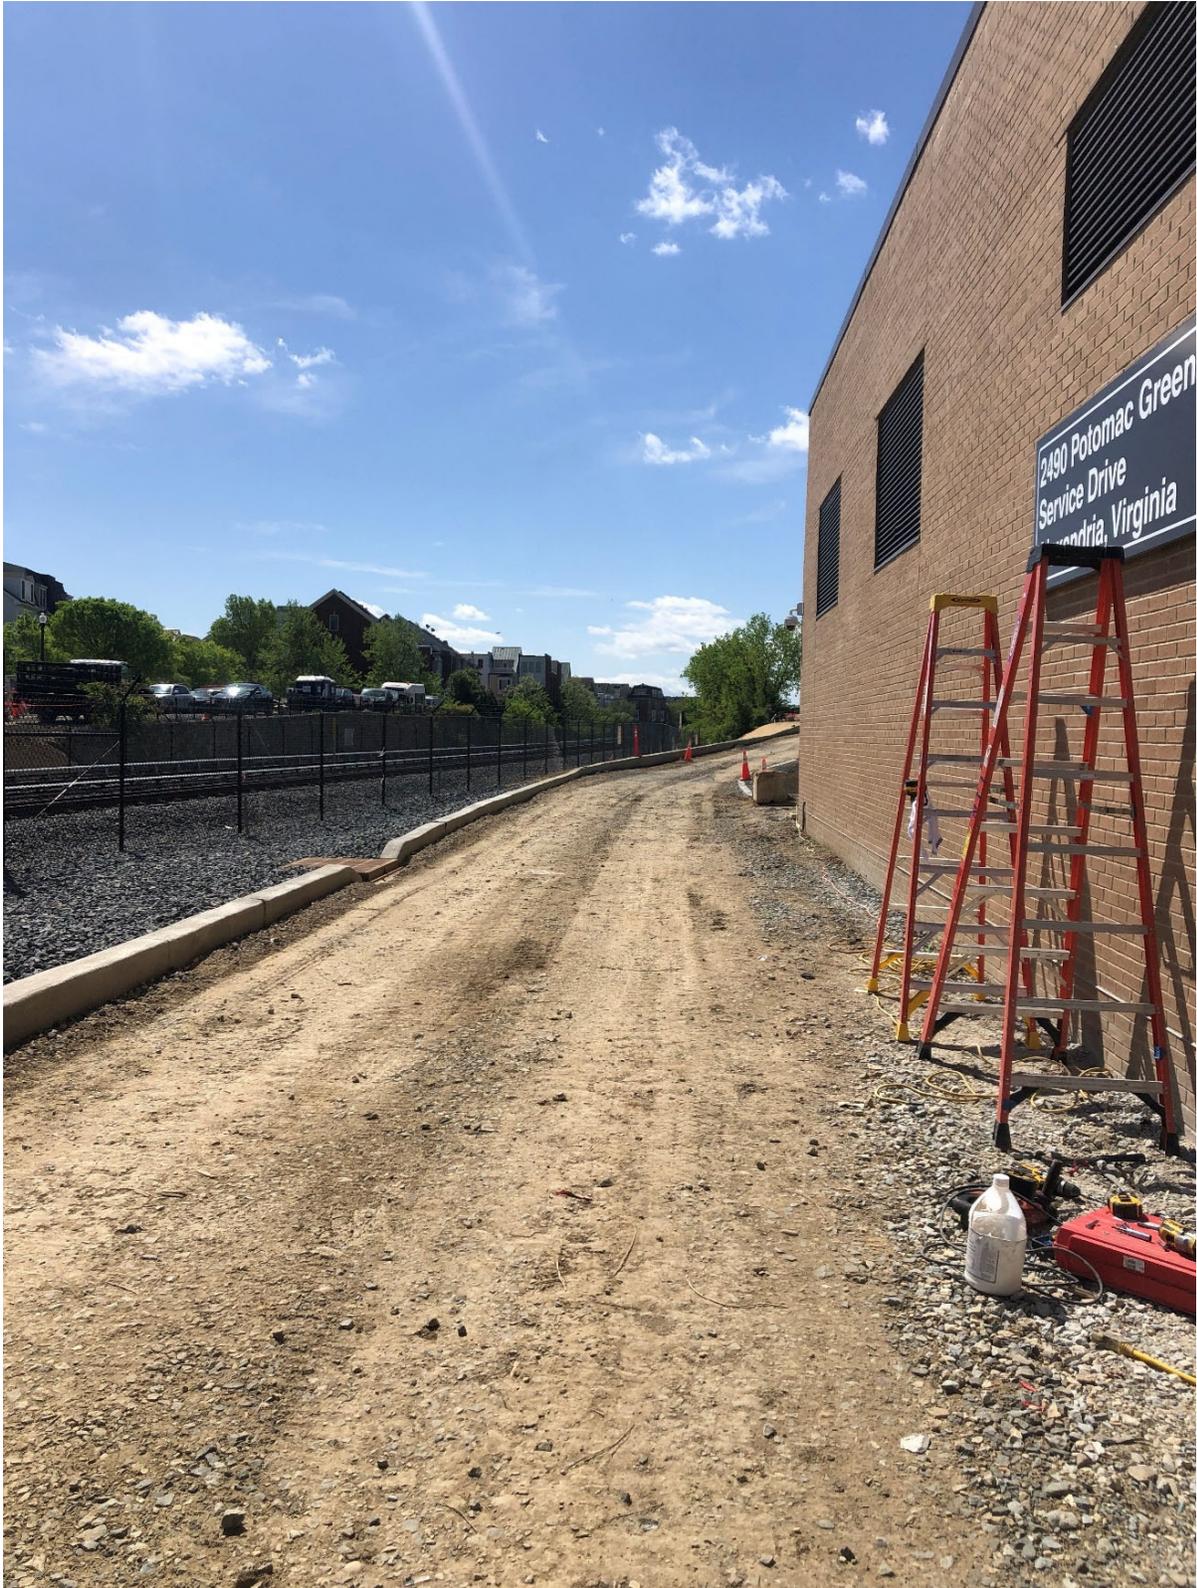
Image 3 – Entrance view of the Gelberg Signs Employee’s work location setup within the construction zone at the Potomac Yard Station.

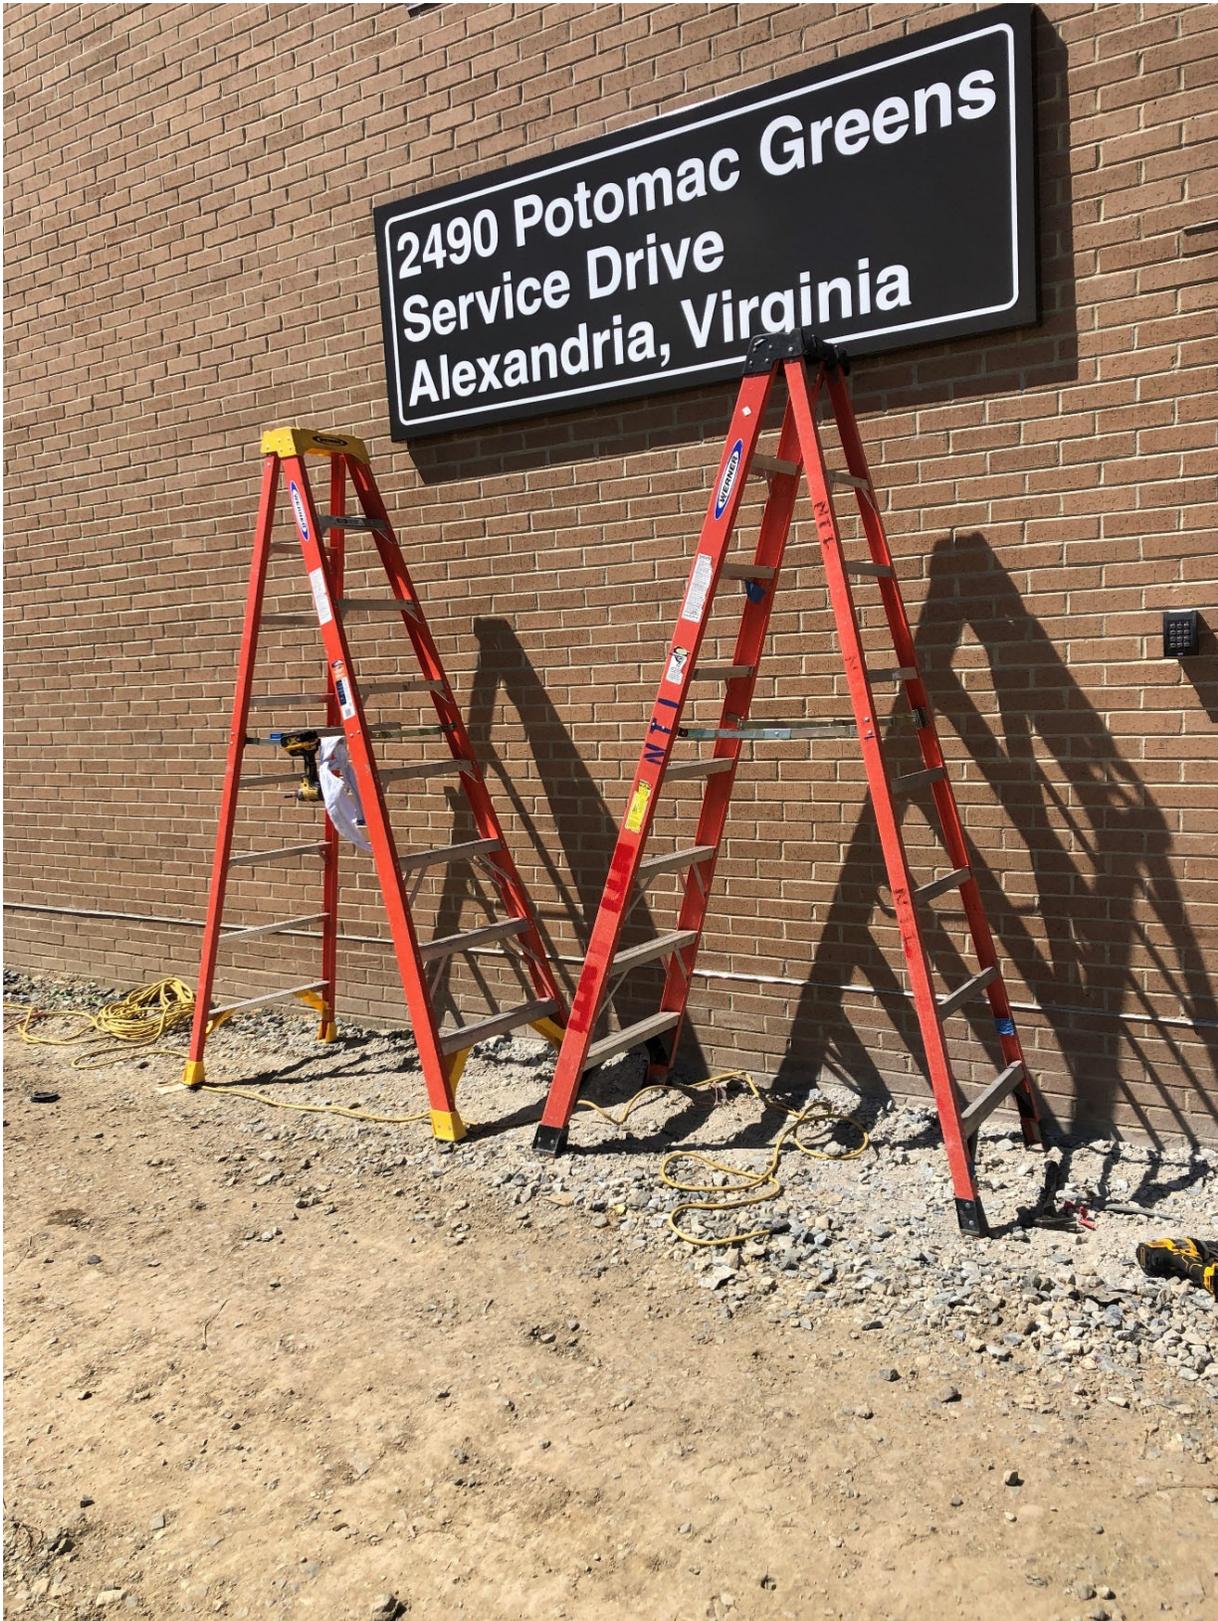
Image 4 – Frontal view of the Gelberg Signs Employee’s work location setup within the construction zone at the Potomac Yard Station.

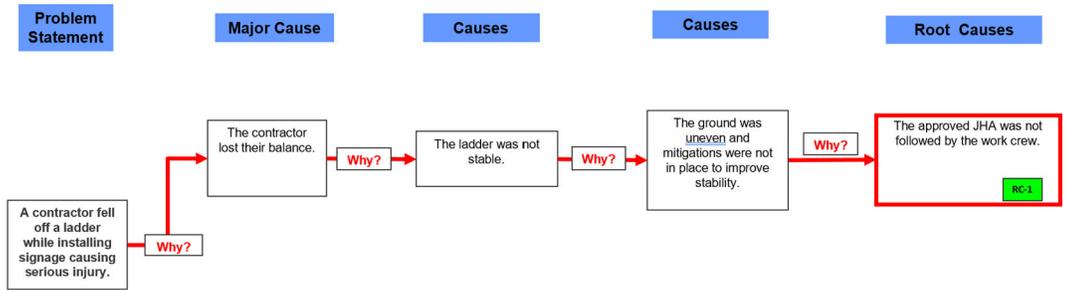
E23264 – Serious Injury – Potomac Yard Station

The probable cause of the serious injury was a failure to follow the approved Job Hazard Analysis. The Gelberg Signs Foreman did not ensure the contractors installing the signage at Potomac Yard were adhering to the approved job hazard analysis (JHA) for the work assignment. Contributing Factors to the incident were uneven ground and a failure to add stability as a mitigation measure.
