WMSC Commissioner Brief: W-0251 – Collision – Metro Center Station – May 21, 2023

FINAL REPORT OF INVESTIGATION A&I E23341

Metro Center Station Collision – Person Struck by Train

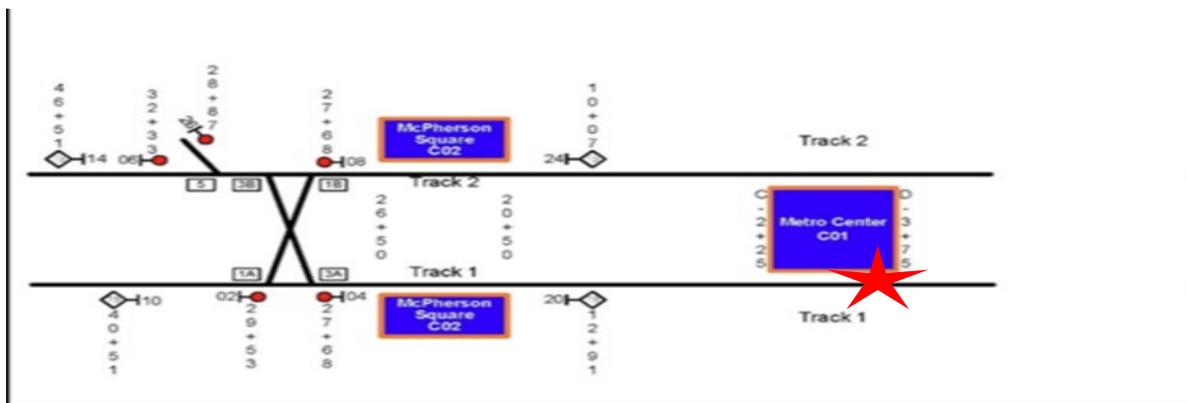
Field Sketch/Schematics

Metro Center Station (C01) – Platform lower level

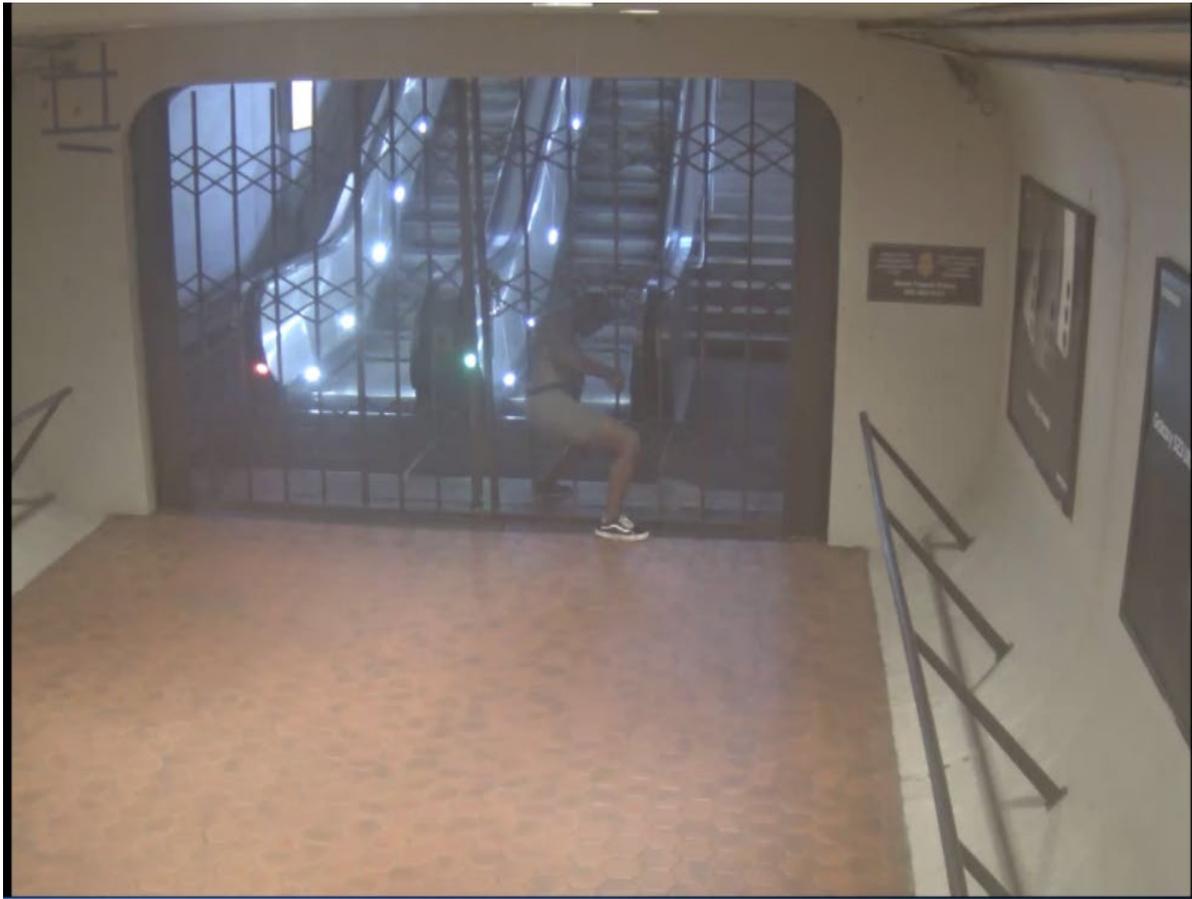
Figure 1 Trespasser pushing through the closed station gate at Metro Center Station.

The CCTV footage determined that the unidentified trespasser entered Metro Center Station at 05:56 hours, utilizing the 12th and G street-level entrance. The individual forcibly entered through the scissor gates from the escalators at 06:00 hours and scaled the turnstile gates at 06:01 hours.

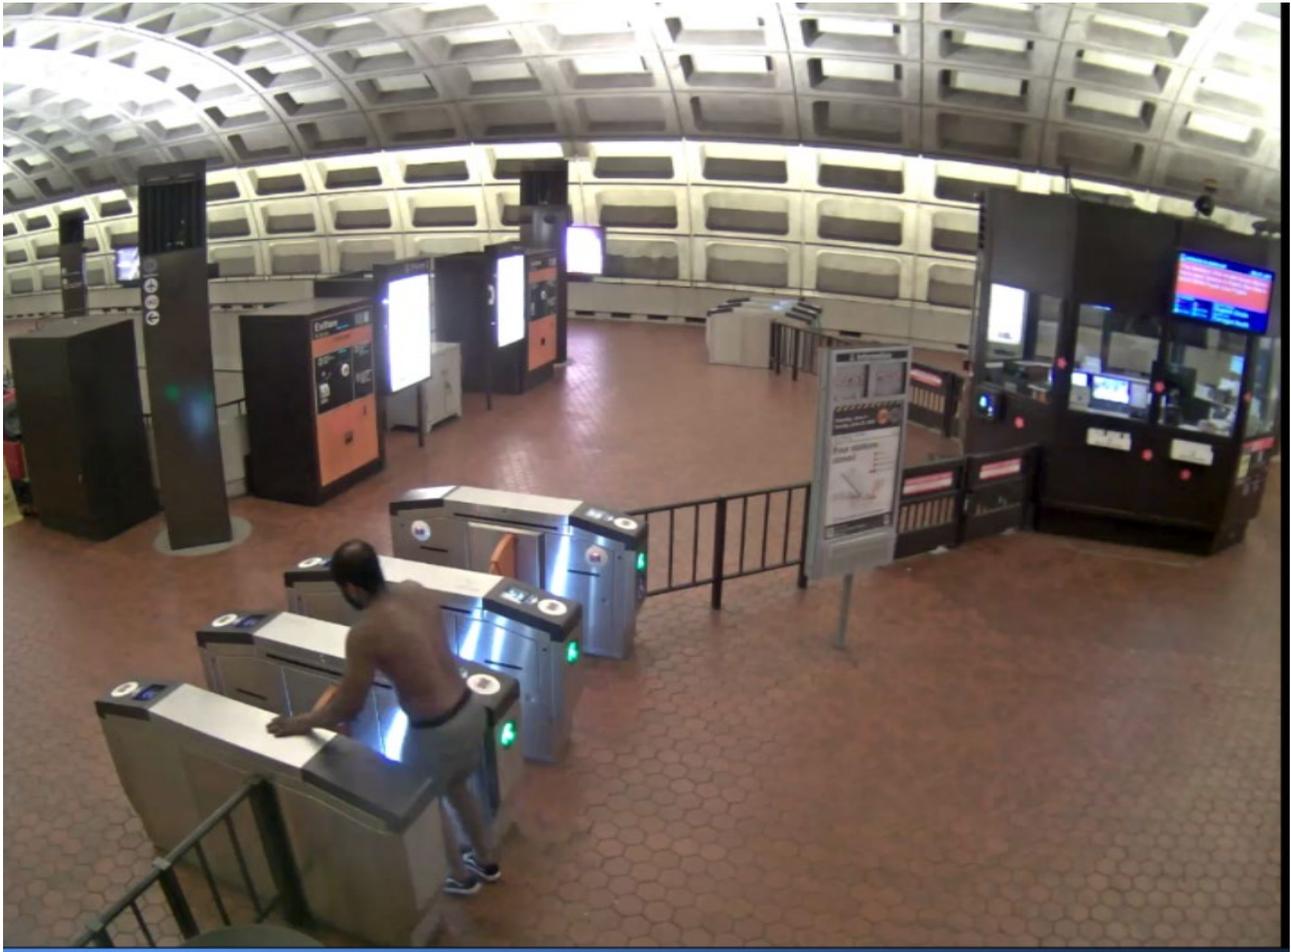
Figure 2 Trespasser scaling turnstile gate

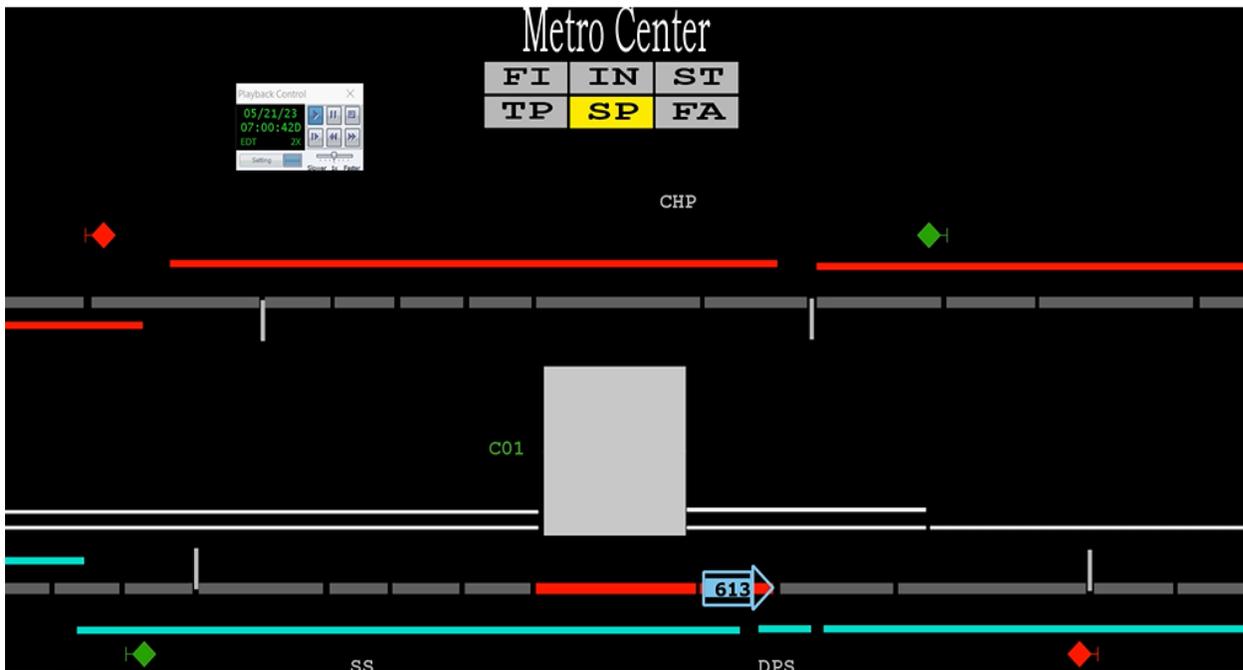
Figure 4 – AIMS Playback Track 1 Metro Center. Third Rail Power De-energized.

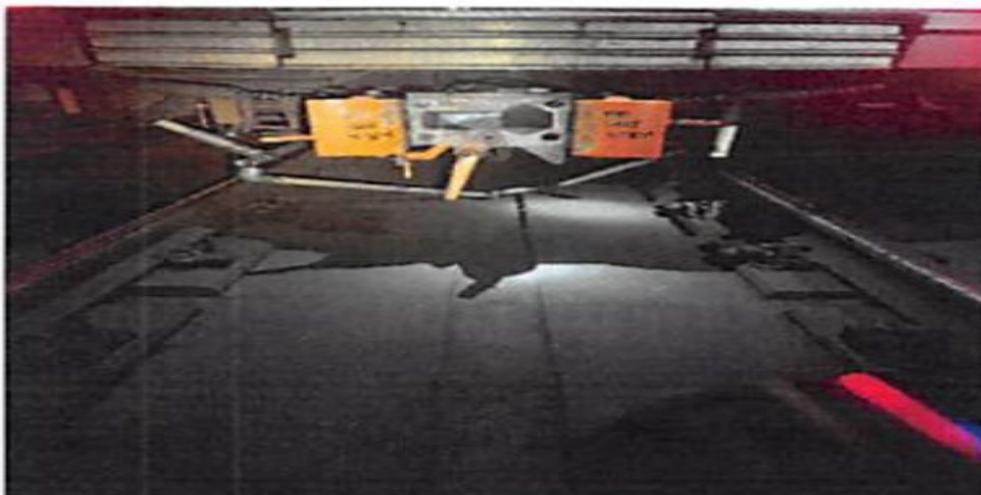
Following the incident, the Train Operator of ID 613 was removed from service for post-incident testing. The train consist was also taken out of service for post-incident inspection. The inspection revealed minimal damage to the TWC coil on car 6088, and no structural damage was found with the consist.

The Rail Supervisor conducted a ground walkaround of the incident train at 07:15 hours after confirming third rail power de-energized. During the inspection, the supervisor discovered a damaged TWC coil.

Figure 6 - Car 6088 damaged TWC cable

Following the investigation, at 08:27 hours, the CMNT team completed the repair of the damaged TWC coil. Additionally, the Emergency Response Team (ERT) thoroughly inspected the track, ensuring its safety.

Under-car inspections of all the consists were completed, and no structural or car body damage was found. A damaged TWC cable was replaced and is fully operational. All train cars successfully passed the Daily Inspection and were released for service.

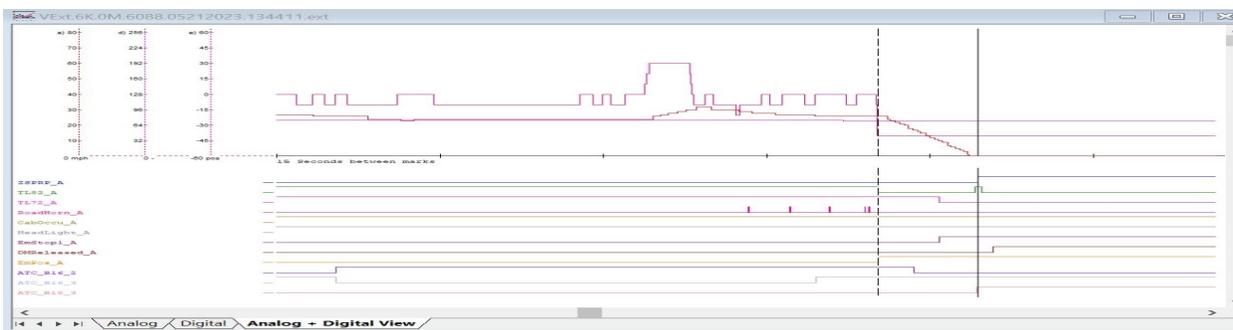
“The VMS data analysis has concluded Train 613 achieved and decelerated close to 3.0 and responded as designed. No issues with the train could be attributed to this incident. Below and attached VMS is the sequence of events that occurred during and after this occurred. CMNT to make certain brakes and propulsion are communicated with VMS- and upon a good DNF, CENV has no hold on id 613.”

Figure 7 Timeline for Train 613/713 Pg-1

Time	MC Position	Event	Actual Speed
06:58:26 hours	Coast to B1, then acceleration to P#	827 feet leaving McPherson St	26 MPH
06:58:31 hours	Coast to B1	ID 613 acceleration to	32 MPH
06:58:36 hours	B1	After traveling 756 feet road horn signal went high, and ID 613 slowed down to	29 MPH
