WMSC Commissioner Brief: W-0254 – Collision – Rhode Island Avenue-Brentwood Station – August 23, 2023

FINAL REPORT OF INVESTIGATION A&I E23591

Collision Rhode Island Avenue Station

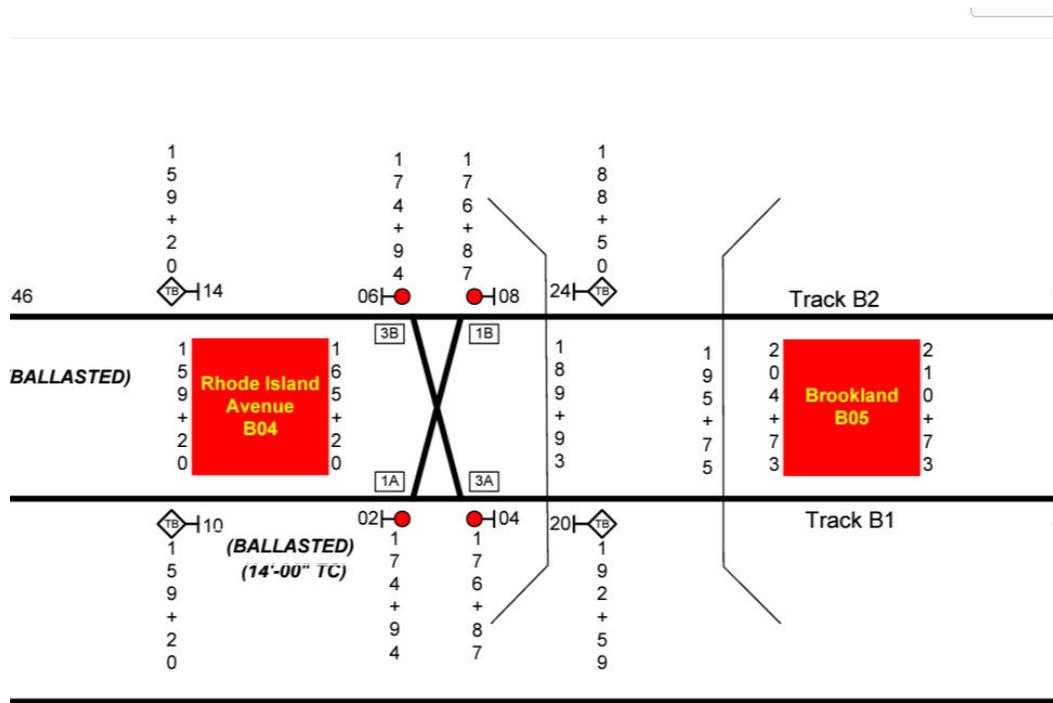
Field Sketch/Schematics

This is an above-ground station with a center platform. Rhode Island Avenue Station contains a Direct Fixation Track, governed by signals B04-06, 08 signals, and B04-02,04 signals. There is an interlocking at CM B2 & B1 174+94 – 176+87. There are two turnback locations at CM B2 188+50 and B1 192+59.

The above depiction is not to scale.

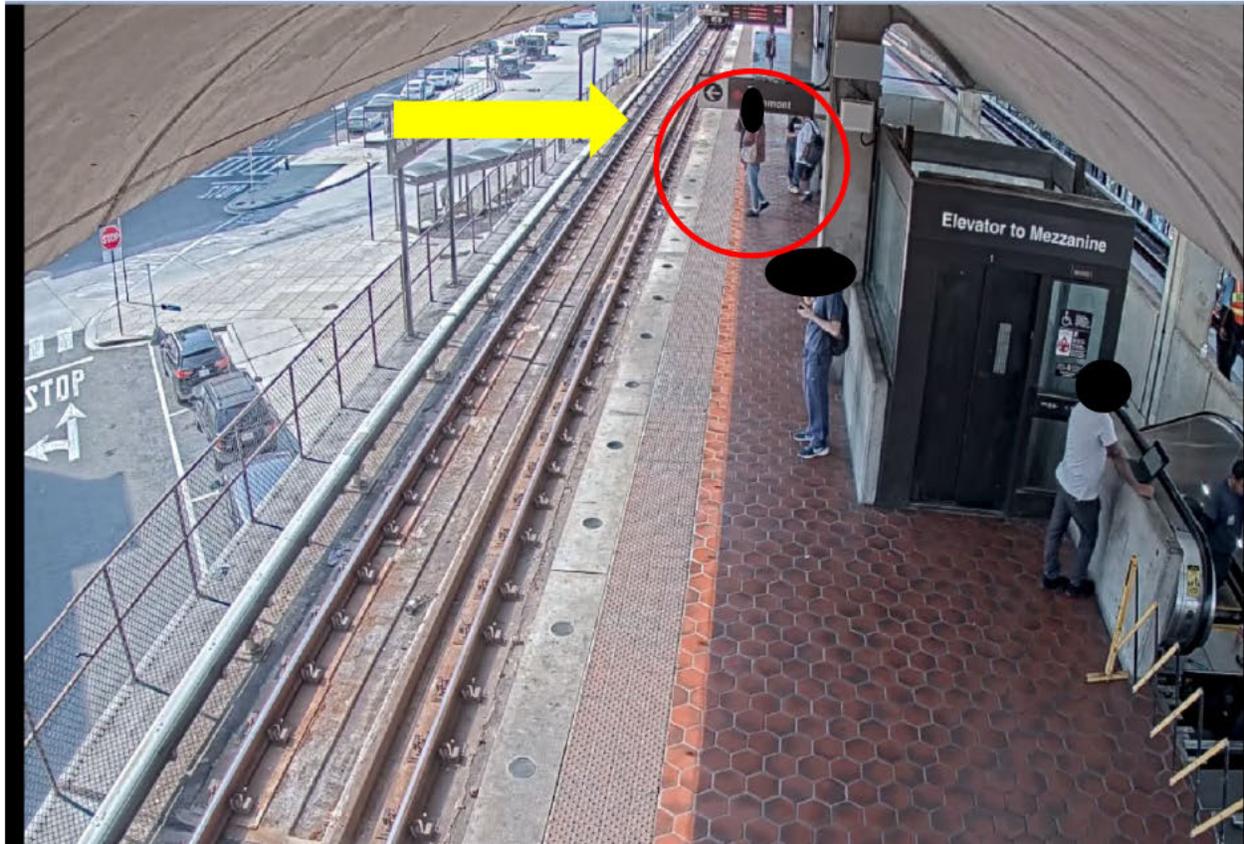
Figure 1 - Injured person on the platform prior to entering the roadway at Rhode Island Avenue Station. The train is entering the platform limits at the top of the image.

A review of CCTV cameras and interview statements from the Train Operator found that the person appeared to enter the rail right-of-way intentionally as the train was entering the platform limits.

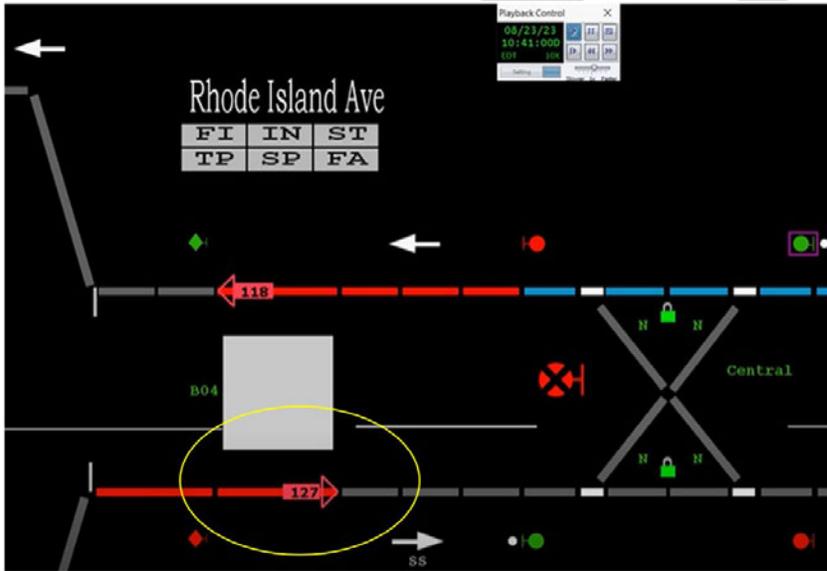
Figure 2 – AIMS Playback of Train ID 127 arriving at Rhode Island Avenue Station at 10:41 hours.

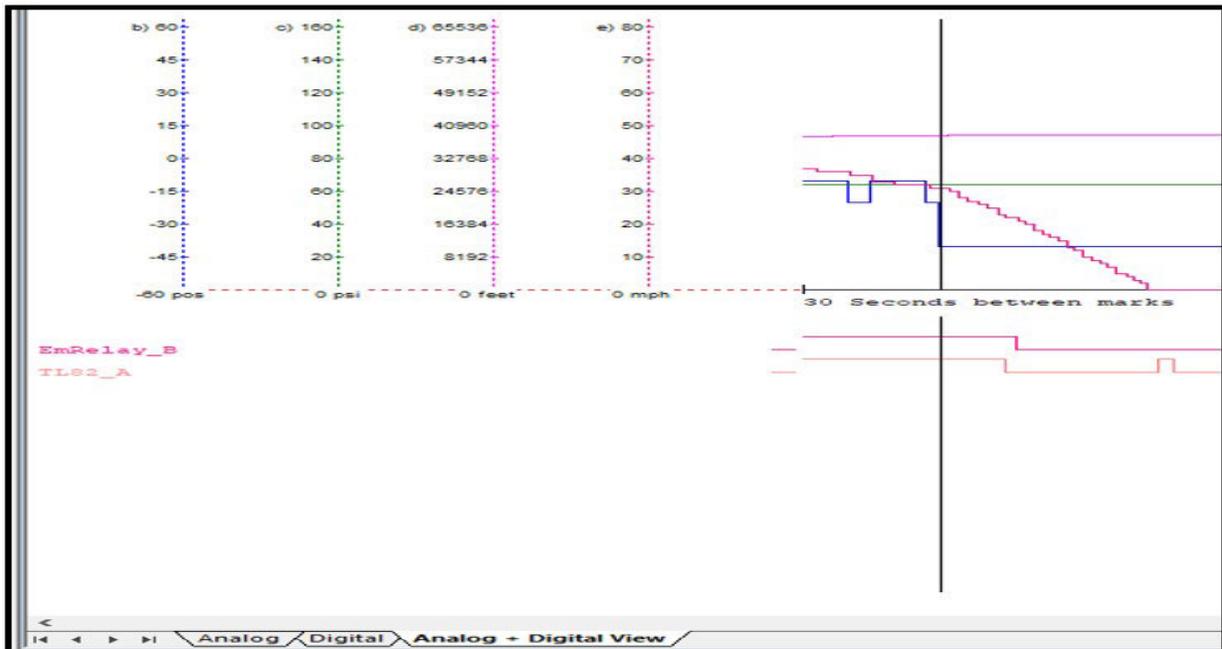
The Railcar data does not show train operator error as a contributing factor in this incident.

Figure 3 VCU Snapshot of Incident Train Note: Times above may vary from other systems' timelines based on clock settings.
