**WMSC Commissioner Brief: W-0262 Collision – near Minnesota Avenue Station – May 1, 2023**

**FINAL REPORT OF INVESTIGATION A&I E23306**

<b>Date of Event:</b>	05/01/2023
<b>Type of Event:</b>	Collision
<b>Incident Time:</b>	22:41 hours
<b>Location:</b>	Minnesota Avenue Station, Track 1, Chain Markers (CMs) D1 272+91 and 310+00
<b>Time and How received by SAFE:</b>	23:17 hours via MAC
<b>WMSC Notification Time:</b>	00:55 hours
<b>Responding Safety Officers:</b>	None
<b>Rail Vehicles:</b>	Train ID 904 L7178-7179.7415-7414.7602-7603.7713-7712T Train ID 907 L7622-7623.7269-7268.7352-7353.7155-7154T
<b>Known Injuries:</b>	Severe Lacerations
<b>Damage:</b>	None
<b>Emergency Responders:</b>	Metro Transit Police Department (MTPD), Office of Rail Transportation (RTRA) Supervisor, District of Columbia Fire and Emergency Medical Services (DCFEMS) Department
<b>SMS I/A Incident Number:</b>	20230502#108170MX

# Minnesota Avenue Station – Collision

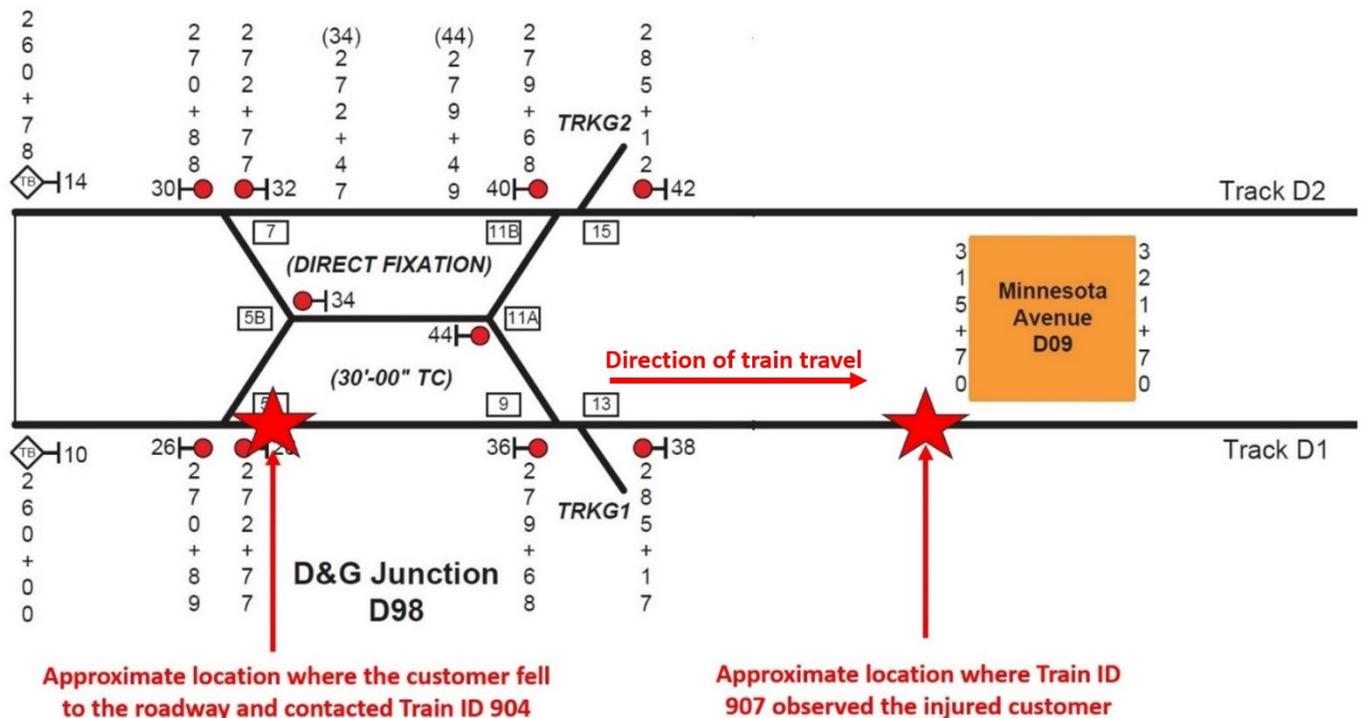
## Field Sketch/Schematics

The customer was observed falling to the roadway from Train ID 904 near CM D1 272+91. The Train Operator of Train ID 907 on Track 1, in approach to the platform limits at Minnesota Avenue Station, observed the injured customer near CM 310+00.

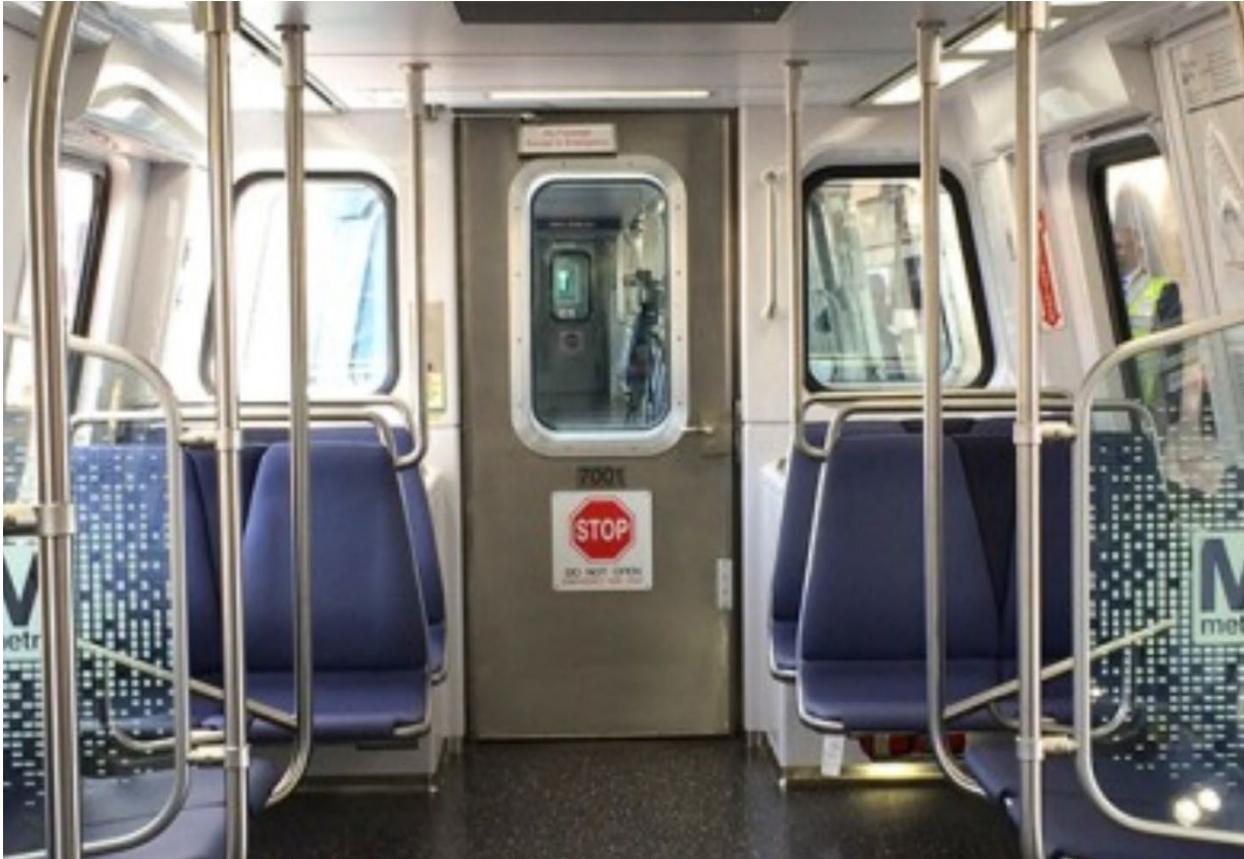
*Image 1 - Sample bulkhead signage on WMATA Railcar prohibiting passage except for emergency use only. (7000 series).*

The probable cause of the collision incident near Minnesota Avenue Station was a customer bypassing marked Emergency Use Only doors separating cars while the train was in motion. The investigation did not identify significant deficiencies in communication or adherence to established response procedures under the direction of responding law enforcement personnel.

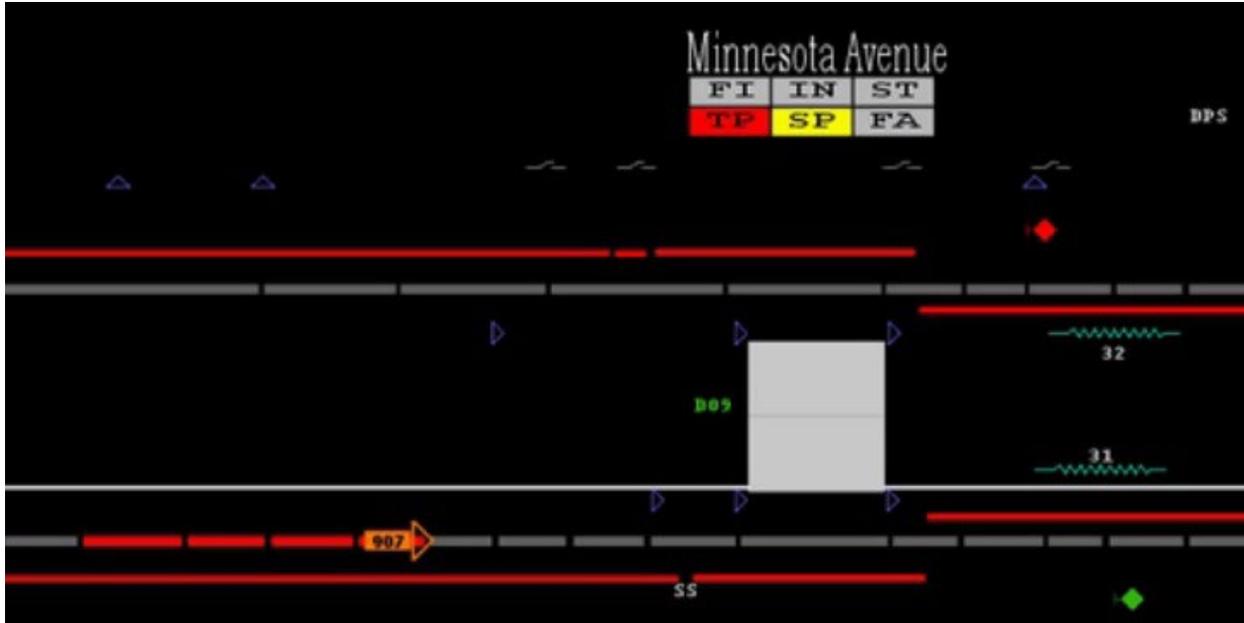
Image 2 - Train ID 907 in approach to Minnesota Avenue Station platform on Track 1 at 23:13:50 hours.

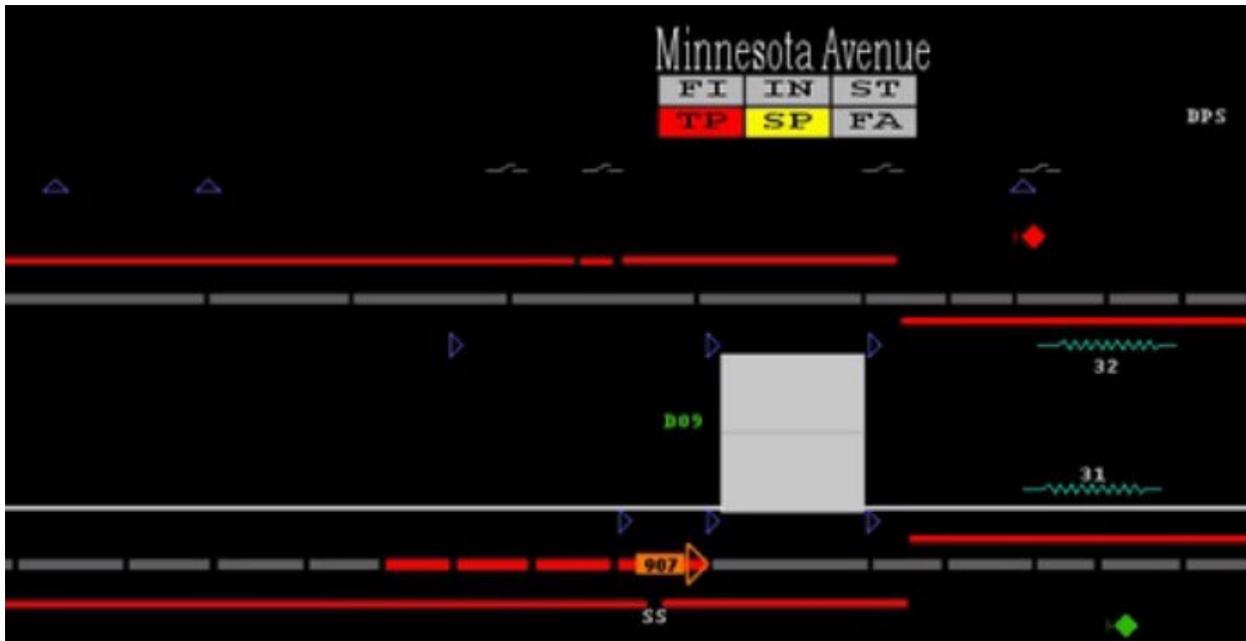
Image 2 - Train ID 907 stopped with a visual of the injured customer near CM D1 313+00 at 23:14:10 hours.

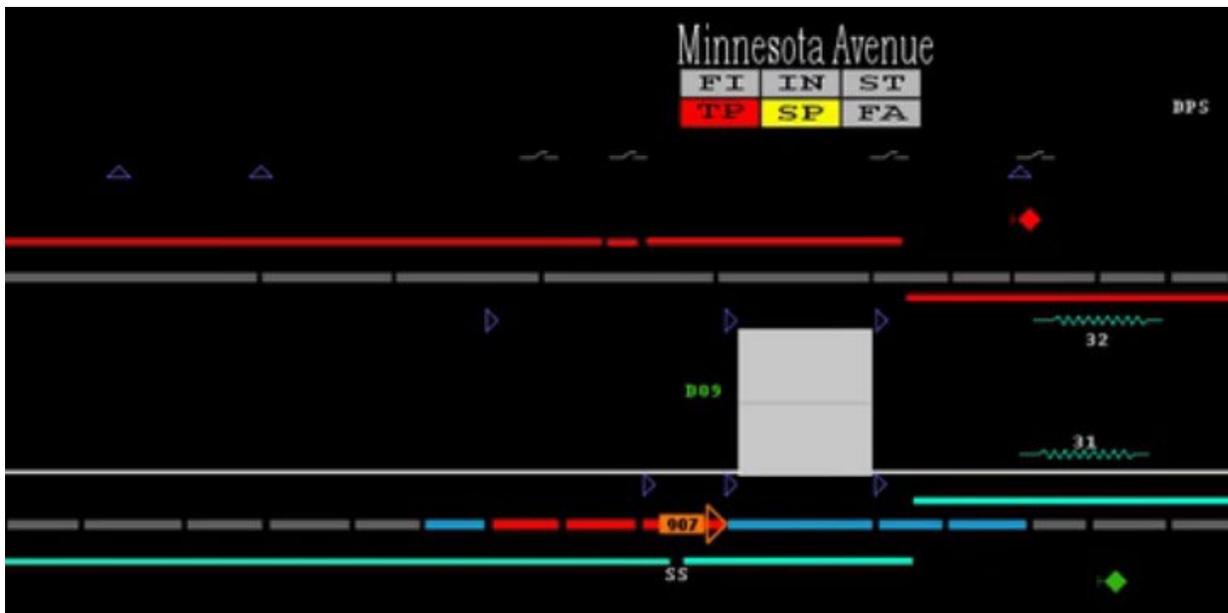
Image 3 – Third rail power was de-energized on Track 1 at 23:19:50 hours.

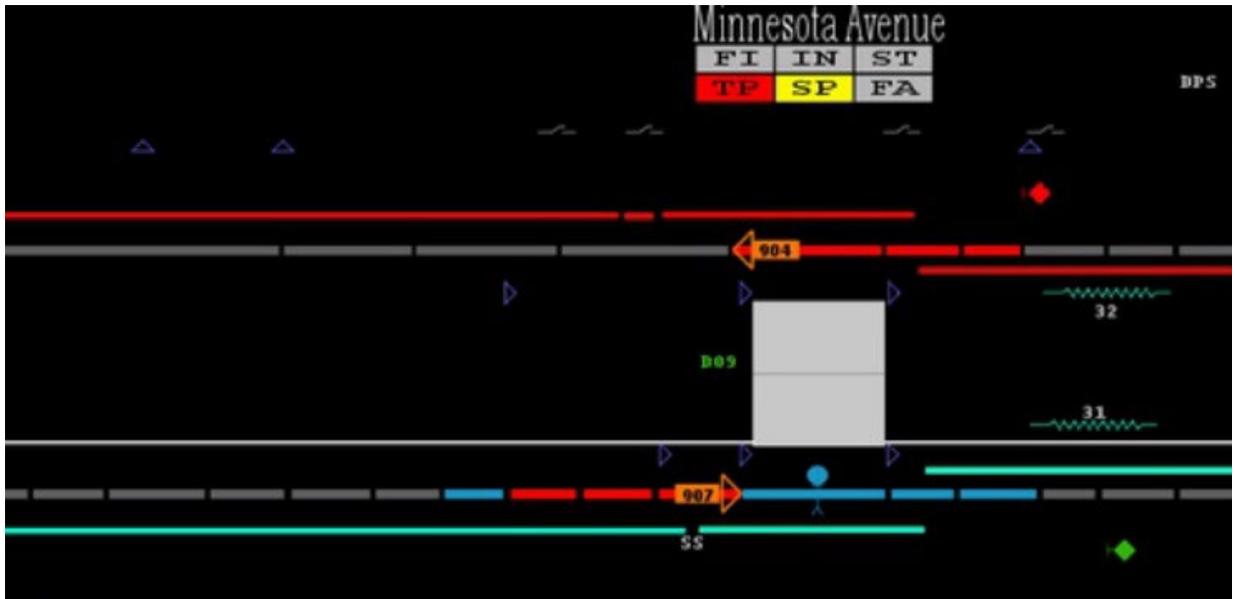
Image 4 – Train ID 904 arrived and was held by MTPD at Minnesota Avenue Station, Track 2, at 23:35:50 hours.

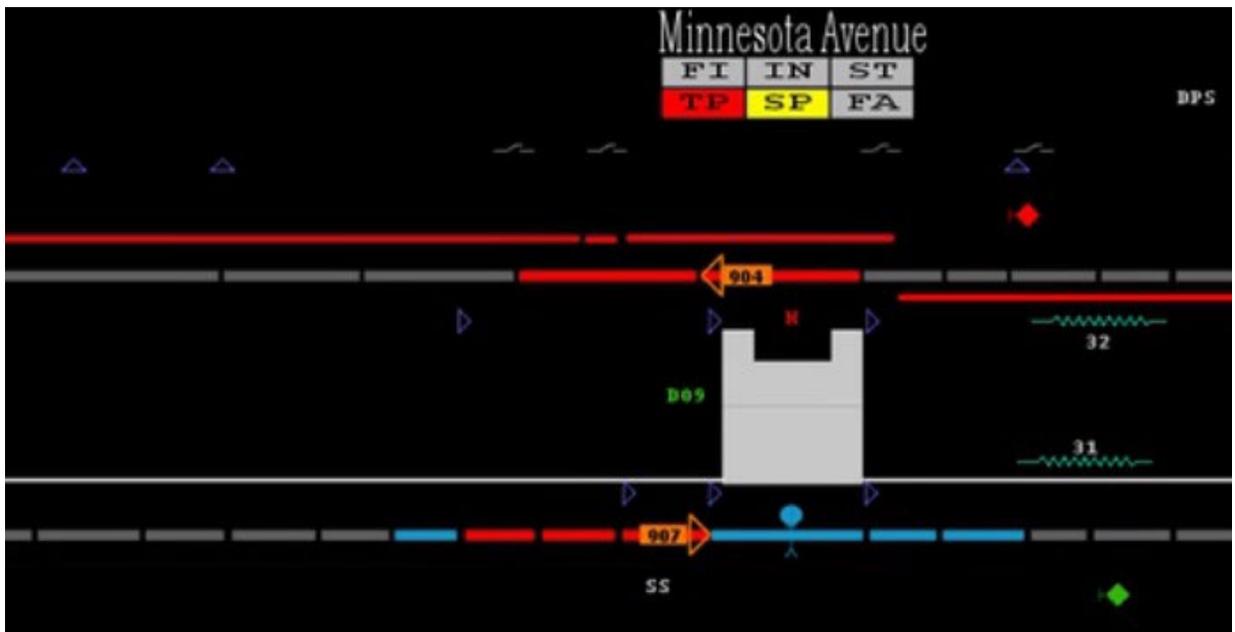
Image 5 – Third rail power was energized on Track 1 at 23:49:20 hours.

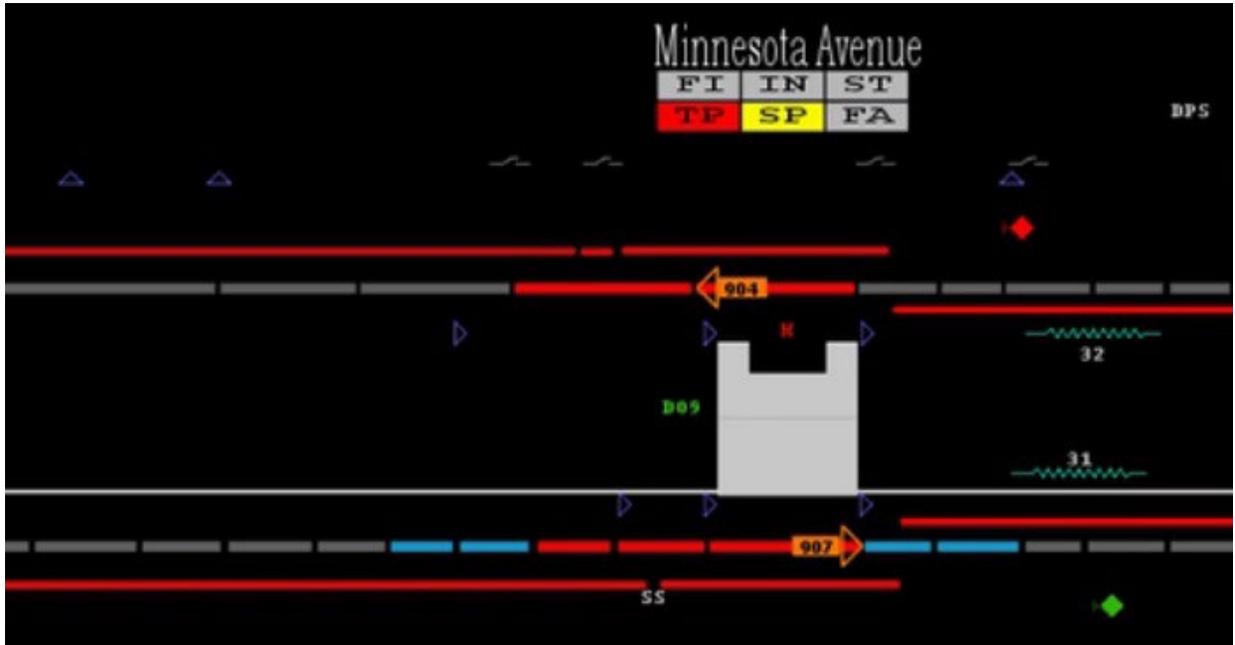
Image 6 – Train ID 907 proceeded to Minnesota Avenue Station, Track 1, to offload customers at 23:52:20 hours. The injured customer was transported to Washington Hospital Center.
