**WMSC Commissioner Brief: W-0266 – Derailment – East Falls Church Station – June 4, 2023**

*Prepared for Washington Metrorail Safety Commission meeting on April 9, 2024*

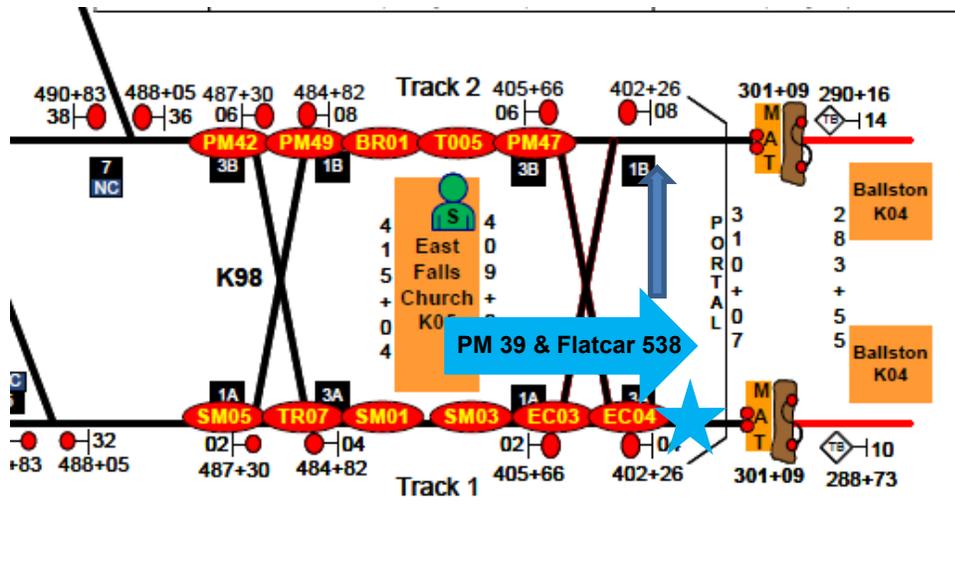
## Purpose and Scope

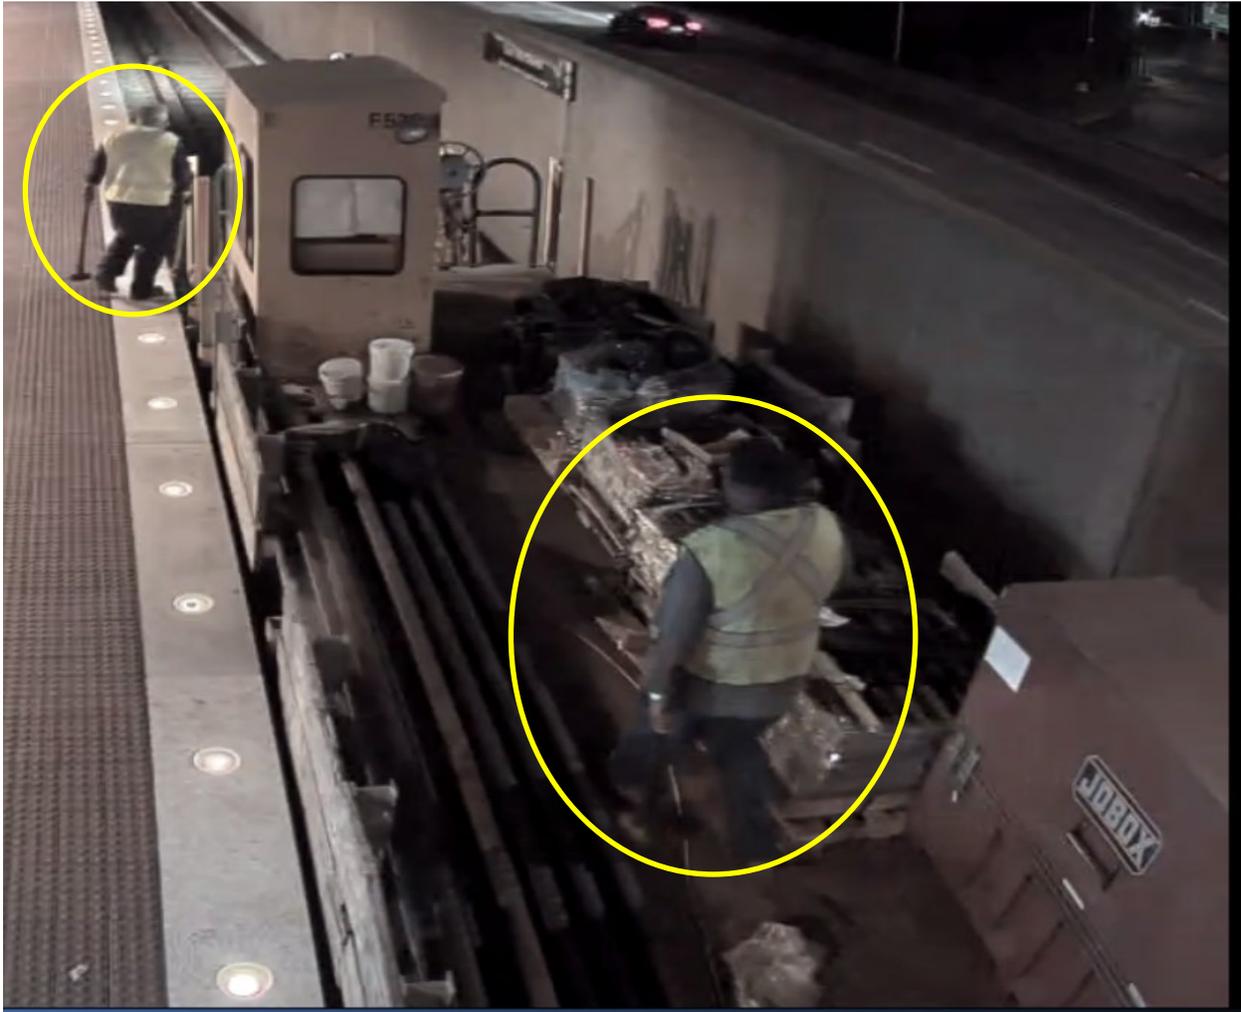
Figure 1 PM-39 East Fall Church Platform loading equipment

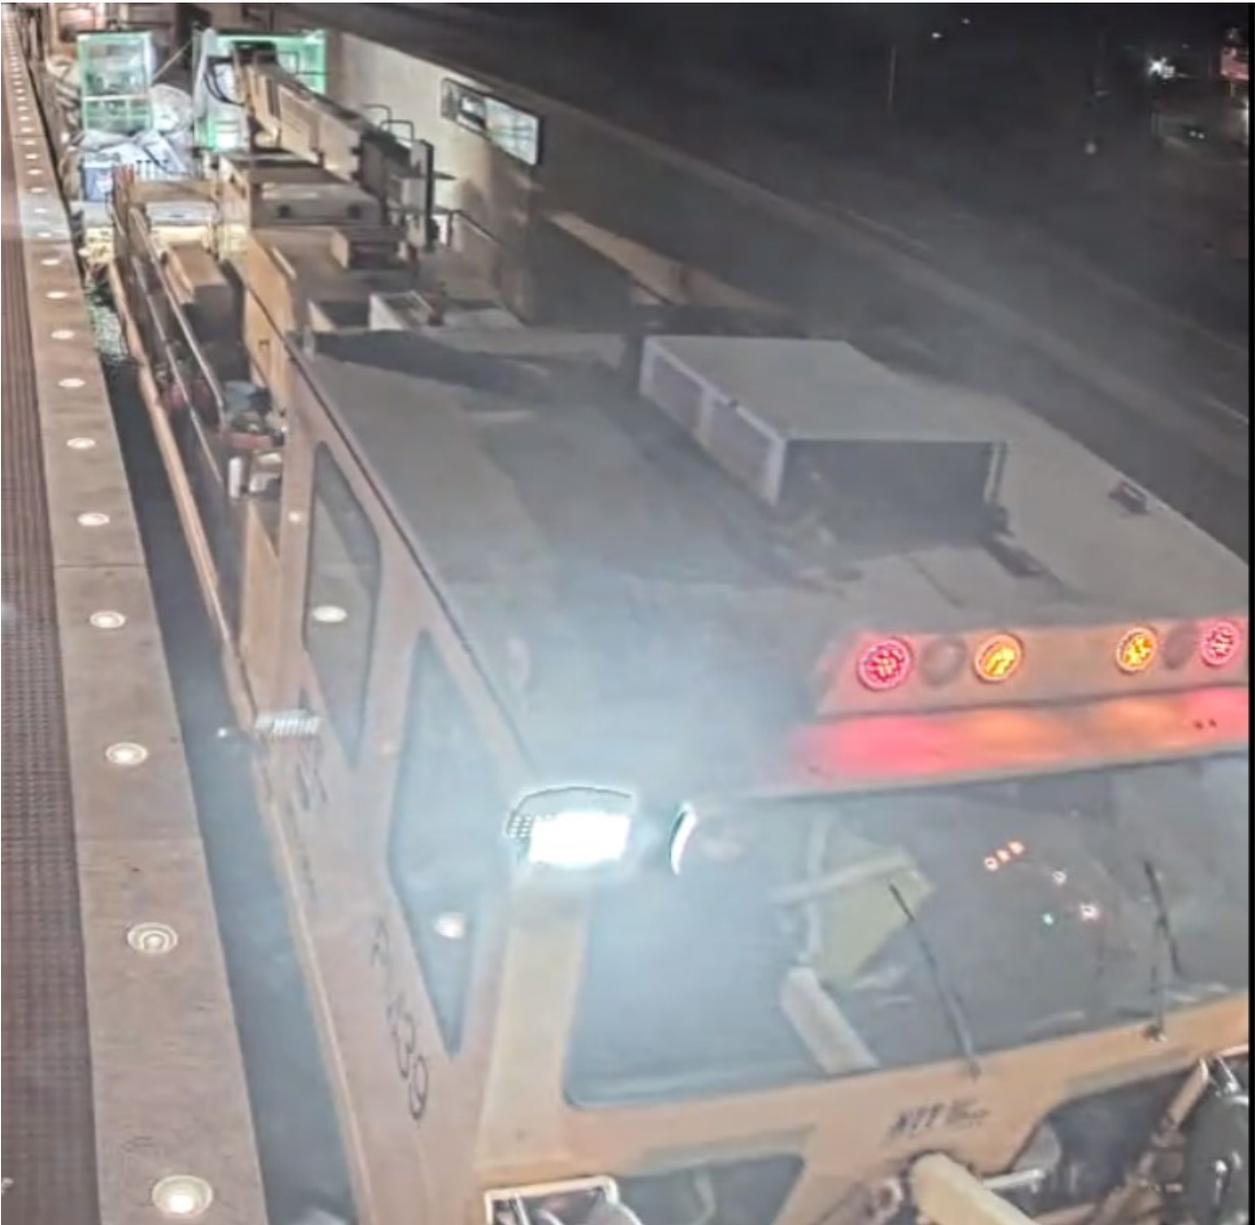
Figure 2 PM 39 enroute to CM 361+00

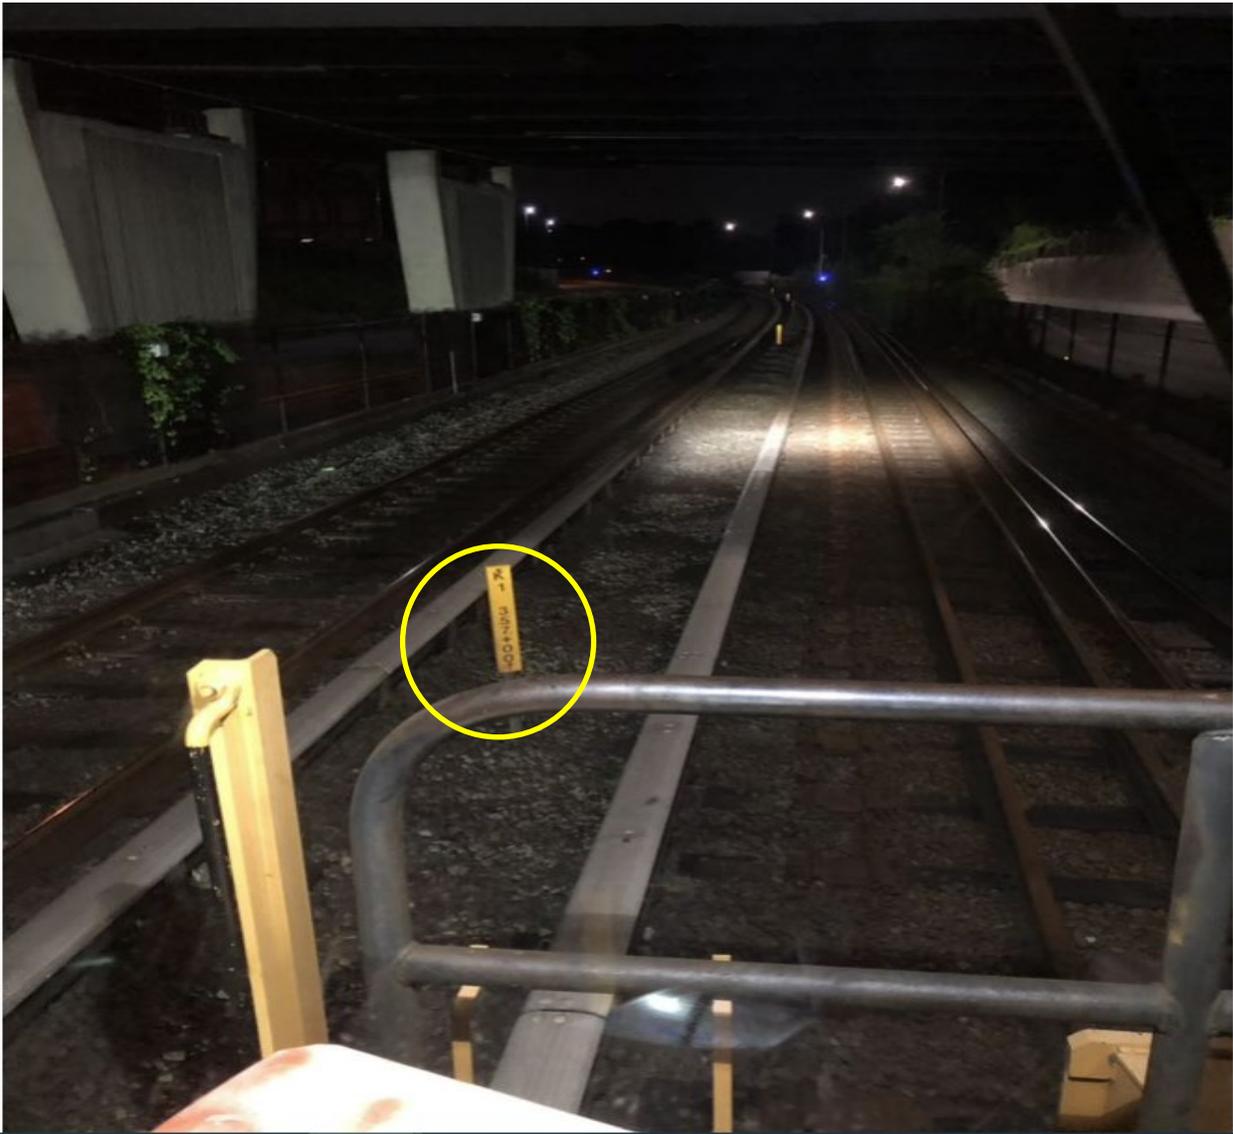
Figure 3 CM 357+00 Place of rest after the derailment.

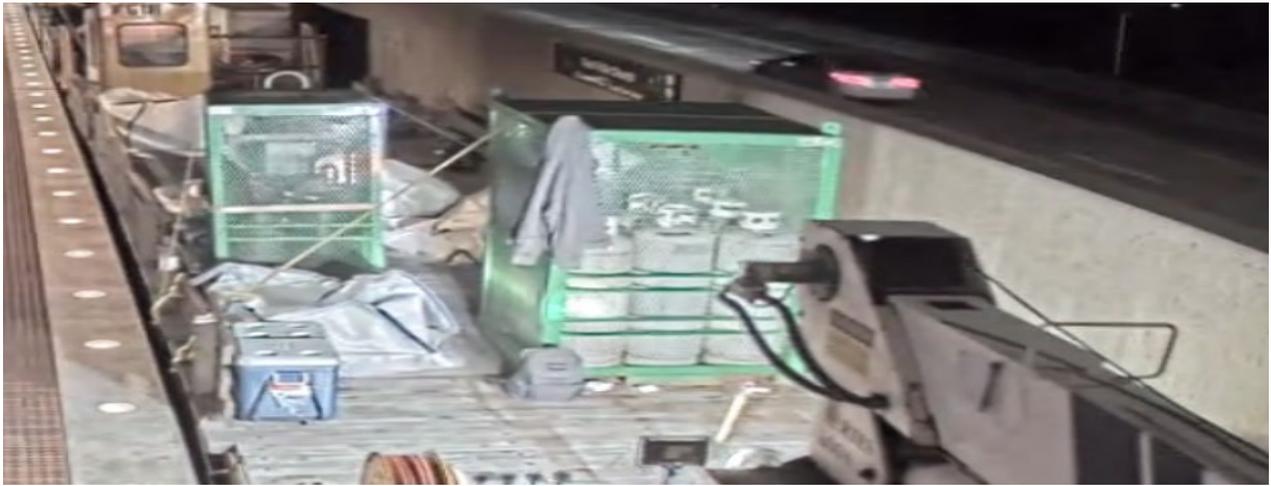
Figure 4 Equipment cages on PM 39

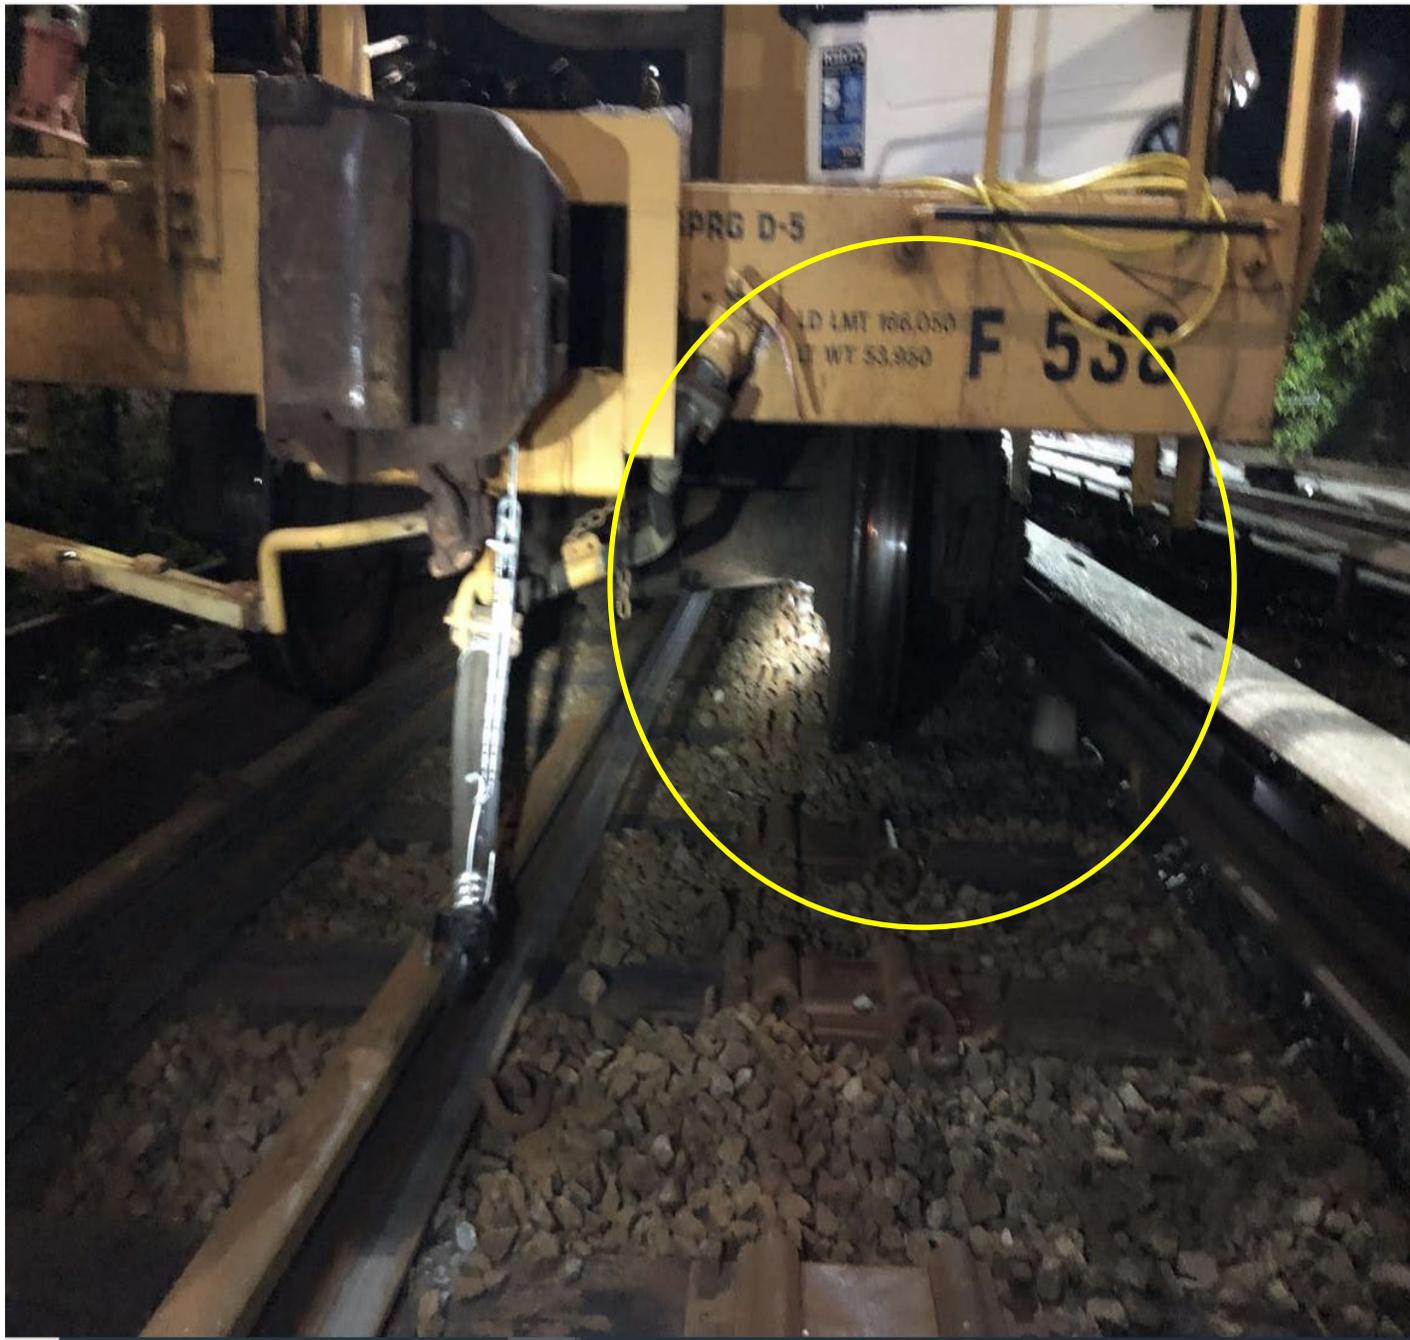
Figure 10 Flat Car 538's front wheelset (Derailment). Note the missing running rail where the rail fasteners are located.

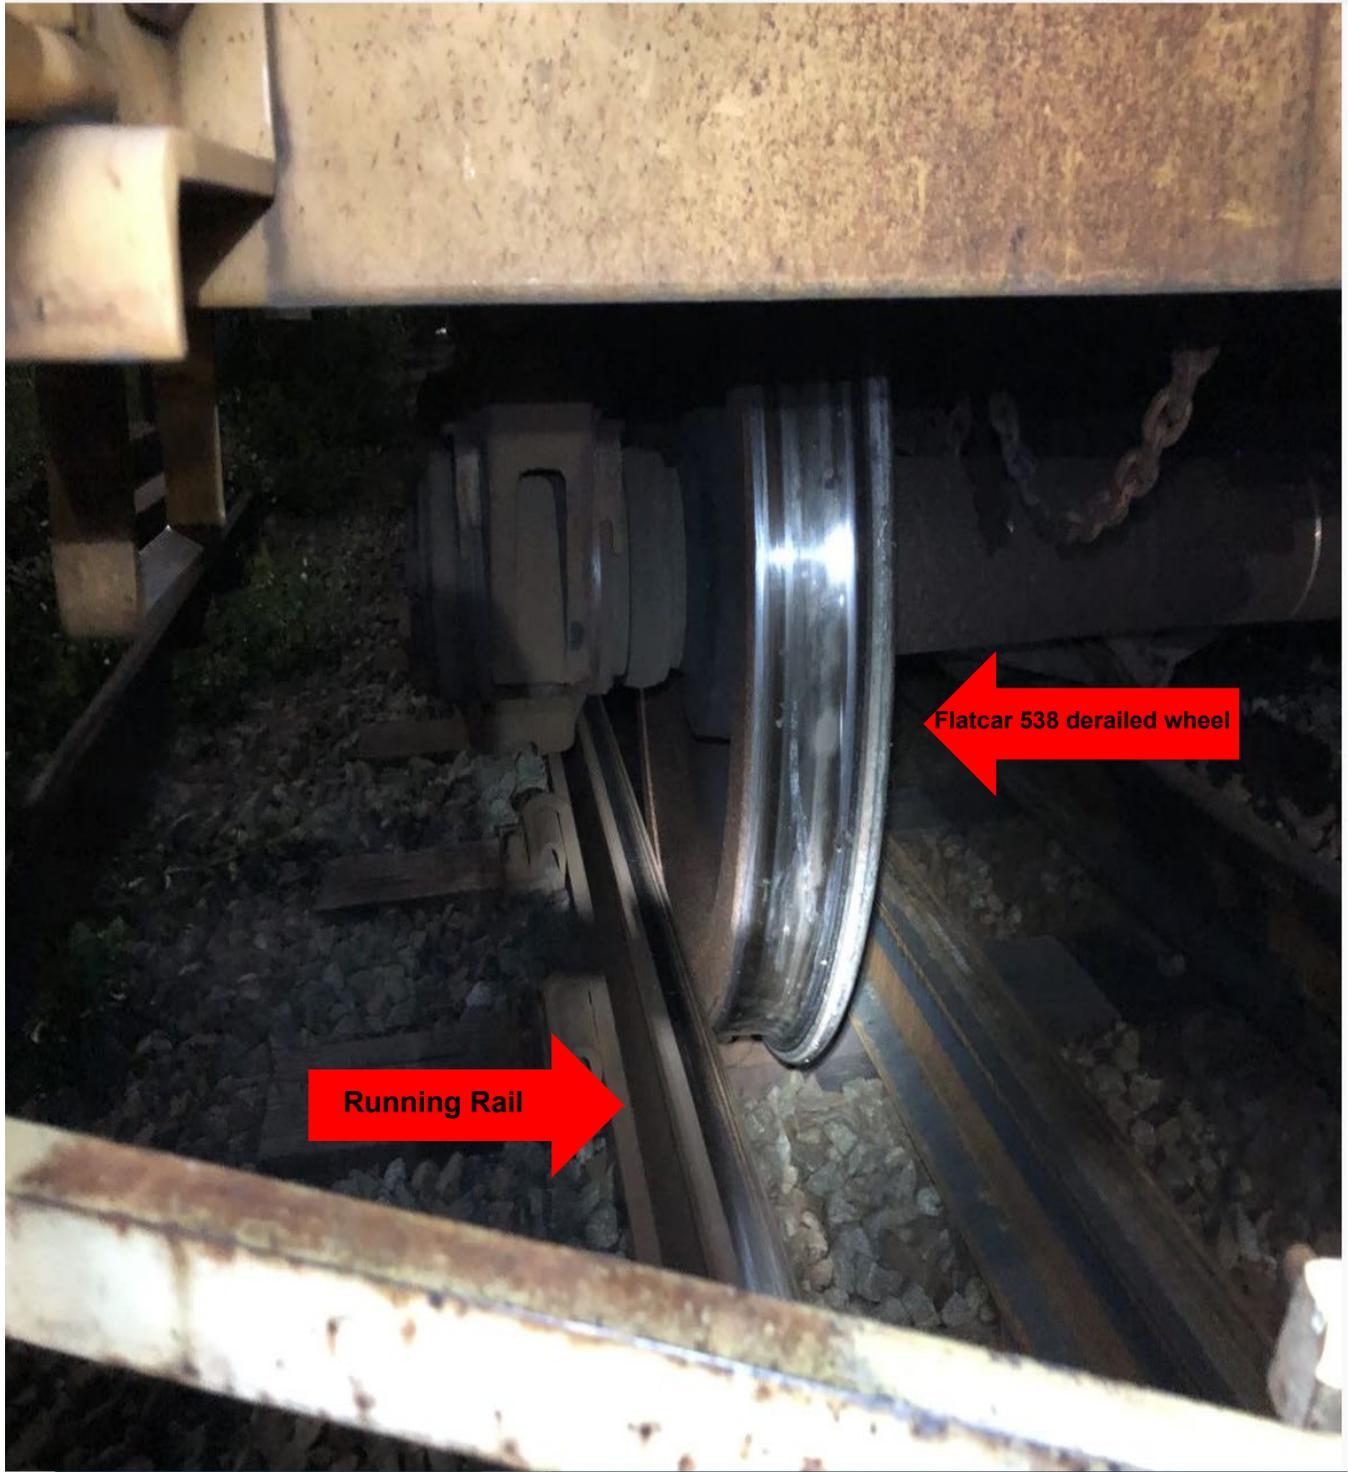
Figure 11 Flat Car 538 front right wheel, derailed to the gauge side (Derailment)

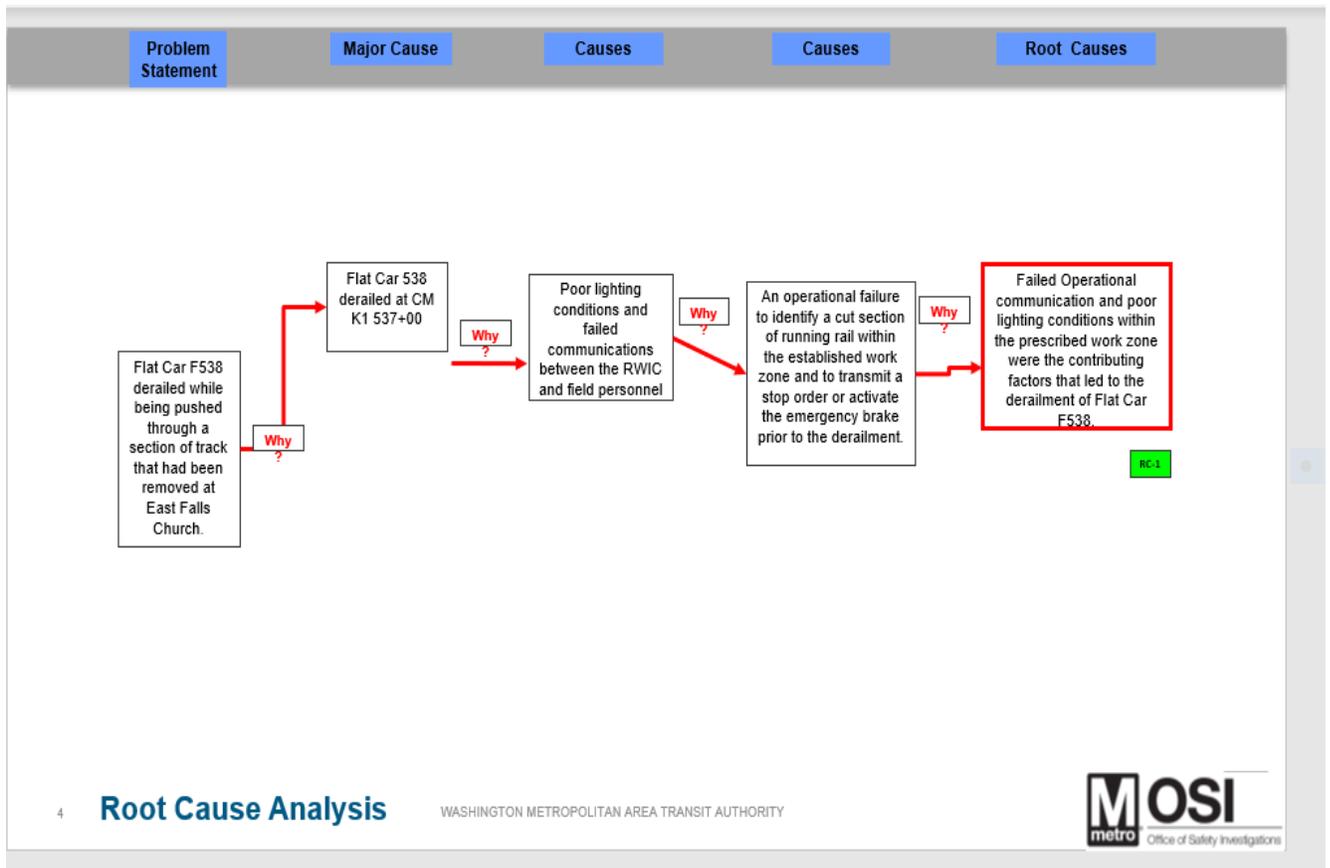
4 **Root Cause Analysis**
