WMSC Commissioner Brief: W-0292 Improper Roadway Worker Protection at Medical Center Station – July 27, 2023

FINAL REPORT OF INVESTIGATION A&I E23521

Date of Event:	July 27, 2023
Type of Event:	Improper Roadway Worker Protection (RWP)
Incident Time:	09:58 hours
Location:	Medical Center Station, Track 2 Chain Marker (CM) A2 407+00
Time and How received by SAFE:	11:10 hours/MAC Notification
WMSC Notification Time:	11:10 hours
Responding Safety Officers:	The Office of Safety Oversight (OSO)
Rail Vehicle:	Train ID 104 (L7204/05X7583/82X7168/69X7651/50T) Train ID 105 (L7086/87X7023/22X7312/13X7097/96T)
Injuries:	None
Damage:	None
Emergency Responders:	None
SMS I/A Number	20230809#110529

Medical Center Station – Improper RWP

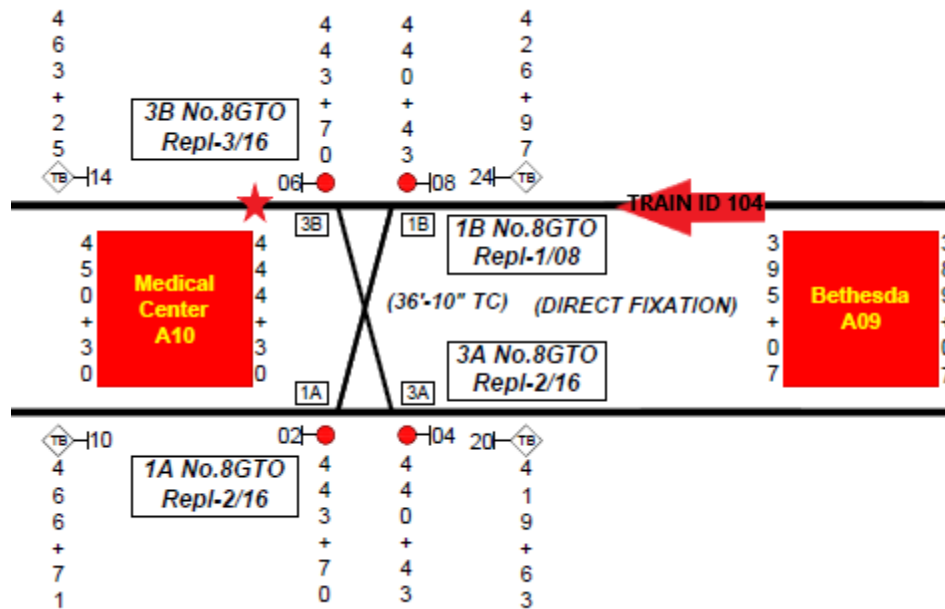
Field Sketch/Schematics

Approximate incident site and location of the incident marked with a "red star." The above depiction is not to scale.

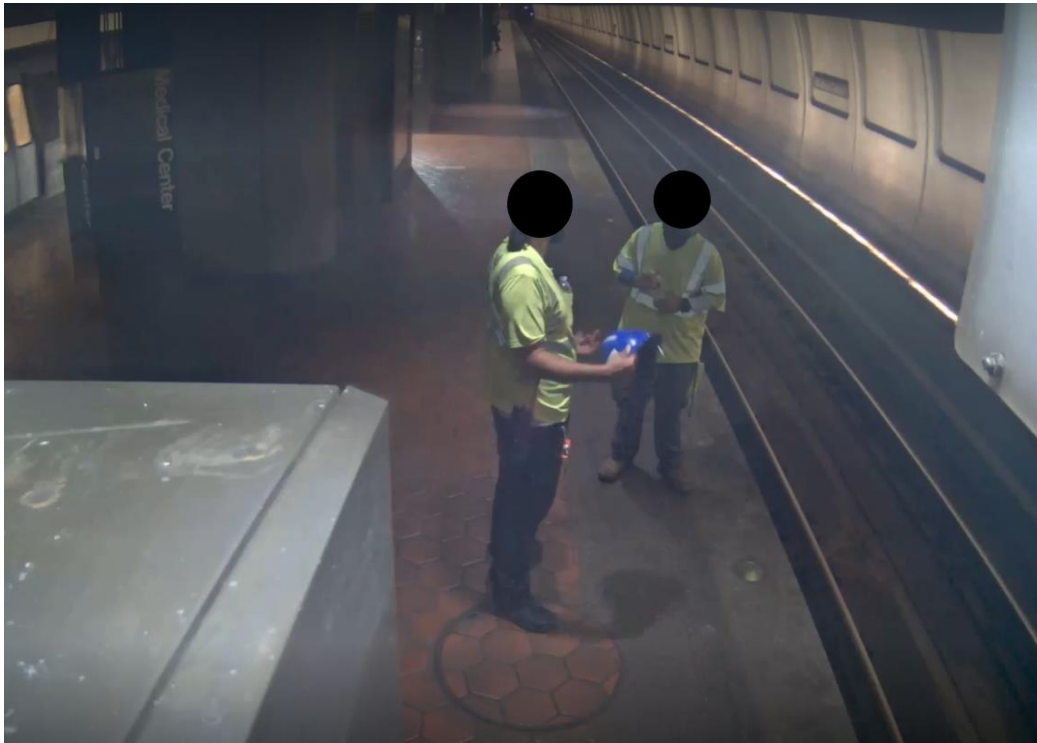
Image 1 – The TRST RWIC and TRST Track Inspector are observed at Medical Center Station on the track 1 side, waiting to continue their track inspection at 09:30 hours.

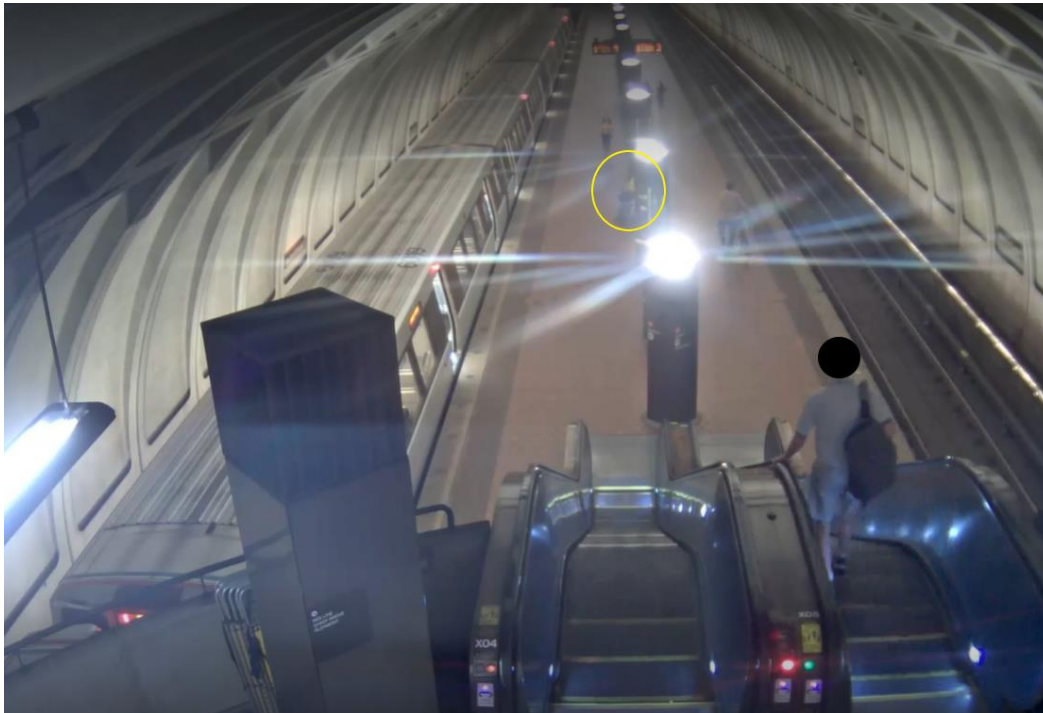
Image 2 – The TRST RWIC and TRST Track Inspector are observed at Medical Center Station seated, orientated towards track 2 at 09:34 hours.

The inspectors acknowledged the mistake of entering the roadway in the wrong direction on the wrong track. In investigative interviews, each inspector stated that they had intended to sit on a bench facing the track they would be walking on, but sat facing the other way due to a rider using the bench. The inspector acting as the Roadway Worker In Charge stated they had not walked this segment of track before. Track numbers are posted on the wall at the end of each station, are posted on each chain maker and can be identified by the normal direction of train travel. The Roadway

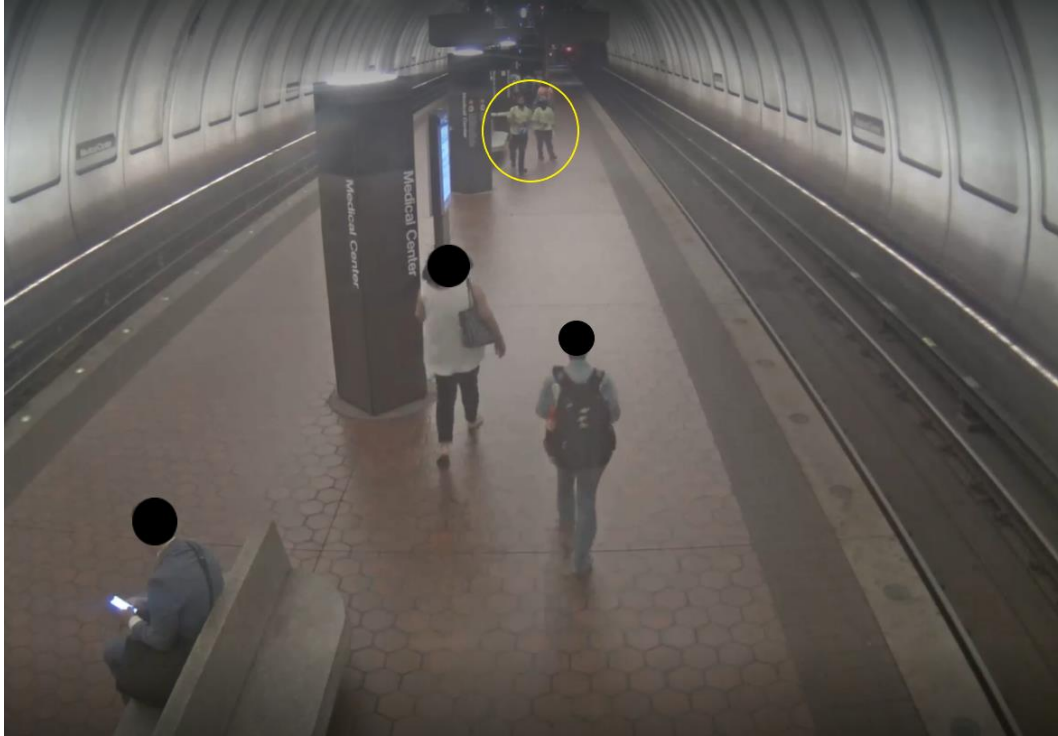
Image 3 – The TRST RWIC and TRST Track Inspector are observed at Medical Center Station after having received permission to enter the roadway at 09:42 hours.

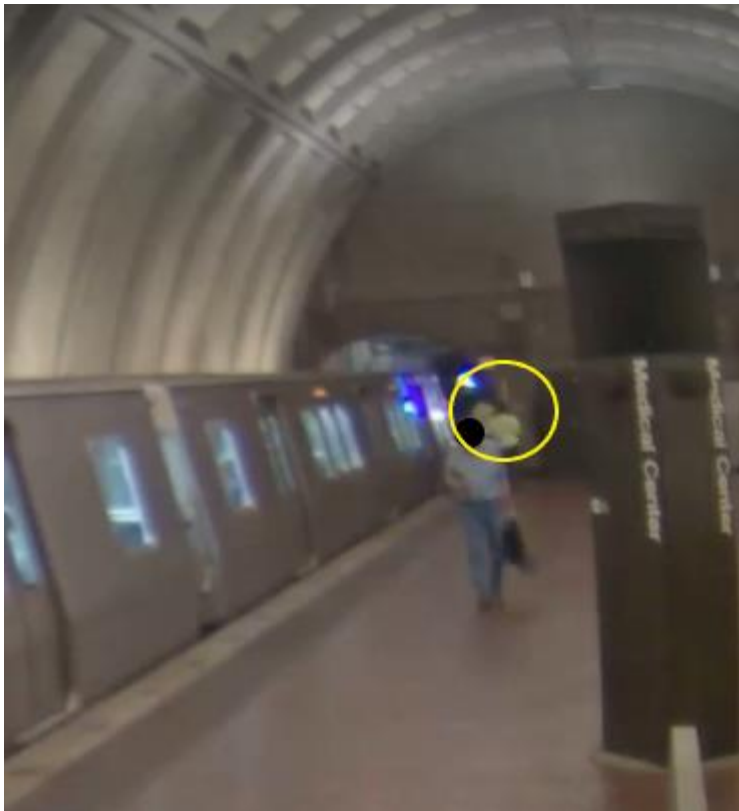
Image 4– The TRST RWIC and TRST Track Inspector are observed at Medical Center Station eight car marker entering the roadway towards Bethesda Station, track 2 at 09:43 hours.

A review of Closed-Circuit Television (CCTV) verified that both the TRST RWIC and the Track Inspector initiated their movement on track 2, proceeding back toward Bethesda Station.

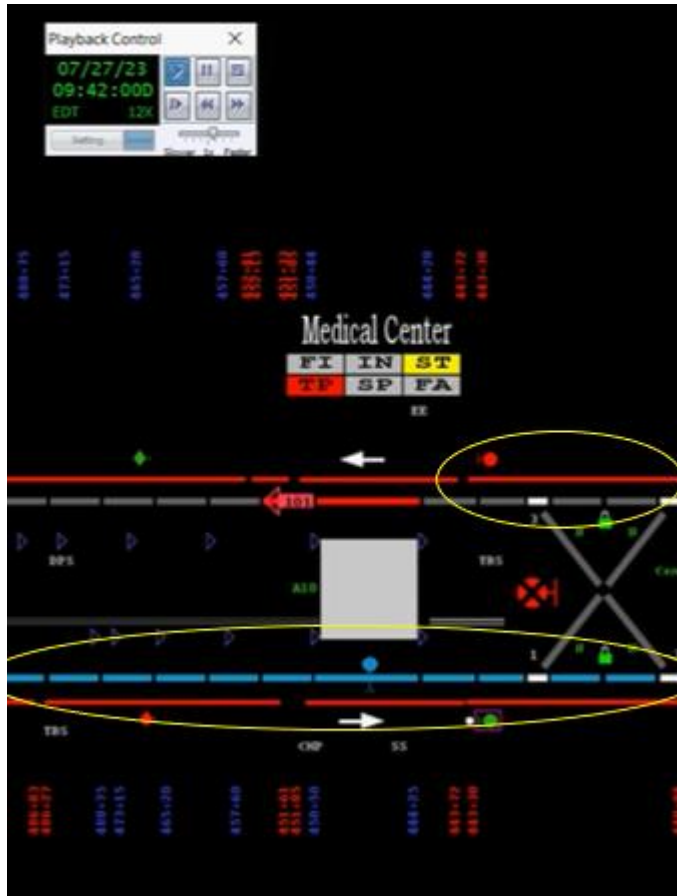
Figure 1 – AIMS depicting a blue block established for track 1, between Medical Center and Grosvenor-Strathmore Stations. Note the absence of the blue block between Medical Center and Bethesda Stations, track 2.

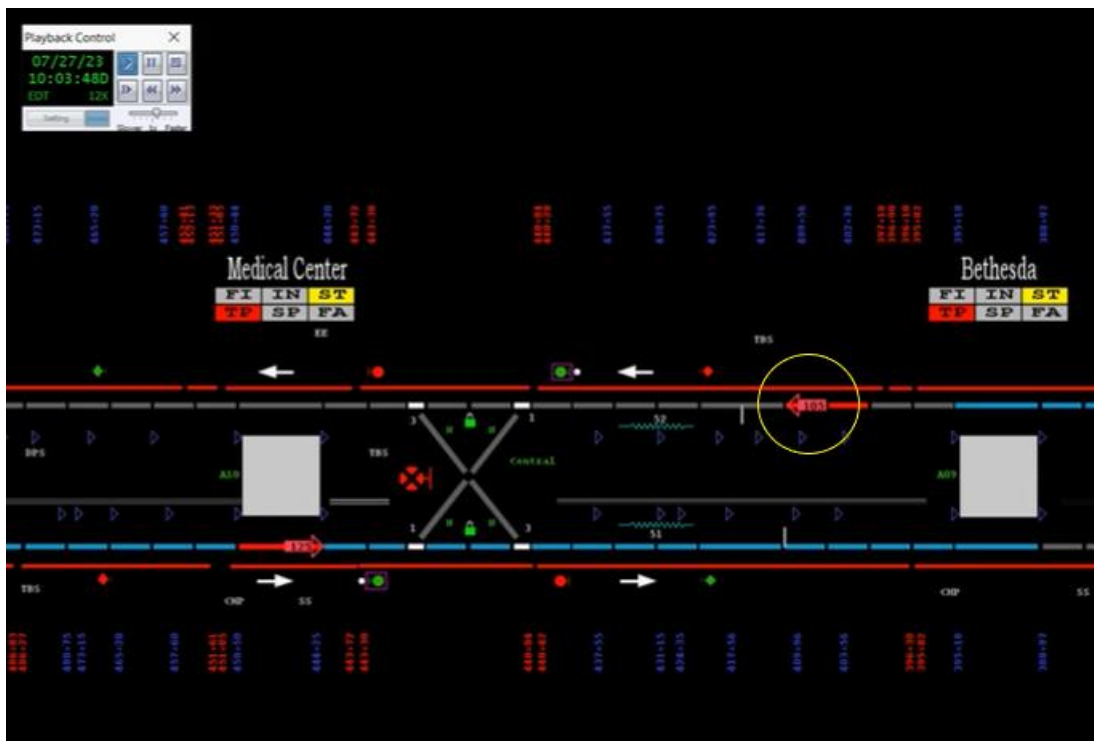
Figure 3 – AIMS depicting Train ID 105 stopped retrieved the RWIC and Track Inspector at approximately 10:03 hours.

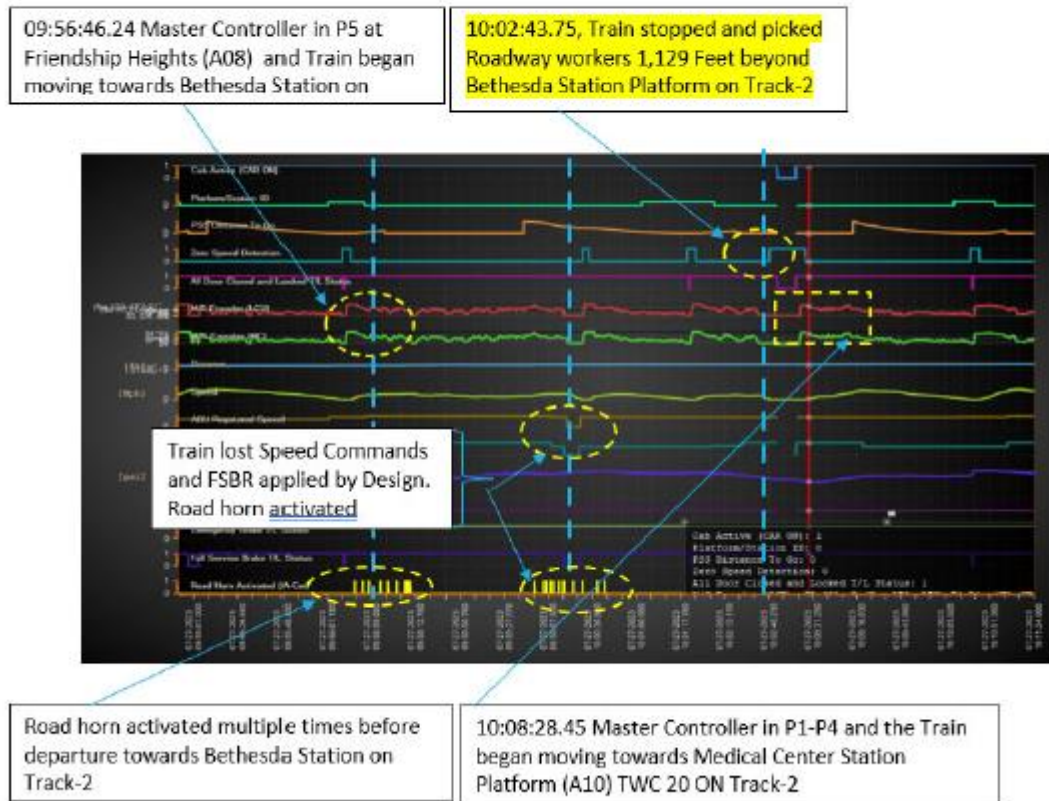
Lead Car 7086 ER Analysis Graph #1

Graph 1 - VMS Data readout for Train ID 105 for the incident.

“IIT has completed the required download and analysis of this incident. Train ID 105 departed from Friendship Heights (A08) and activated the road horn multiple times during departure. Train ID 105 lost speed commands between Friendship Heights and Bethesda and regained speed commands. Train ID stopped for Roadway workers 1,129 Feet beyond the Bethesda Station Platform.

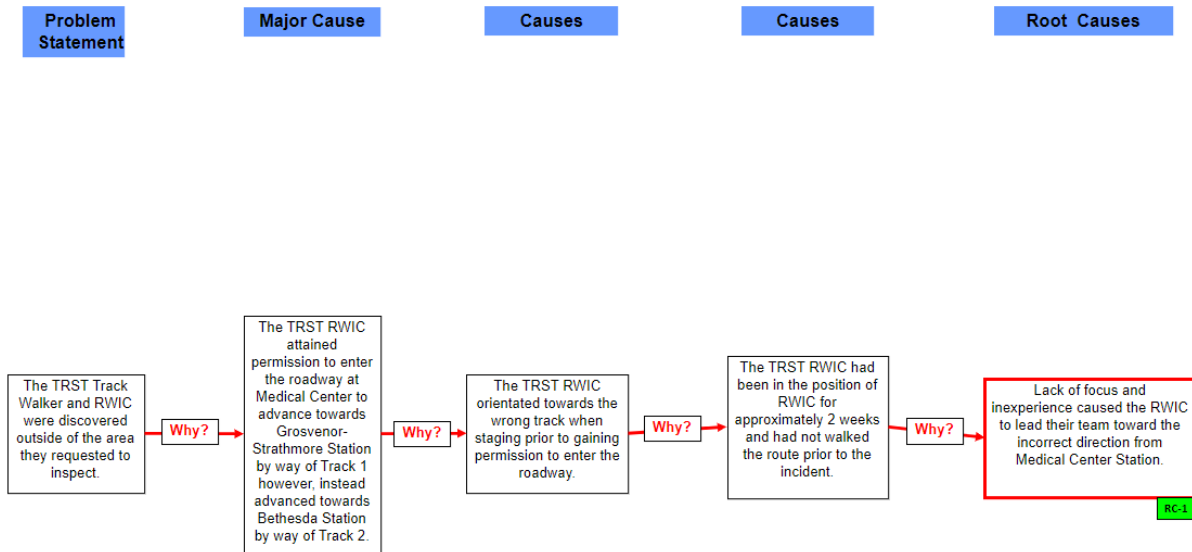
Appendix D – Why-Tree Analysis

The probable cause of the Improper RWP event on July 27, 2023, between Bethesda Station and Medical Center Station on track 2 was the RWIC's inattention to their location and orientation and inexperience in their role as a RWIC.
