W-0328 Collision – Forest Glen Station – August 18, 2023

FINAL REPORT OF INVESTIGATION A&I E23573

Date of Event:	August 18, 2023
Type of Event:	Collision
Incident Time:	11:56 Hours
Location:	Forest Glen Station, track 1
Time and How received by SAFE:	11:58 Hours – SAFE/MAC
WMSC Notification Time:	12:27 Hours
Responding Safety Officers:	WMATA: OEP WMSC: None Other: None
Rail Vehicle:	Train ID 110 L3133/32x3176/77x3152/53T
Injuries:	Serious, Life-Threatening Injuries
Damage:	Rail Car 3133: TWC Antenna and Brackets
Emergency Responders:	Montgomery County Fire & Rescue Service (MCFRS), Metro Transit Police Department (MTPD)
SMS I/A Incident Number:	20230818#110766

Forest Glen Station – Collision

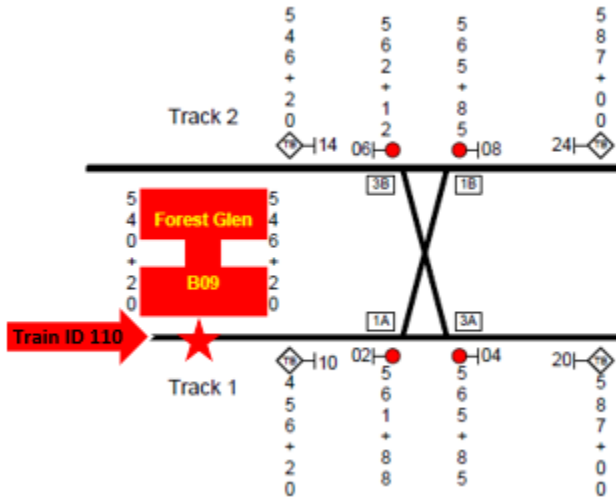
Field Sketch/Schematics

Forest Glen Station, track 1, CM 540+20

The above depiction is not to scale.

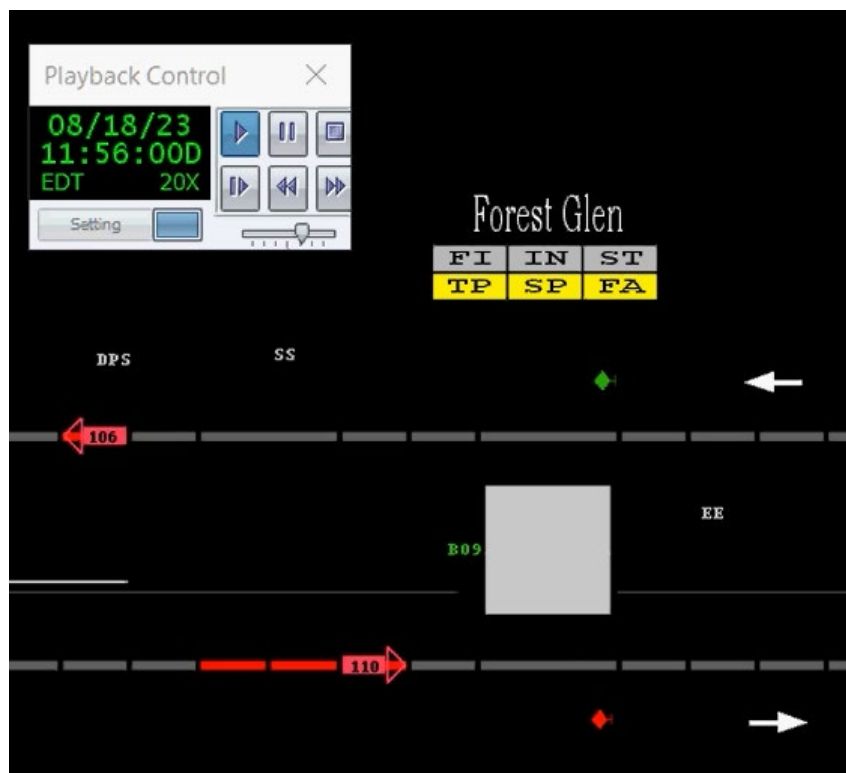
On Friday, August 18, 2023, a review of the Closed-Circuit Television (CCTV) revealed that at 11:56:26 hours, the person entered the rail right-of-way intentionally, as the train was entering the platform limits at Forest Glen Station on track 1.

Figure 1 - Train ID 110 at Forest Glen Station, track 1 at 11:56 hours.

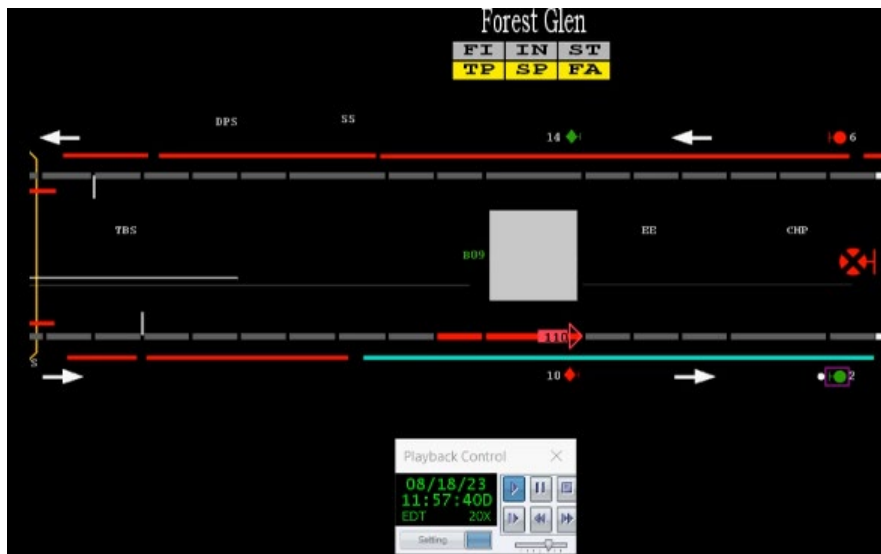
The Advanced Information Management System (AIMS) playback revealed that third-rail power was de-energized at 11:57:40 hours.

Figure 2 – Third rail power de-energized at Forest Glen Station on track 1.

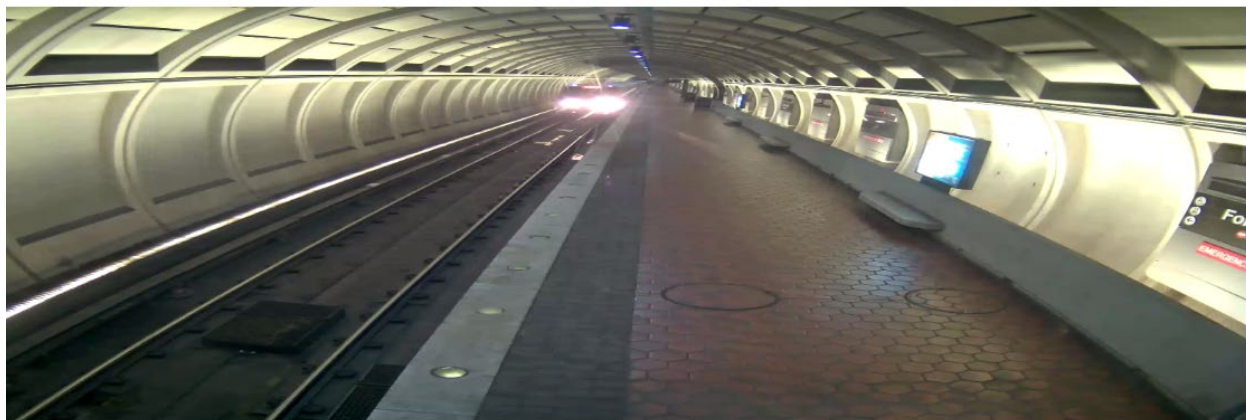
Image 1 – Image of Train ID 110 stopped after striking the person on the roadway at 11:56:26 hours..

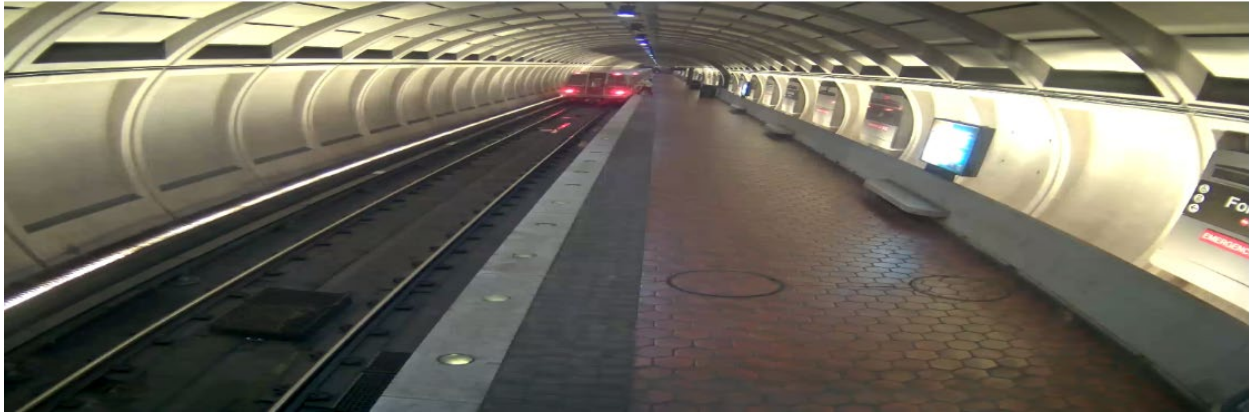
Image 2 – Image of the Train Operator on the platform performing an inspection at 11:58:46 hours.

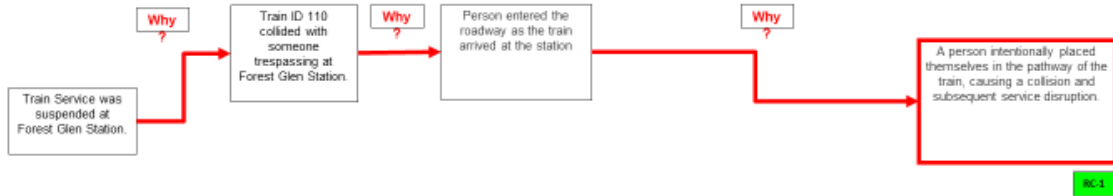
Appendix F – Why-Tree Analysis

The probable cause of the collision at Forest Glen Station on August 18, 2023, was a person's action to place themselves on the roadway for unknown reasons. No mechanical deficiencies or human factors errors were identified that contributed to this event.

5 Root Cause Analysis
