W-0340 Collision – Spring Hill Station – February 8, 2024

FINAL REPORT OF INVESTIGATION A&I E24114

Spring Hill Station – Collision

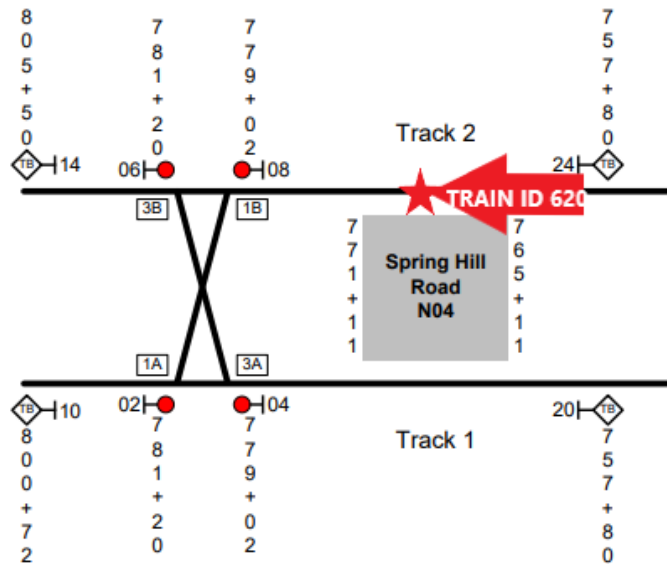
Field Sketch/Schematics

The above depiction is not to scale.

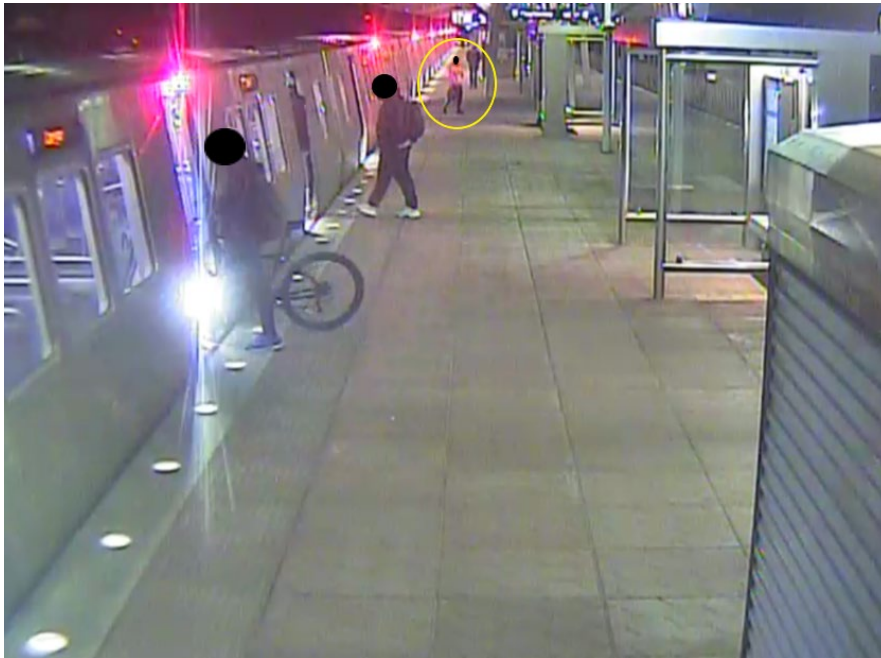
Image 1: Subject Customer arrived on track 1, Spring Hill Station, at 20:30 hours.

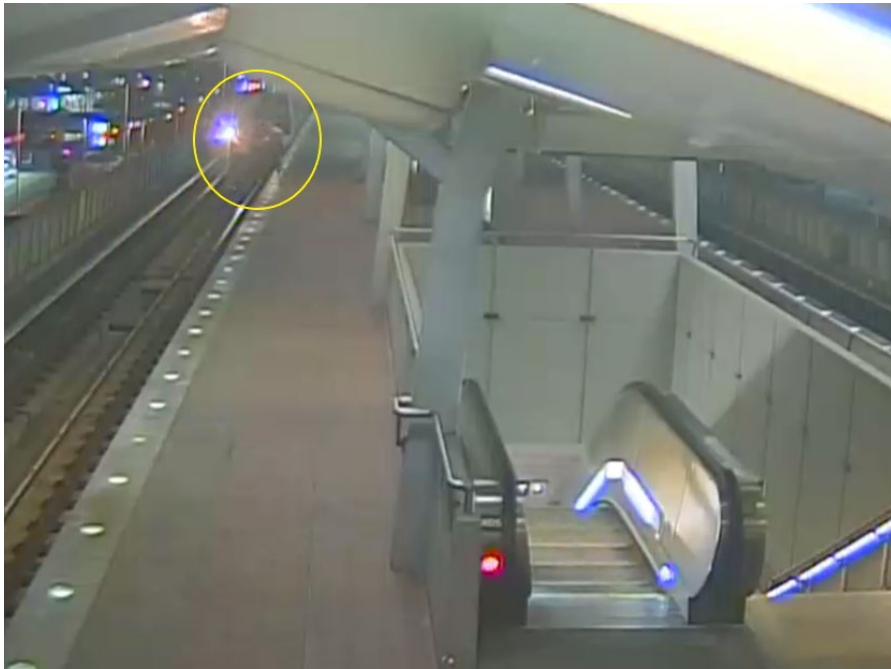
Image 2: The subject customer was observed jumping in front of Train ID 620 at 22:34 hours.

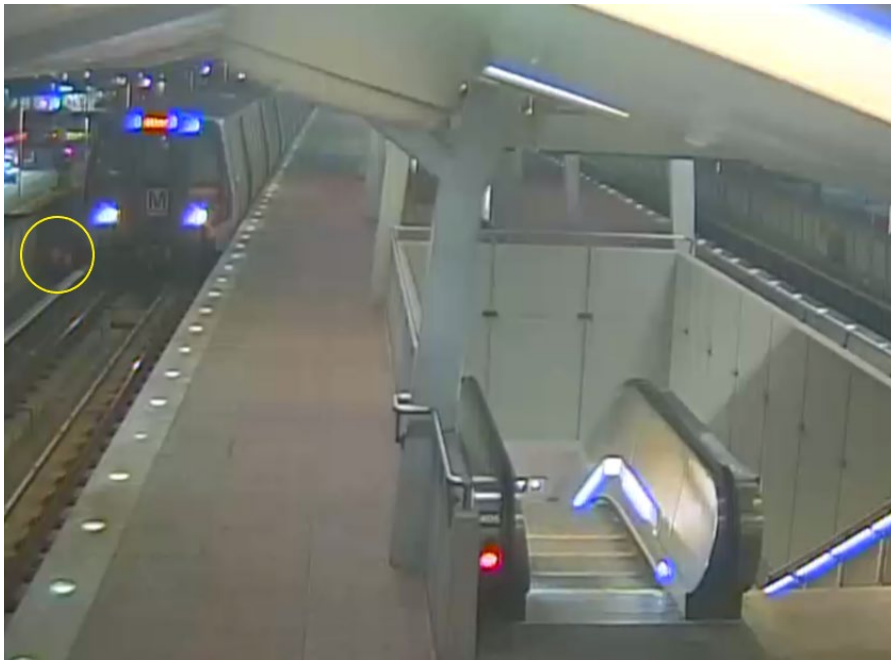
Image 3: Subject customer was observed on the wall side of the third-rail to the side of Train ID 620 at 20:35 hours.

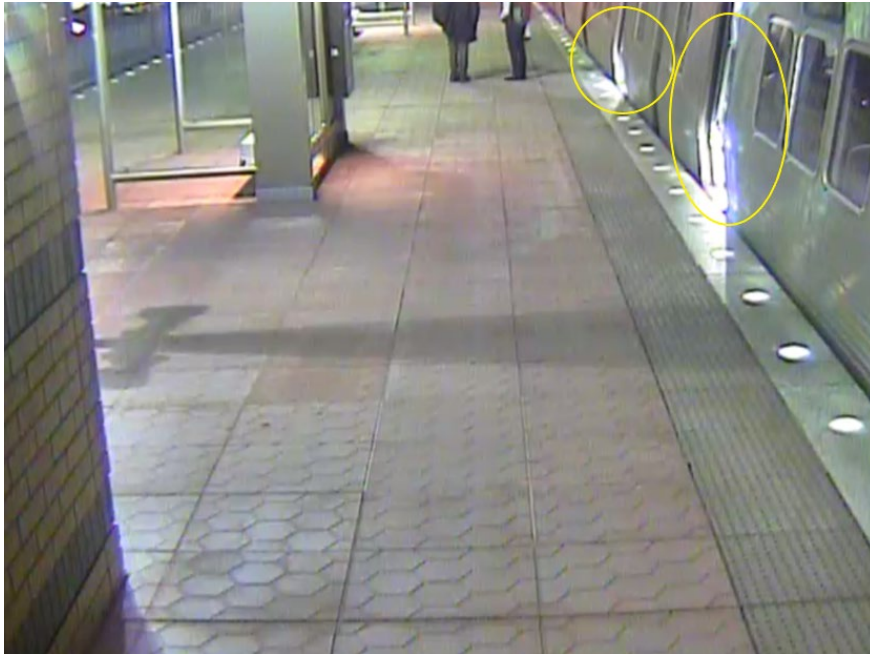
Image 6: Train ID 620 commenced alighting customers at 20:43 hours.

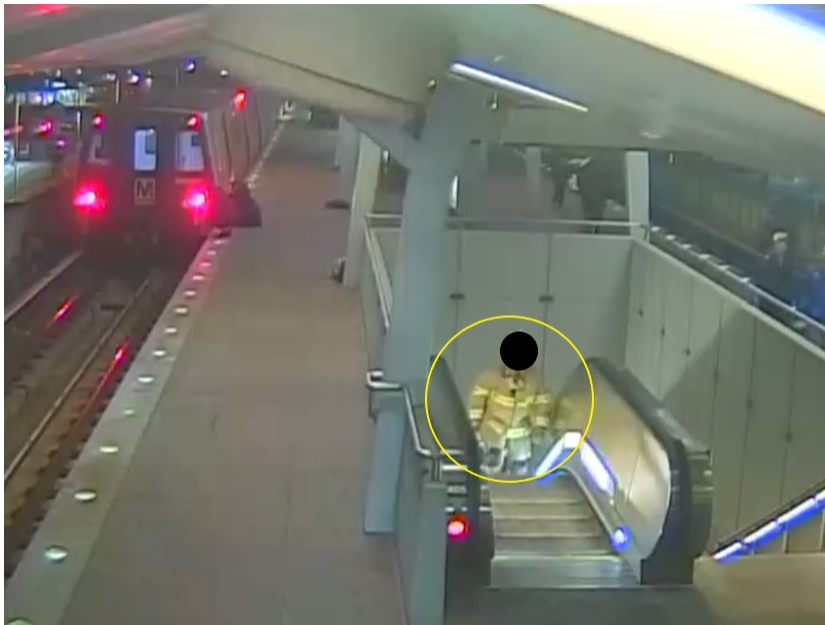
Image 7: FCFRD arrived on scene at 20:44 hours.

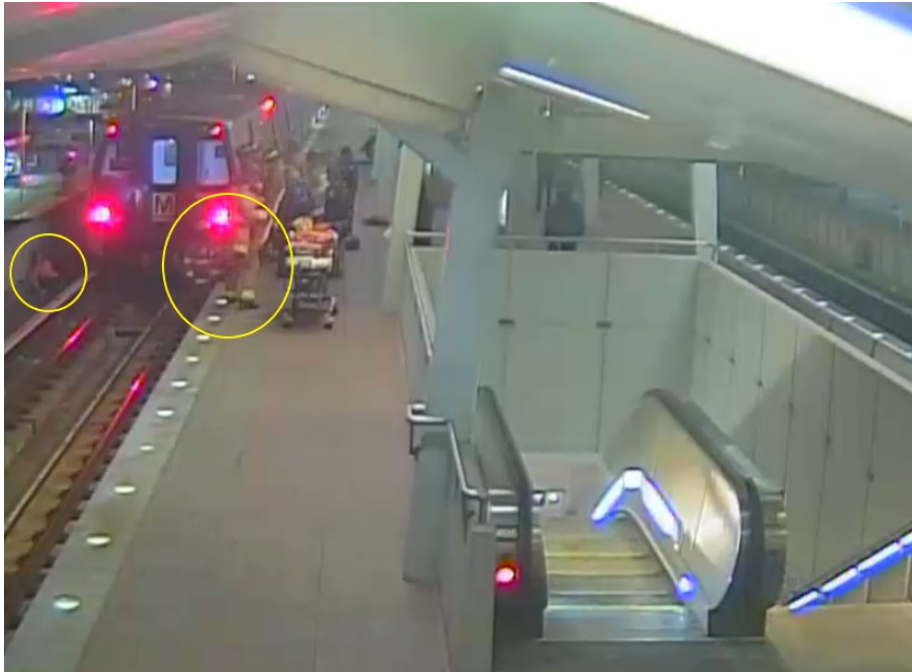
Image 8: FCFRD enter the roadway to retrieve the subject customer at 20:47 hours.

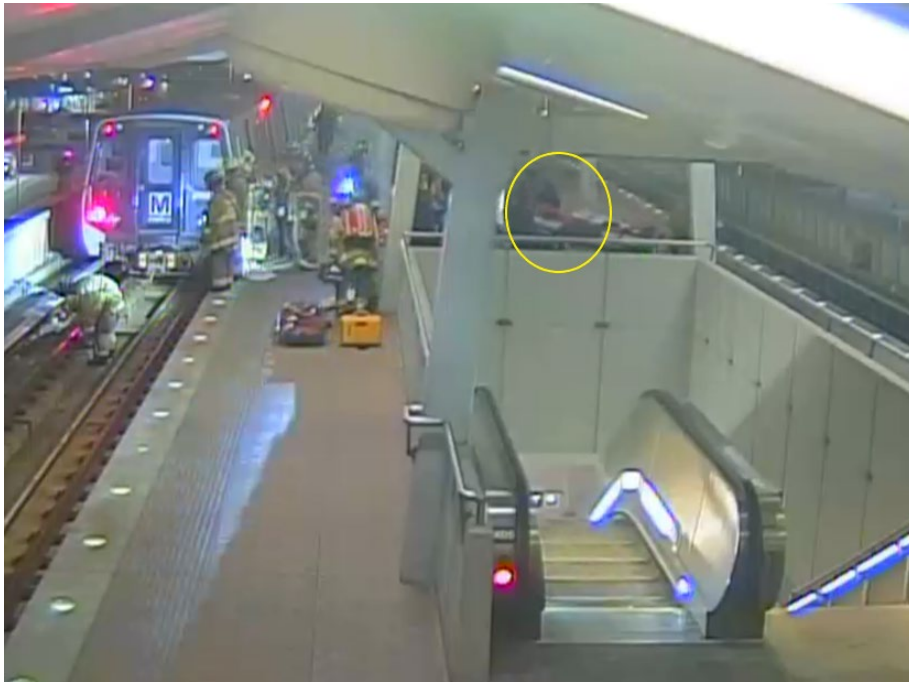
Image 9: FCFRD extricated the subject customer from the roadway at 20:52 hours.

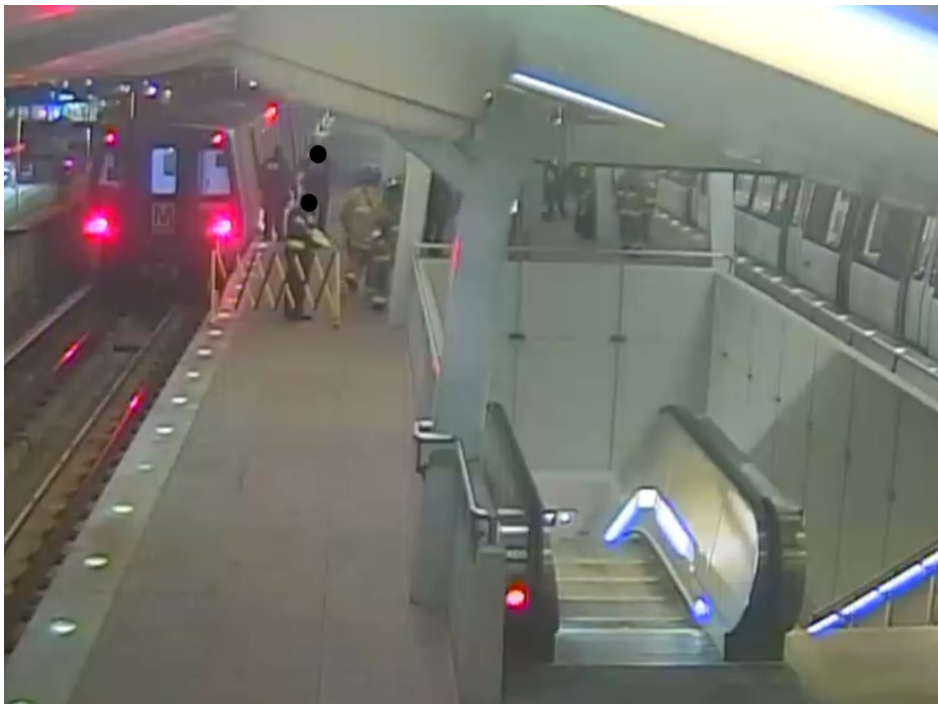
Image 10: Scene documentation and clean up commenced at 21:05 hours.

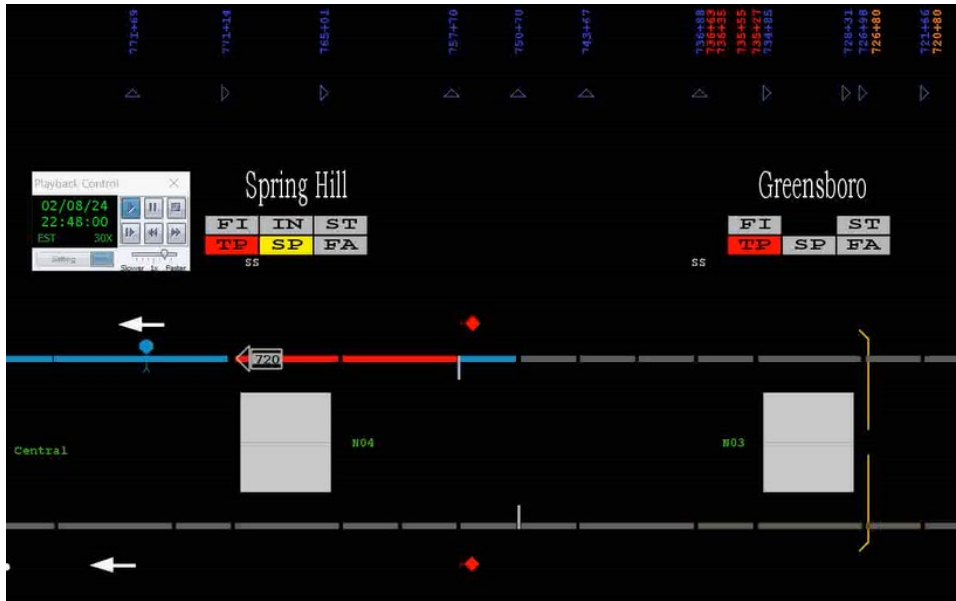
Image 11: Power was re-energized between the Spring Hill Interlocking and the end of the Greensboro Station platform limits, track 2 at 22:48 hours.

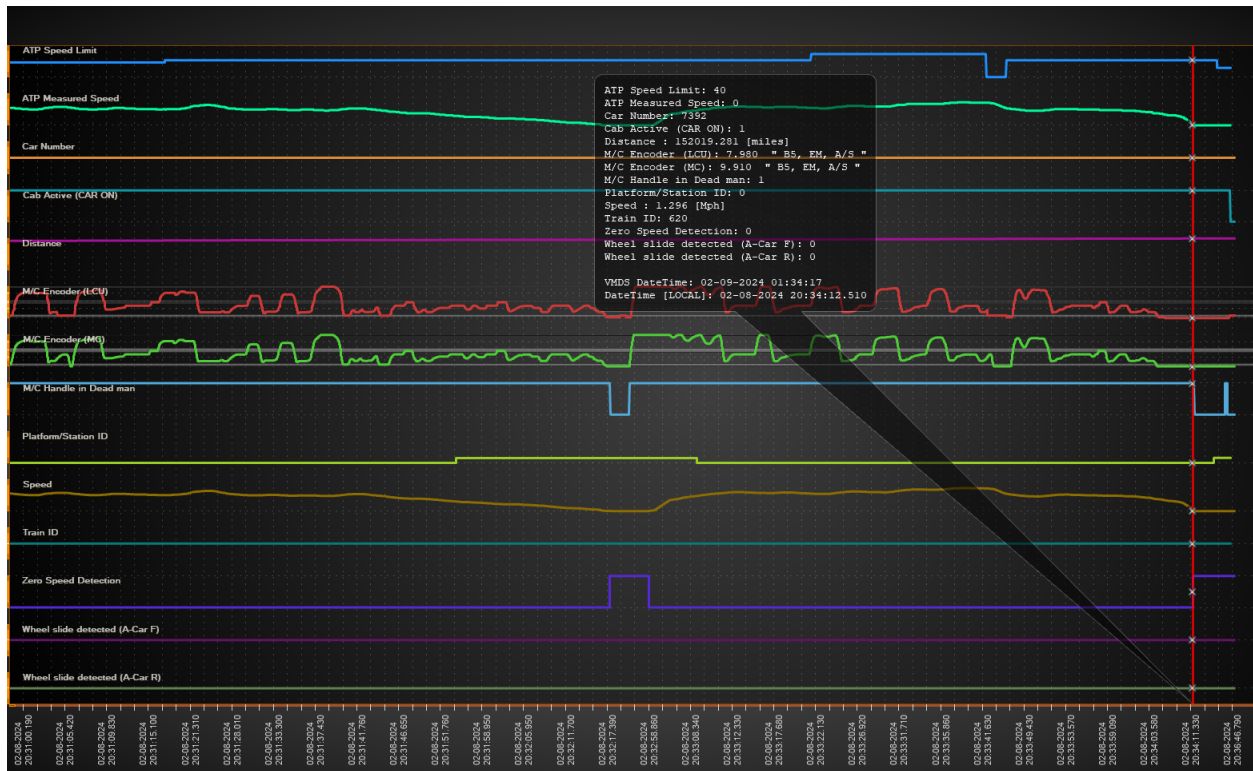
Figure 1 –Train ID 620 Train Performance

The train deceleration rate calculated is into the specification limits (approximately 3.0 MPHPS).
 Data analysis shows no train functional anomalies.
