**Automatic Train Control Violations
Innovation and Huntington stations
March 17, 2023 – March 28, 2024**

Document Purpose:

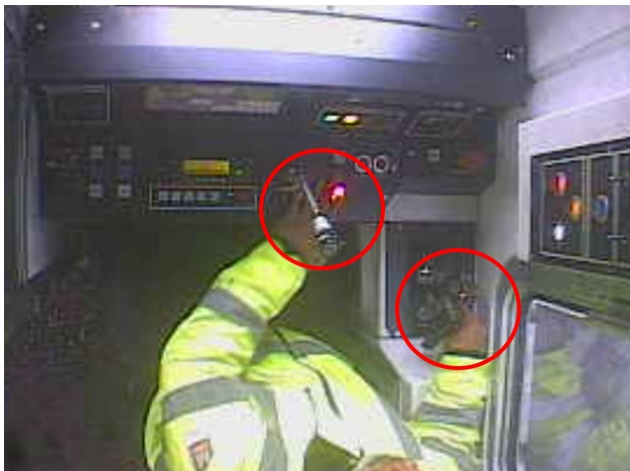
Image 1 - Console video capture of Operator entering ATO prior to Loudoun Gateway Station.

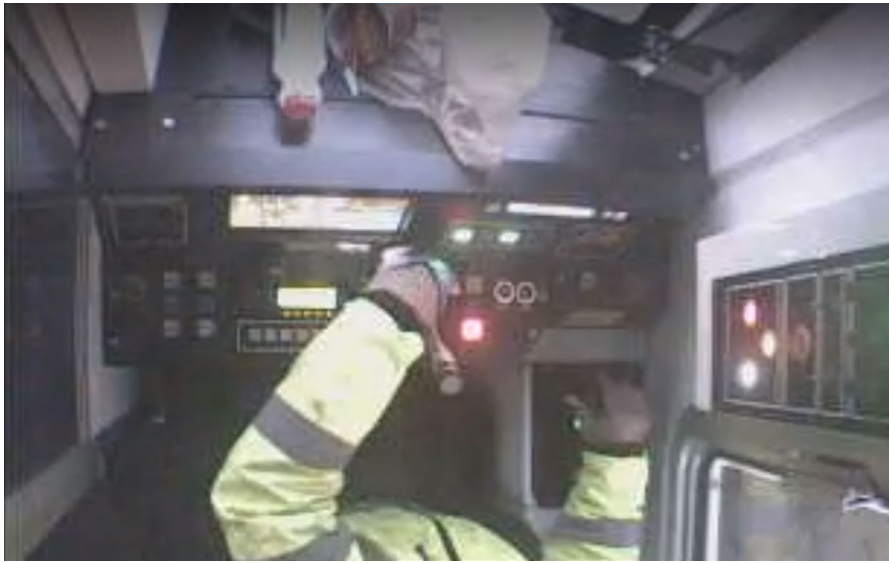
Image 2 - Screenshot from Operator's Cab Video of Car 7618 at 07:14 hours. Train Operating in Manual Mode.

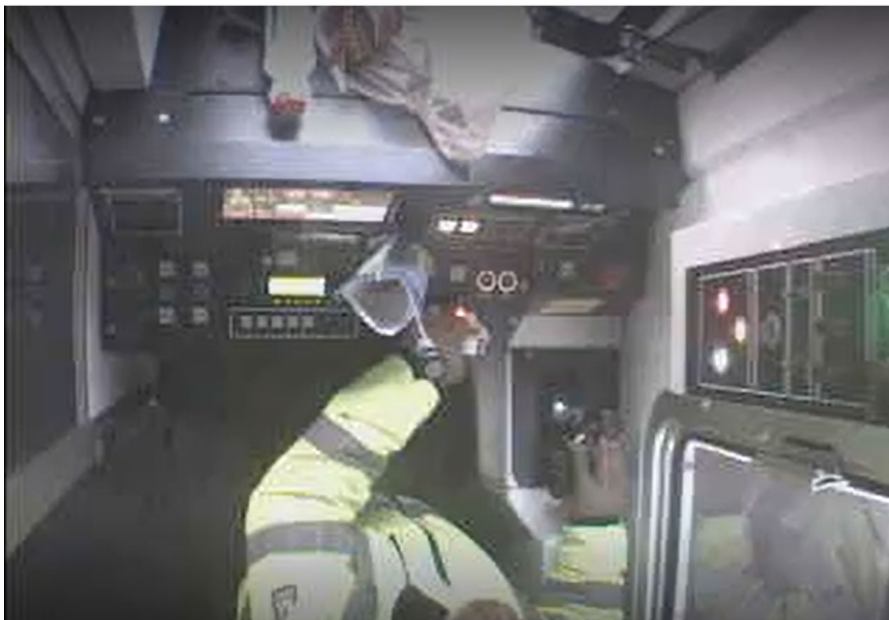
Image 3 - Train Operator entering ATO mode at 07:28 hours. Food and drink items open and on the console.

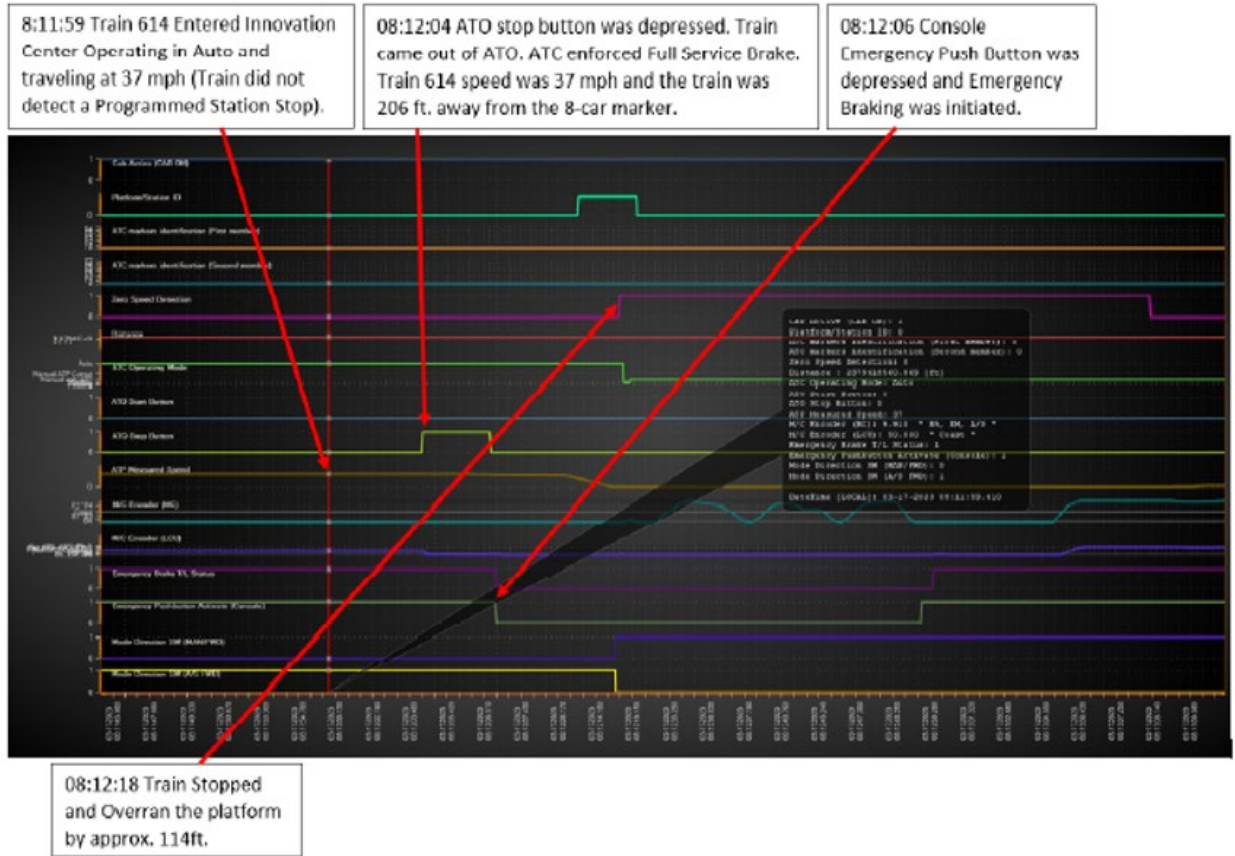
On March 22, 2023, CMOR/IIT completed an additional inspection and provided the following analysis of the Train Operator's outbound trip on Track 2 from Ballston to Ashburn Station:

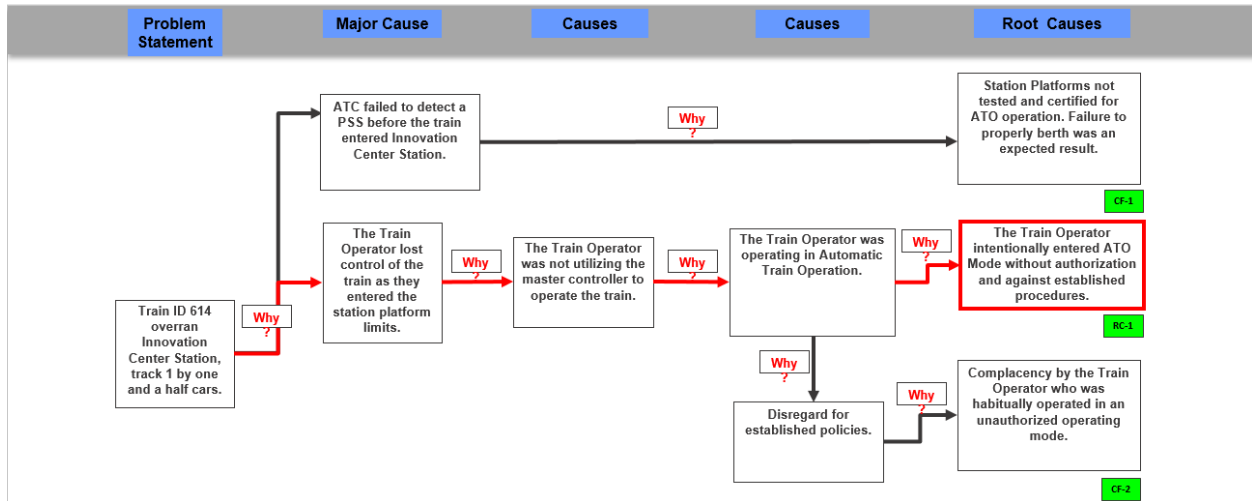
5 Root Cause Analysis

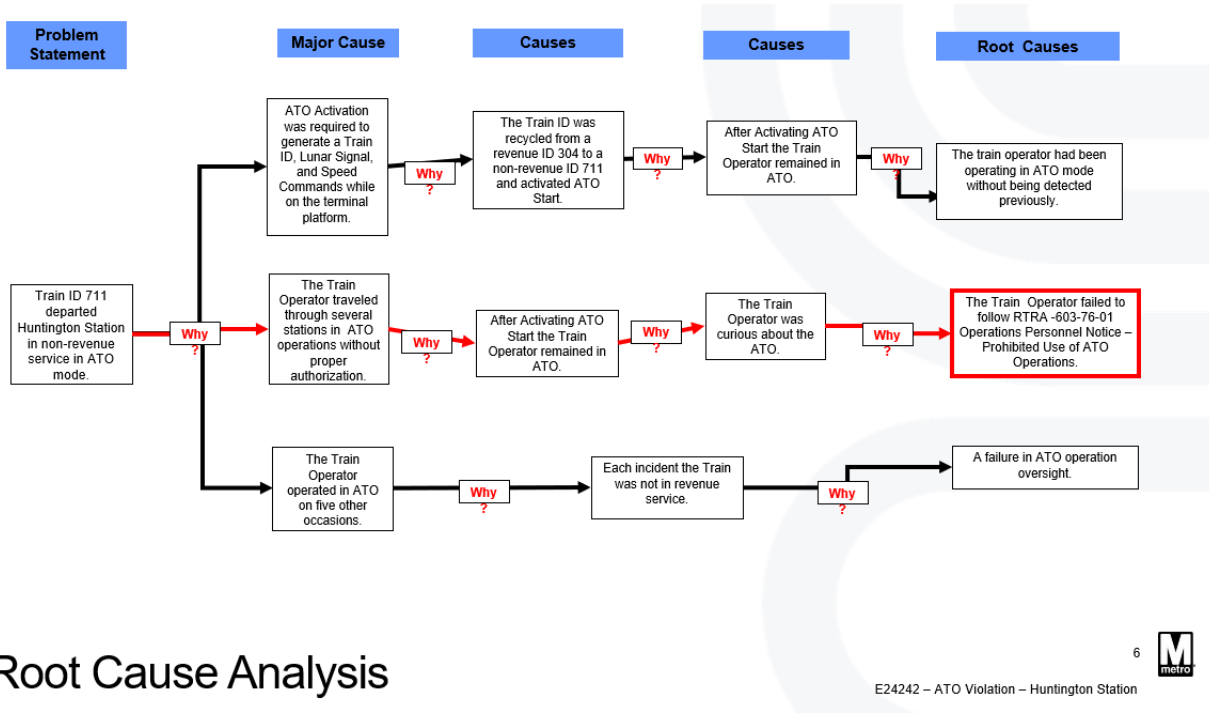
Appendix C – Why-Tree Analysis
