WMSC Inspection Report 20241205A

Inspection of the New Carrollton S&I Shop and Yard

New Carrollton Yard (D99)

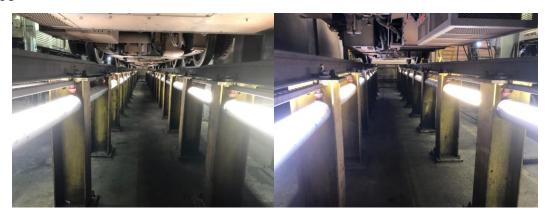
Defect 1

Some lights out in the blow pit area.

Hazard Rating: 4C

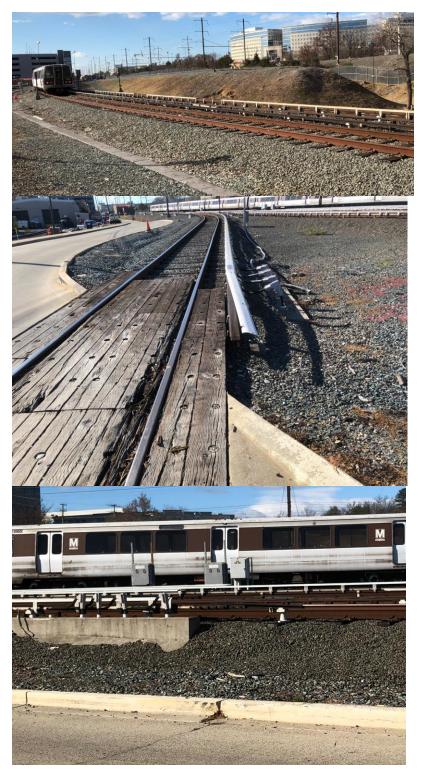
Defect 3

There were several missing third rail covers by the East and South side of the S&I Shop, a damaged third rail cover by the rail crossing on the east side of the S&I Shop, and a missing third rail cover across the CTEM building.

Hazard Rating: 3D
